NOTICE OF VIOLATION, DONNER SUMMIT PUBLIC UTILITIES DISTRICT, NEVADA COUNTY

INSPECTION REPORT

Facility: Wastewater Treatment Plant
53823 Sherritt Ln
Soda Springs, CA 95728
Nevada County

Attachment A
Photo Log
Donner Summit Public Utility District
Wastewater Treatment Plant
30 June 2008

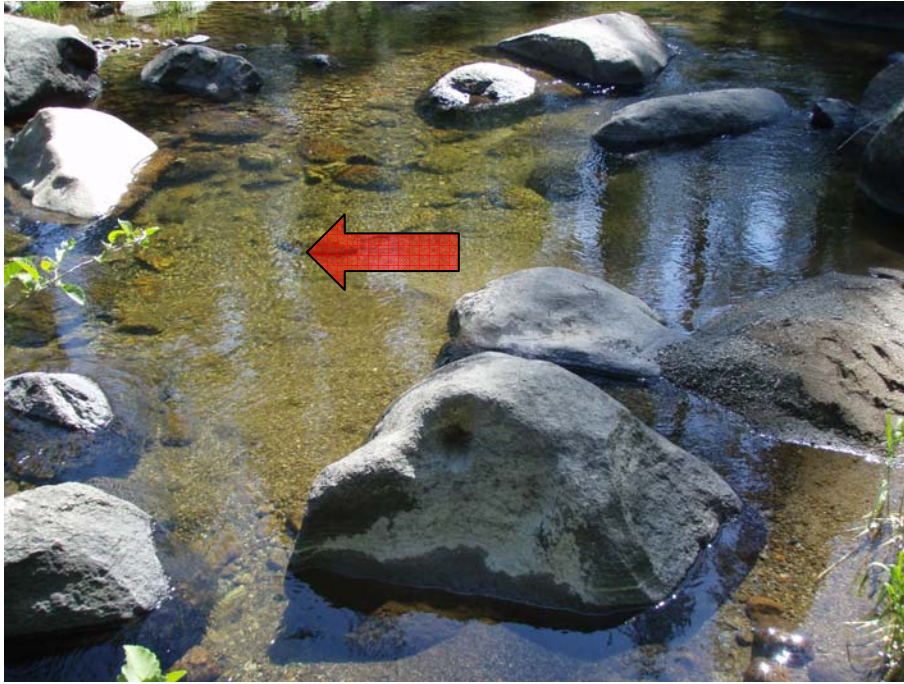
This location is approximately 50 feet upstream of the effluent discharge point, and represents background conditions unaffected by the effluent discharge from the WWTP. The Discharger routinely collects samples from this location to measure compliance with receiving water limitations. At the time of our inspection, the water appeared clear (Figure 1). A minimal amount of attached algae was present, and was the least of the four river observations. Samples were collected at this location.

Figure 1. Monitoring point R-1 (50 feet upstream of effluent discharge point). The arrow indicates the approximate sample location. SMJ.

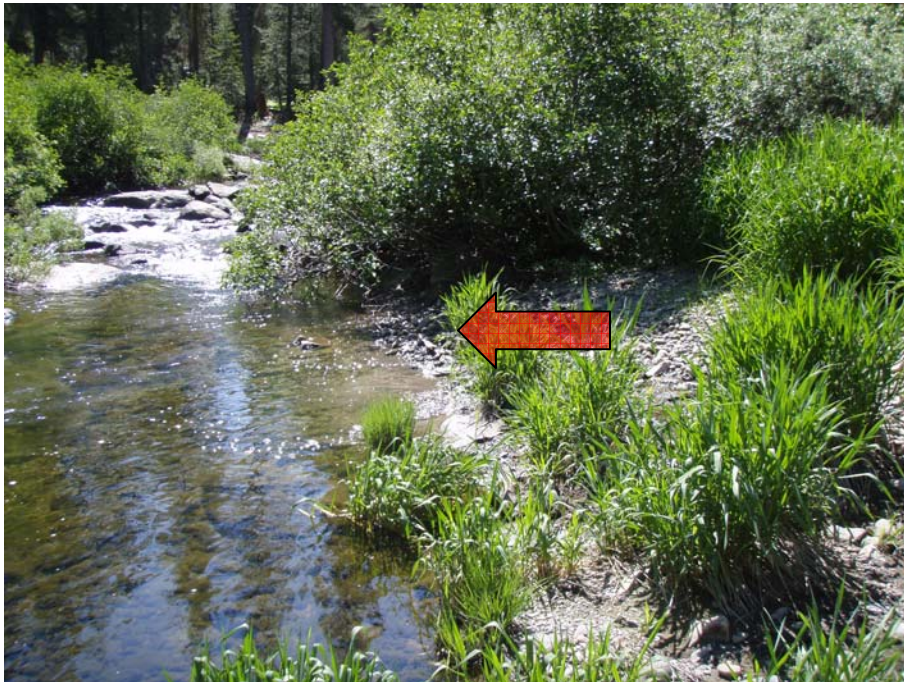
This location is where the effluent discharges from a diffuser consisting of a pipe buried beneath gravel near the edge of the river. Effluent flows through the gravel and down into the river. Effluent was discharging into the river at the time of our inspection (Figure 2). Some of the effluent was visible trickling between the gravel. The effluent appeared clear and was visually indistinguishable from the river (Figure 3). Some attached algae growth was present near the effluent discharge point, particularly along the side of the river where effluent mixes with the receiving water (Figure 4). No samples were collected at this location.

Figure 2. Effluent discharge point, looking upstream. The arrow indicates the gravel diffuser. SMJ.

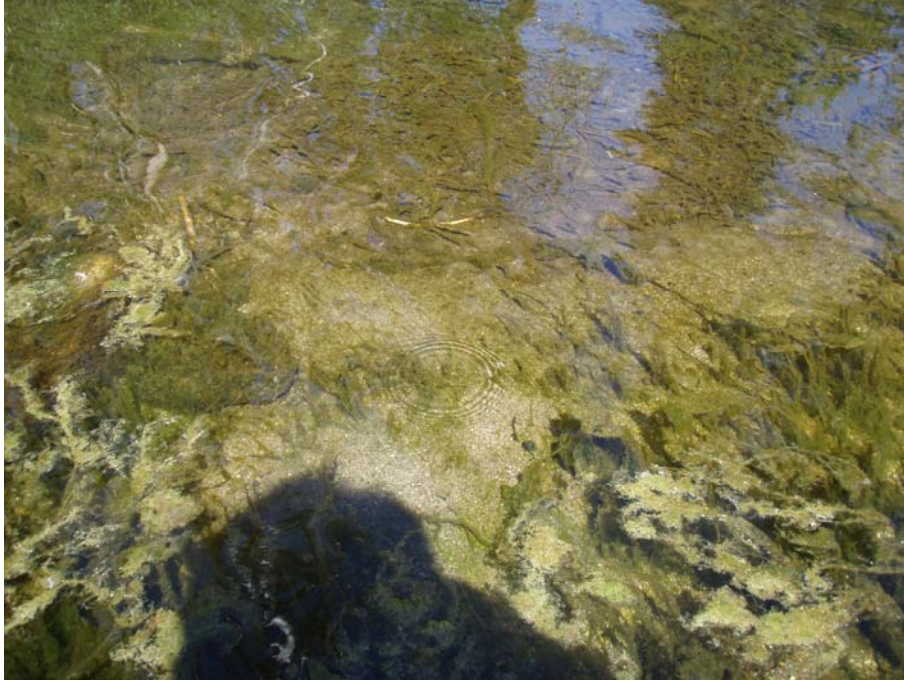
Figure 3. Adjacent to effluent discharge point. SMJ.

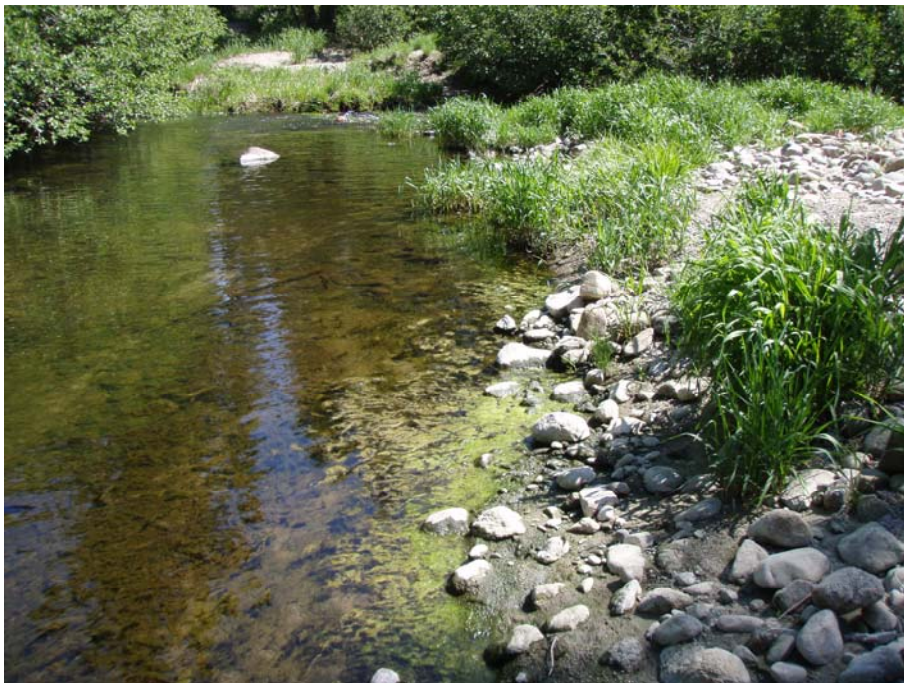
Figure 4. Directly downstream of effluent discharge point, looking upstream. SMJ.

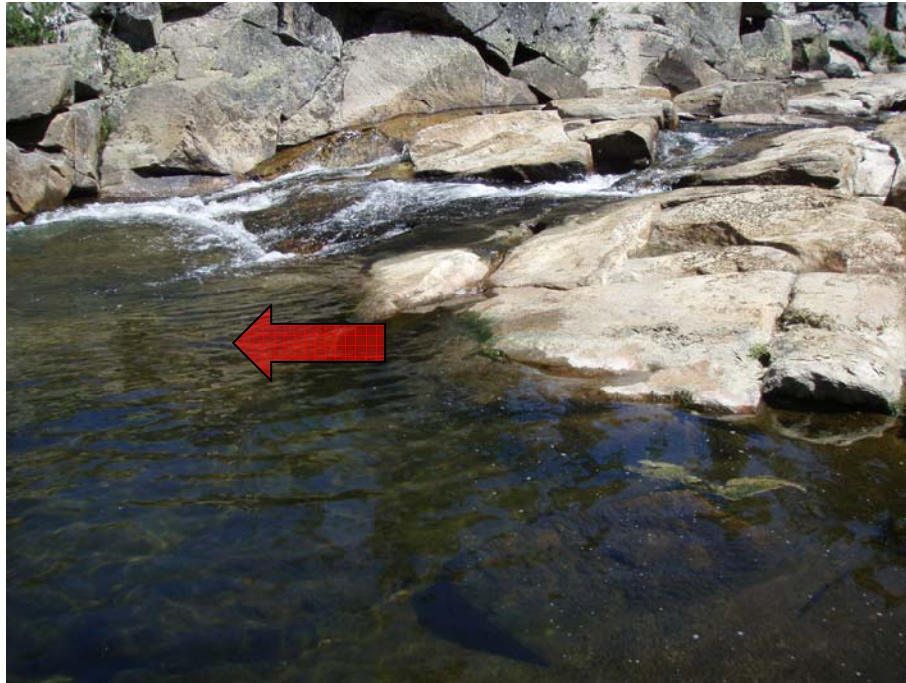
This location is approximately 500 feet downstream of the effluent discharge point, and represents the compliance point where complete mix with the receiving water is expected. R-2 appeared clear (Figure 5). Attached algae growth at R-2 was the most pronounced of all of the observed locations (Figures 6, 7). Samples were collected at this location.

Figure 5. Monitoring point R-2 (500 feet downstream of effluent discharge point). The arrow indicates the approximate sample location. SMJ.

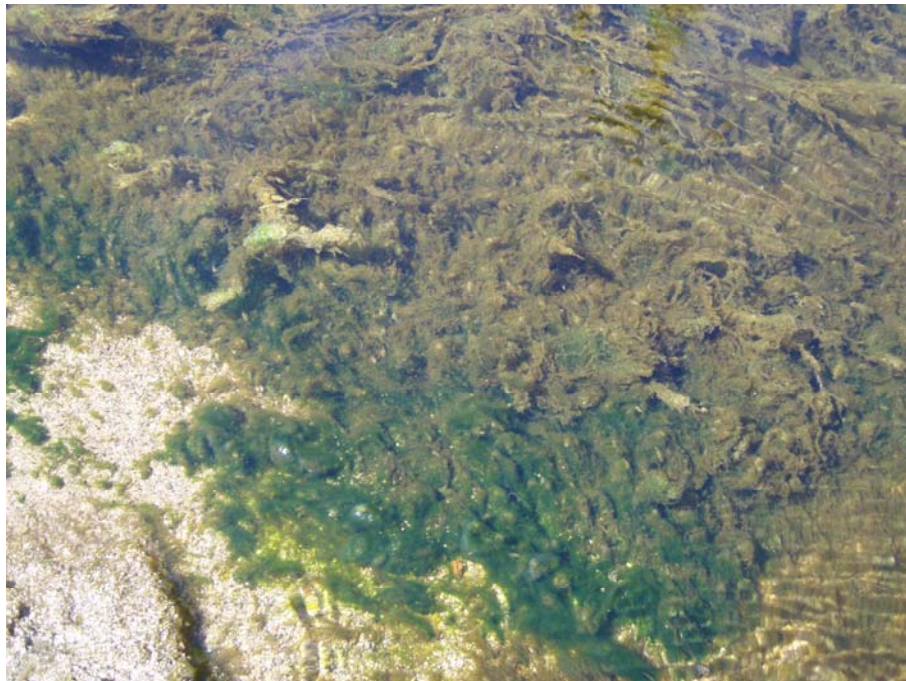
The treated effluent adds nitrate, organic nitrogen, phosphorous, and orthophosphate to the South Yuba River. These nutrients are known to promote algae growth. There was algae growth below the effluent discharge point that appeared to be caused by the discharge, in violation of Receiving Water Limitation No. G.5.

Figure 6. Monitoring point R-2. SMJ.

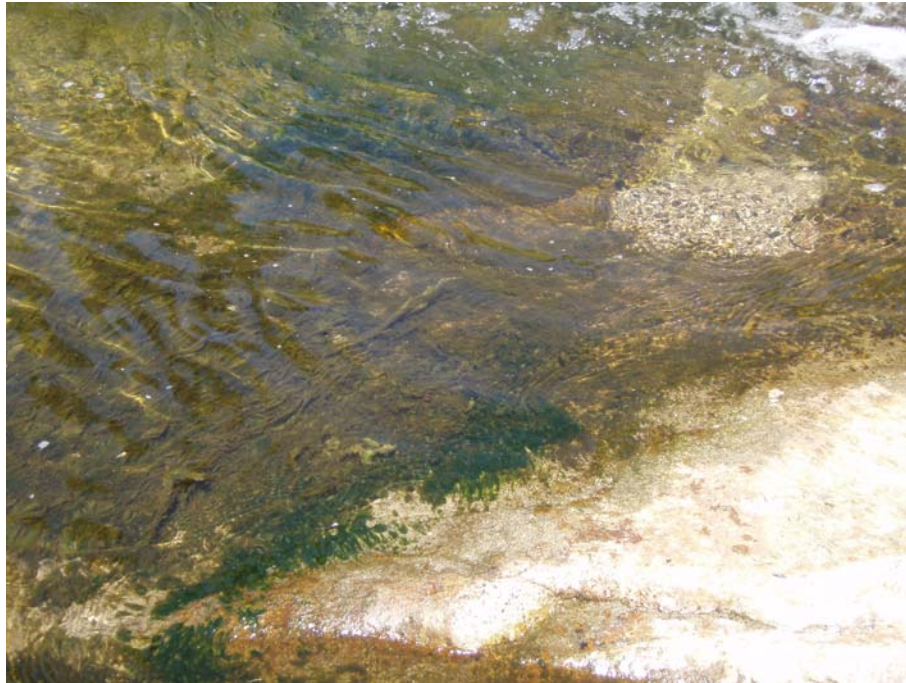
Figure 7. Monitoring point R-2. SMJ.

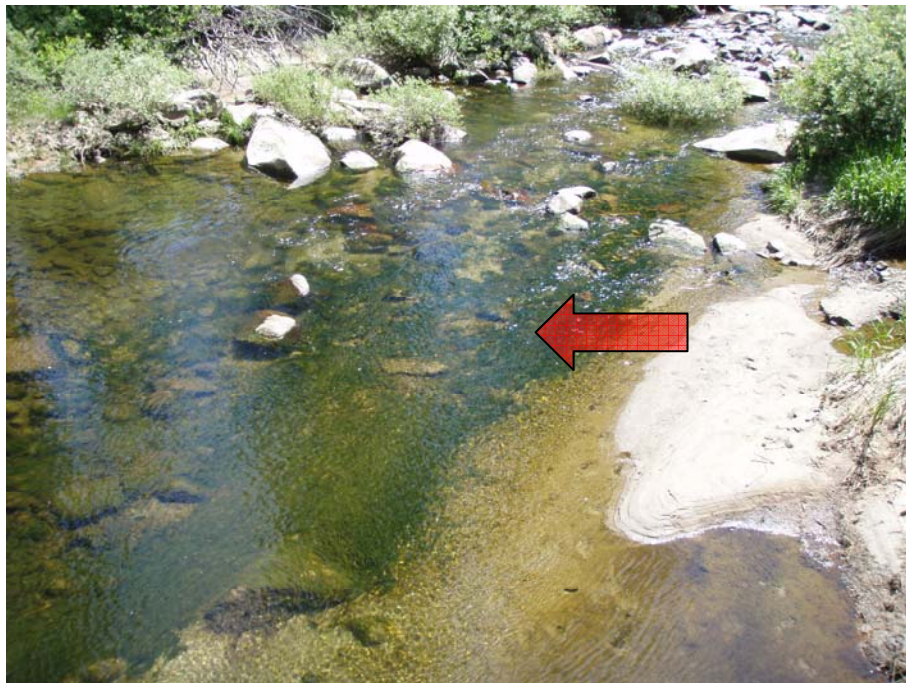
Donner Summit PUD, this is the location where the Complainant's photos were taken. The river at this location appeared clear (Figure 8). Some attached algae growth was present. Samples were collected at this location.

Figure 8. Directly upstream of Towle Mountain Rd, from the bridge. The arrow indicates the approximate sample location. SMJ.

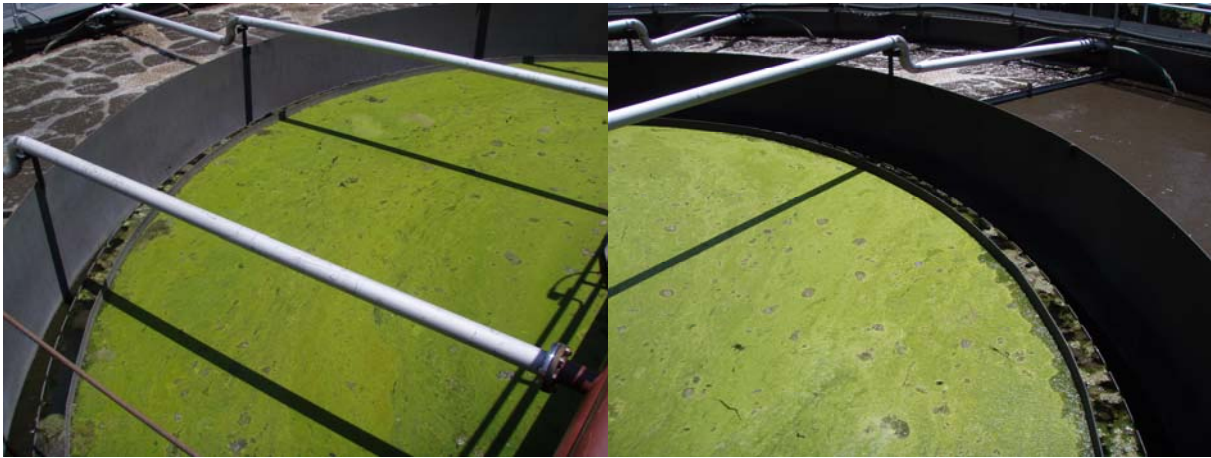
Figures 10 to 13. Package Secondary Treatment Plant No. 1.

We briefly observed the secondary treatment processes, and discovered some operational concerns at the facility. The surface of secondary clarifier No. 1 was vibrantly green (Figures 9, 10), unlike prior observations in October 1999 and February and August 2007 (Figures 11 to 13). The secondary clarifier No. 2 had algae growth on the weirs, trough, and other submerged structures (Figures 14, 15). The facility representatives indicated that they had not cleaned the algae off the clarifiers due to some operational problems with the filters. They expressed concerns that the excess algae, if released to the filters, could cause operational problems. They were planning to switch over to land disposal within the next few days, and indicated they would address the algae on the clarifiers after that time.

Algae growth in the secondary clarifiers is an indication that the facility may be having operational problems.

Figures 9, 10. 30 June 2008. The uniform color green appears different due to different photographic exposure durations. SMJ.

1. The inability of the WWTP to denitrify and to remove nitrate from the discharge. The WWTP cannot consistently meet its effluent limitation for nitrate, as evidenced by historical nitrate effluent concentrations. Please provide plans and a time schedule for reducing nitrate concentrations in effluent to comply with effluent limitations and to prevent further violations of receiving water limitations.
2. The condition of the clarifiers, and the concerns raised about filter operations support that the WWTP is encountering operational problems. Please provide a detailed explanation of the problems, and the measures being taken to improve operations at the facility.

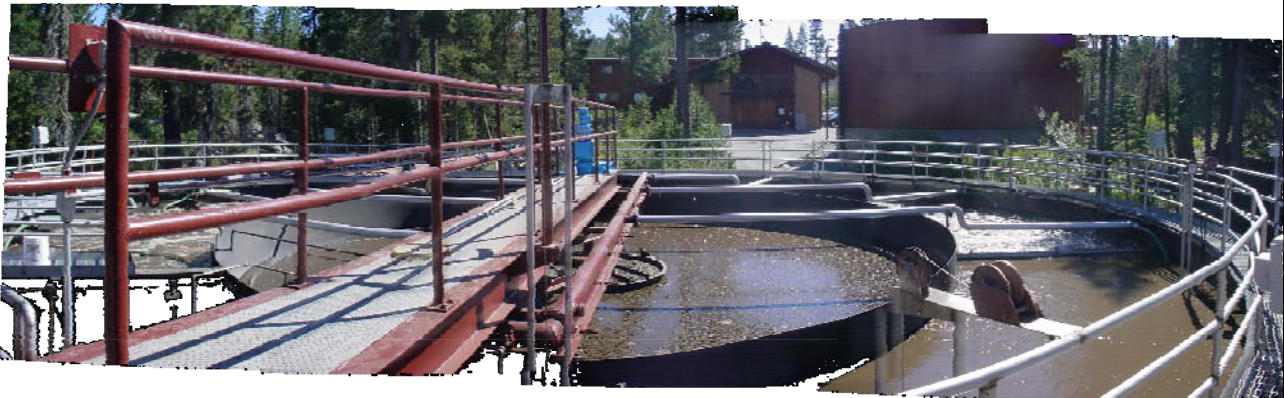
Figure 11. 9 August 2007. SMJ.

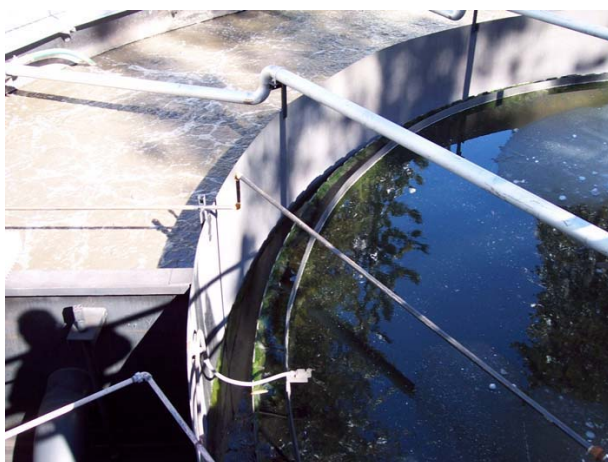
Figure 12. 14 February 2007 (Winter conditions). Scott Slamal, Tetra Tech, Inc.

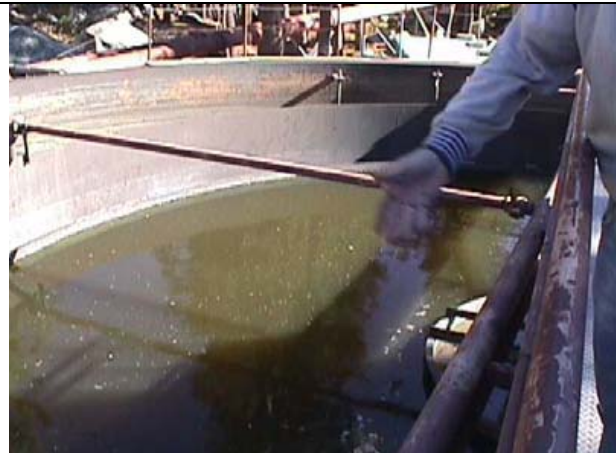
Figure 13. 7 October 1999. Robert Fagerness, Regional Water Board staff.

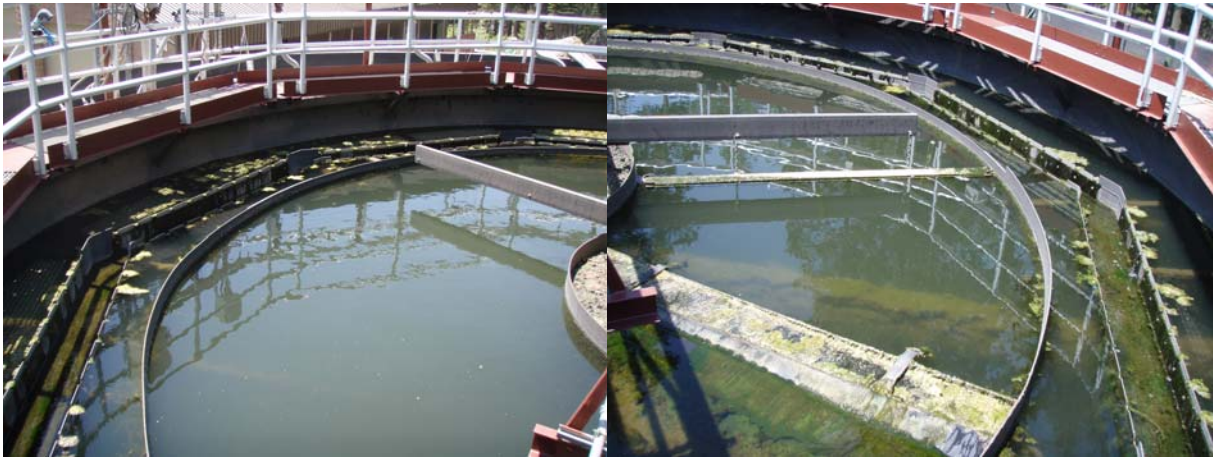
Figures 14, 15. Package treatment plant No. 2. Algae is growing on effluent troughs, scum trough, and other submerged structures. Floating algae is also growing outside of the scum ring. SMJ.
