Donner Summit Public Utility District Groundwater Monitoring Study

January 2010

Prepared for
Donner Summit Public Utility District

Prepared by
ECO:LOGIC

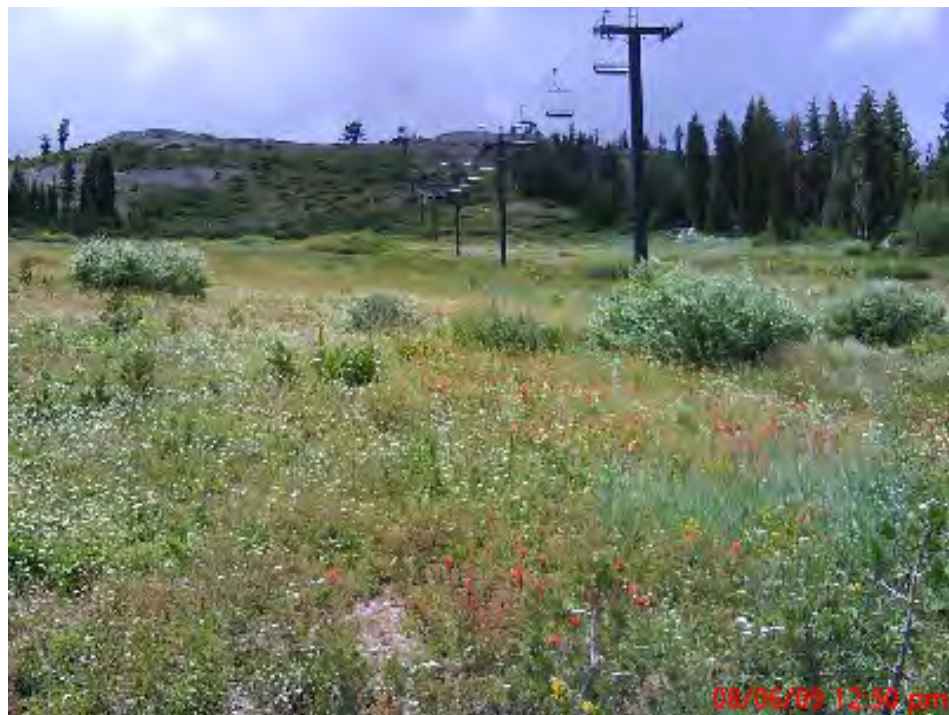
Figure 7
View of Central Area II, Looking South from Zone A
(Irrigation begins near base of hill in background)

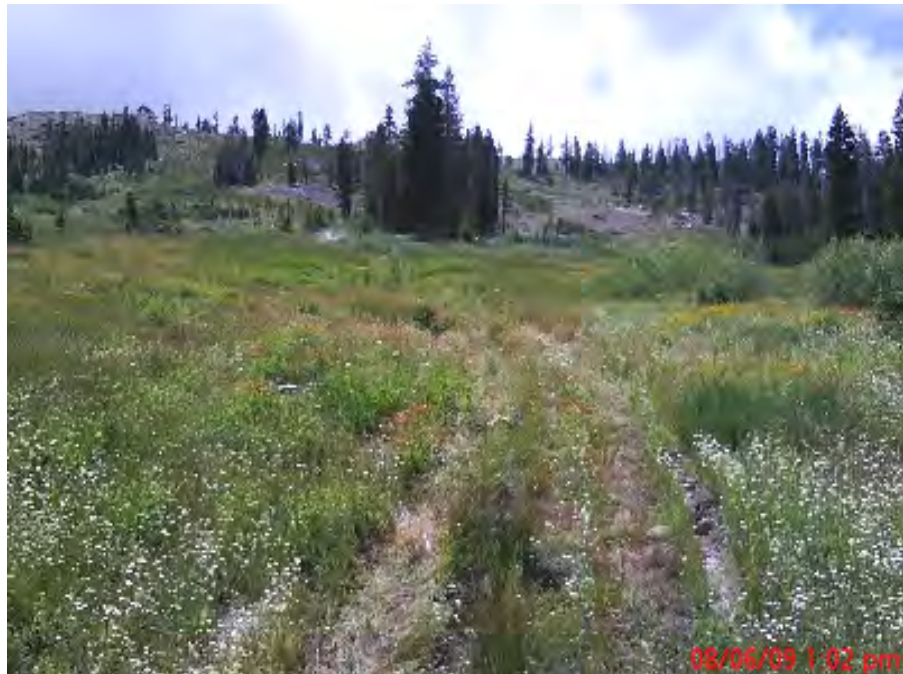
Figure 12
View of Western Application Zone III.
(Effluent is being applied near base of hill in background. No runoff was observed, although a small area of damp soils and willows is present below area being irrigated.)

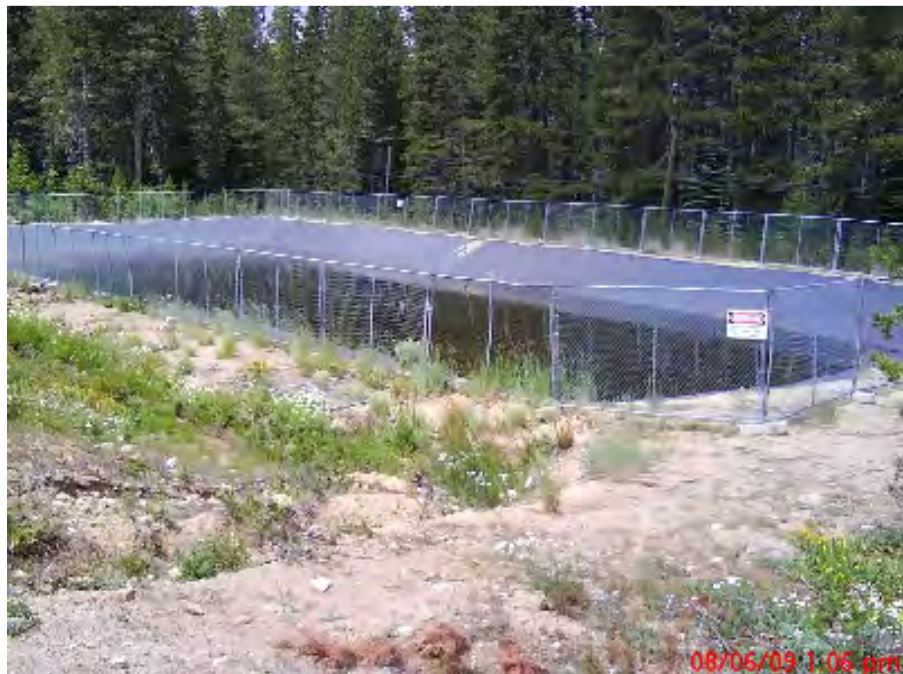
Figure 13
Irrigation Runoff Recovery Pond Located in Northwest Corner of Property

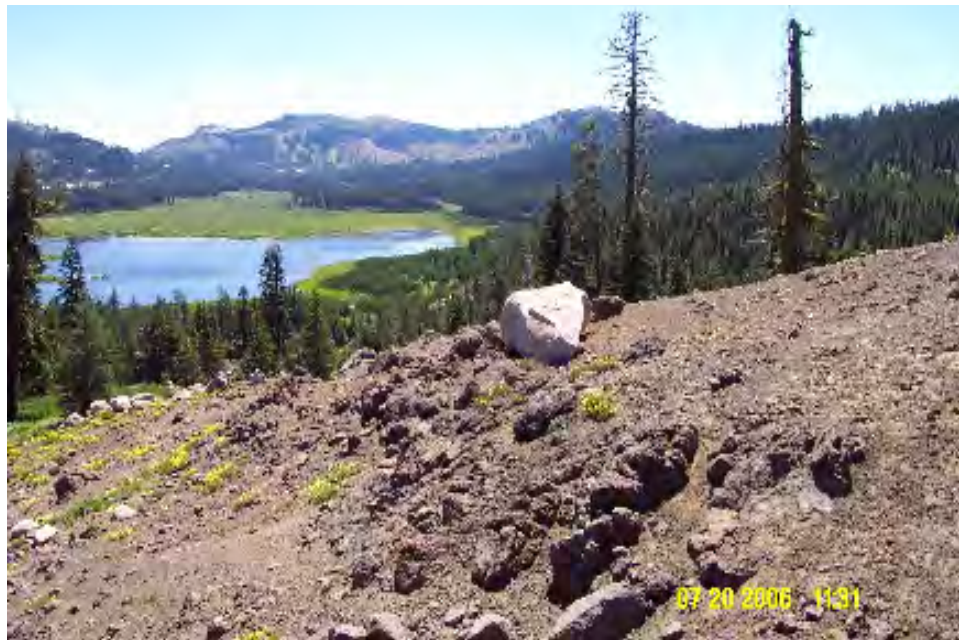
Figure 17
View of Basalt Agglomerates Located Near East End of Top of Ski Hill
(Note large granite glacial erratic on top of basalts.)

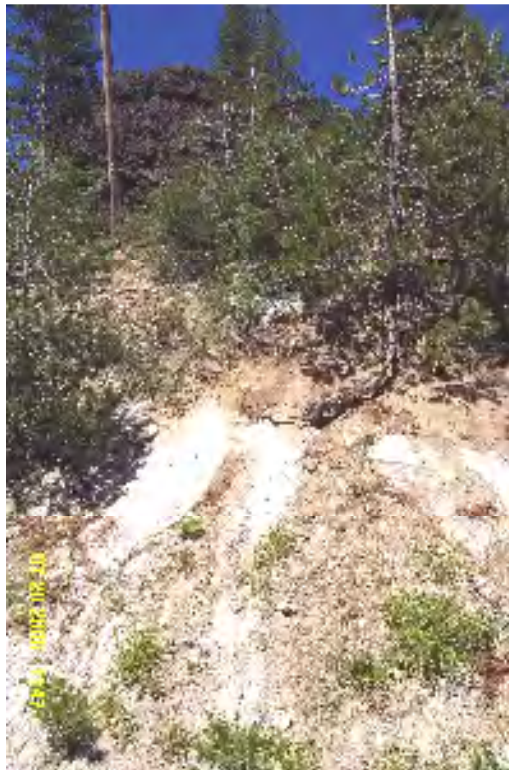
Figure 18
View of Weathered Tuffs Overlain by Basalt
(Photo taken along road on east end of Hill. Andesite is apparently absent here.)

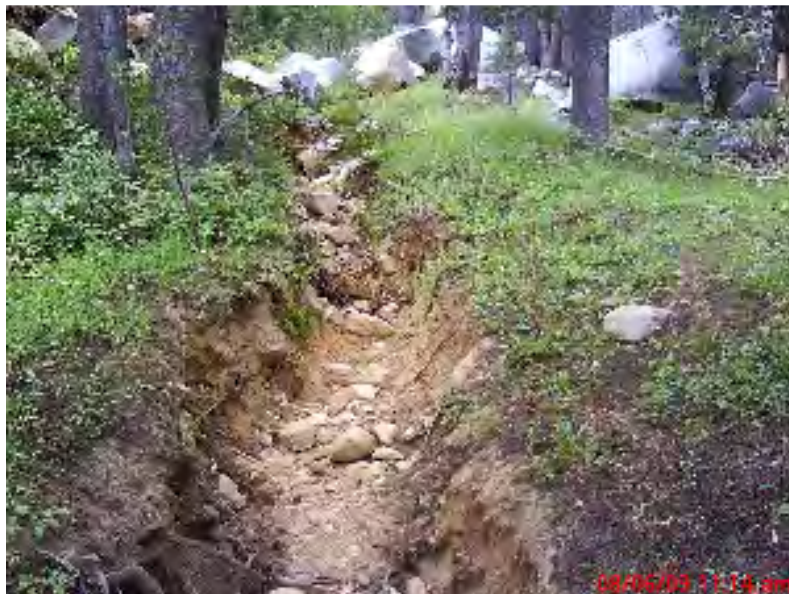
Figure 20
Dry Runoff Channel Located on West Side of Middle Field Taken Above Pipeline Road, Looking South (about 100 feet west of the spring area) (Channel receives runoff from snowmelt or large storm events. Note granite outwash/till)

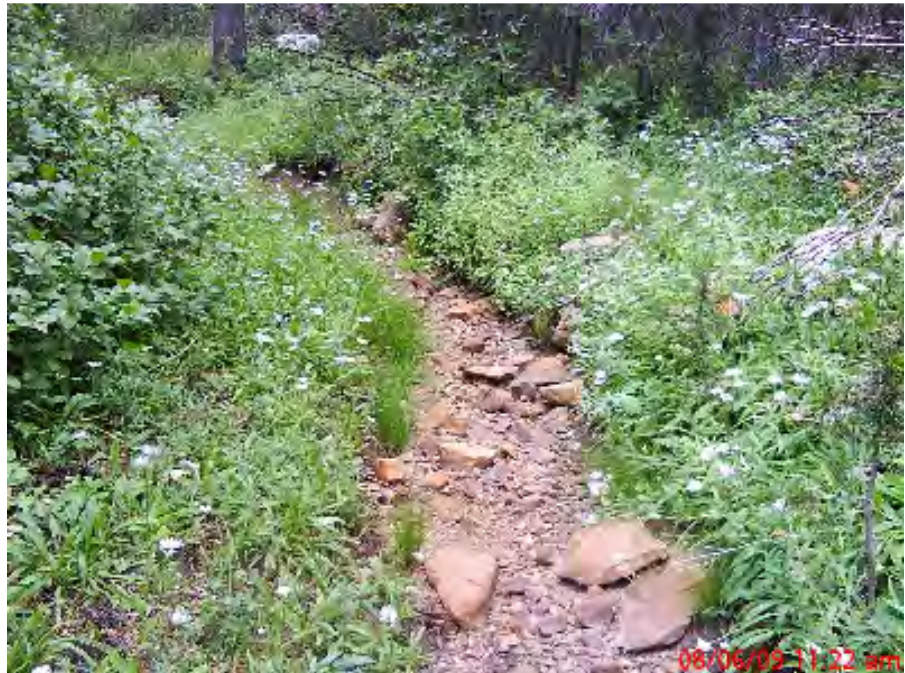
Figure 21
Dry Channel Located Below the End of the Runoff Collection Ditch Near
The Pond
(Notice iron-oxide stained rock)

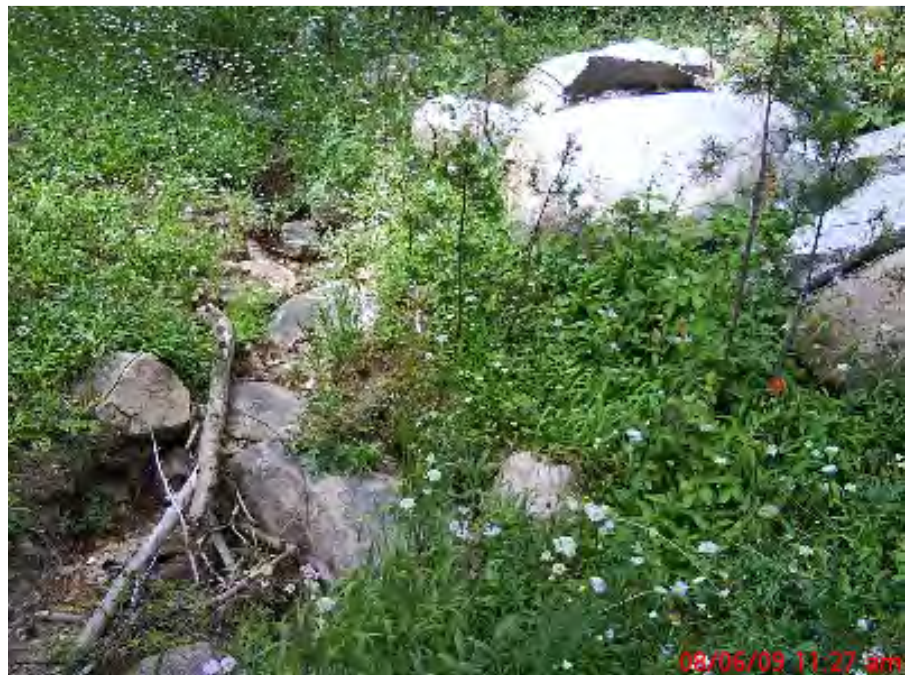
Figure 22
View of Dry Stream Channel On Far West Side of Property Showing Typical
Granitic Glacial Materials In Dry Channel
(Not as much iron stain, here, as in Figure 24)

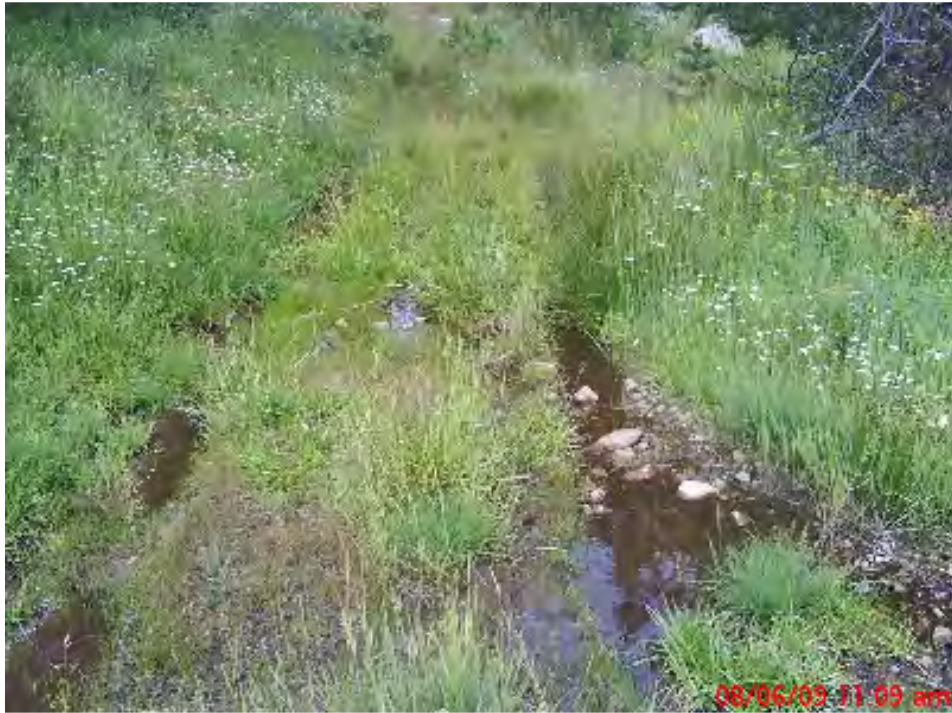
Figure 25
View of Spring Seepage on Pipeline Access Road Just Below Ski Slopes
(The flow appeared to be only one to two gpm.)

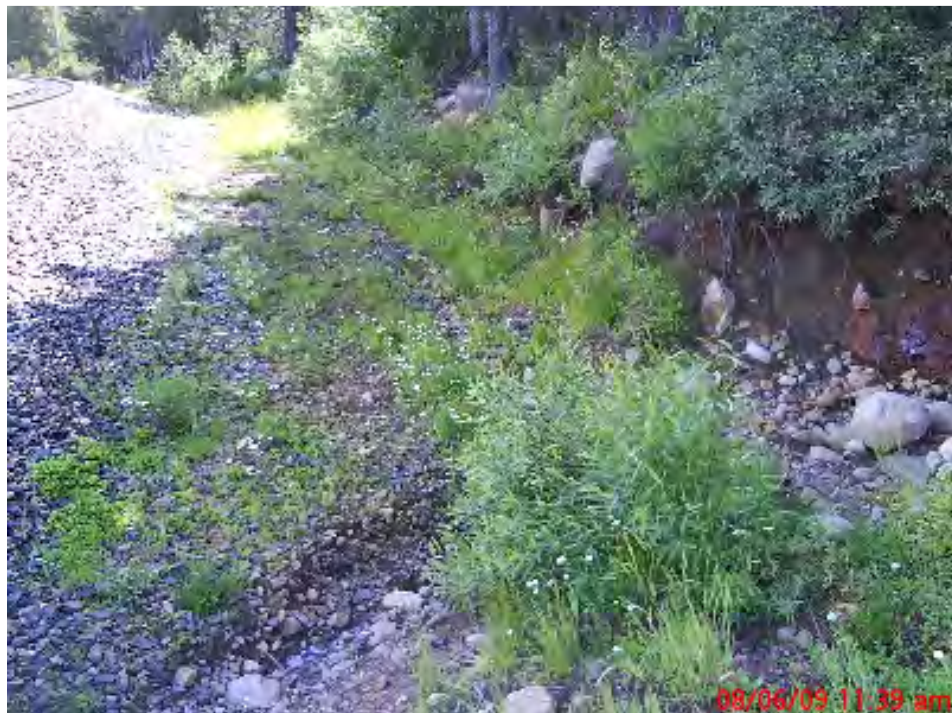
Figure 26
All Seepage Appears To Infiltrate Along The Railroad Tracks
