Donner Summit Public Utility District Groundwater Monitoring Study

January 2010

Prepared by
ECO:LOGIC

Groundwater Monitoring Study

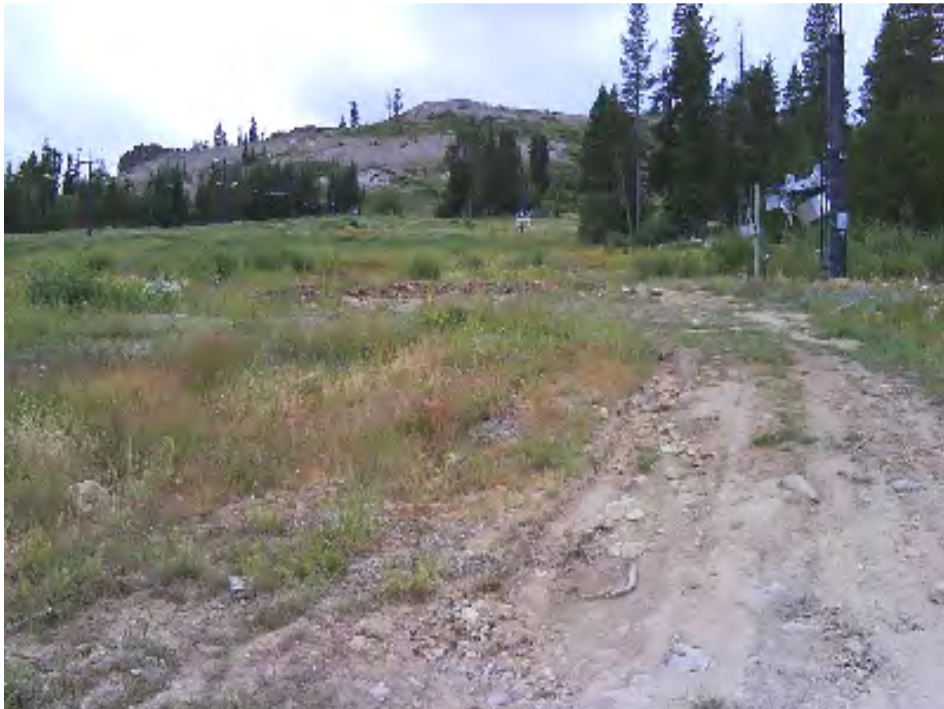
Figure 4
View of Area I Looking South, Taken from Bottom of Zone A
(Irrigation Zone D starts at base of hill in background)

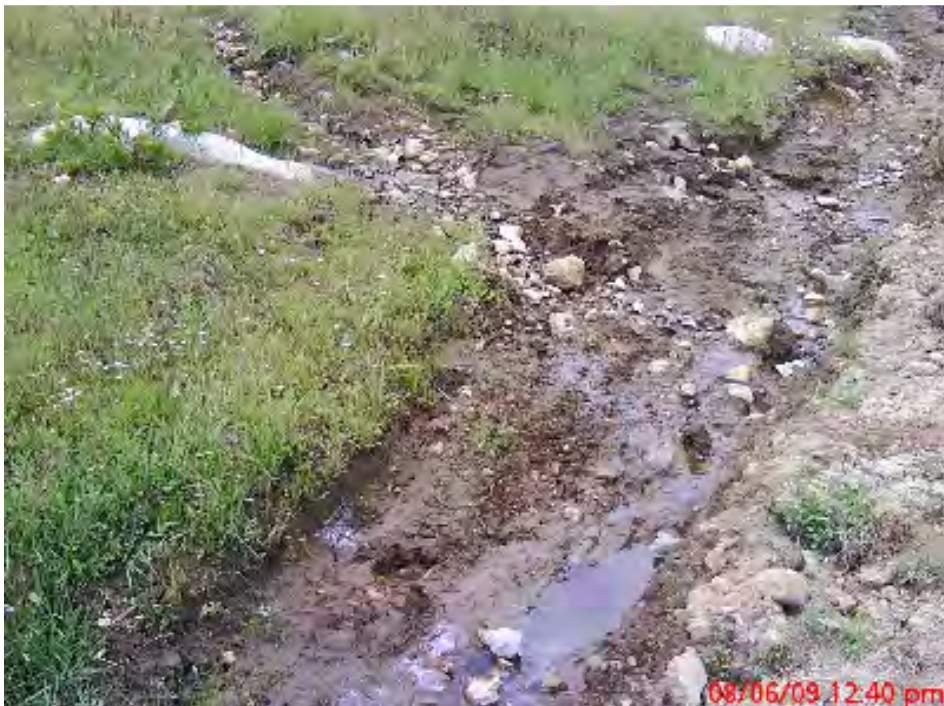
During ECO:LOGIC's site visit, a small amount of irrigation runoff was observed from Areas I and II, but none was observed from Area III. The runoff collected in the ditches located near the base of Zone B, but much of the collected water appeared to re-infiltrate the land surface (thereby providing subsurface irrigation of the grasses in Zone A) before reaching the main collection ditch. Only stagnant water was observed in the collection ditch near the lined recovery pond.

Figure 5
View of Runoff From Area I, Near Bottom of Zone B, Entering the Collection Ditch

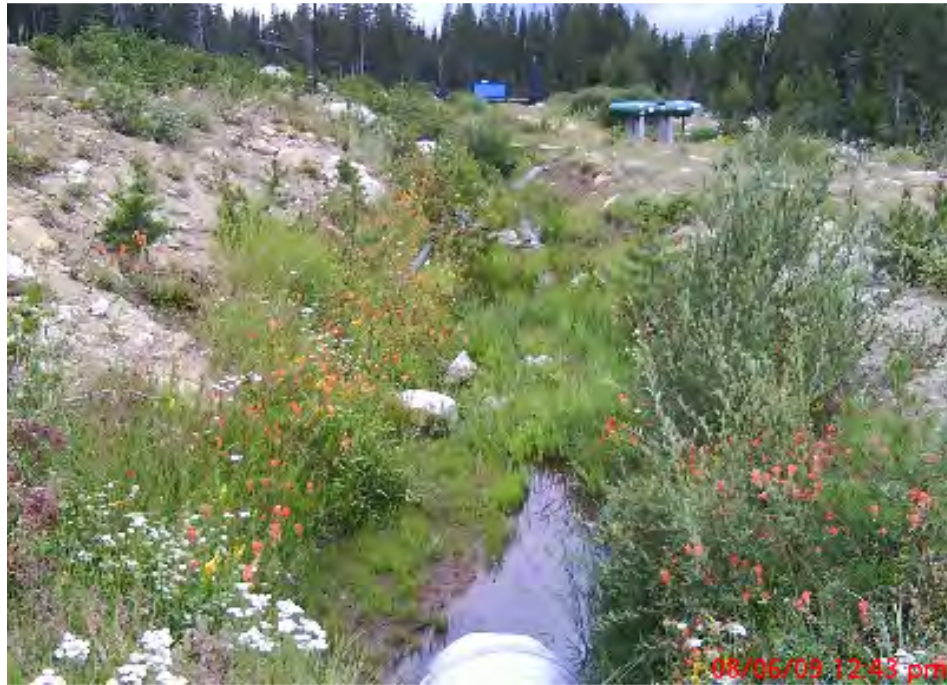
Figure 6
View of Runoff Collection Ditch Looking East from Area I
(Note Adjacent Granitic Outwash)

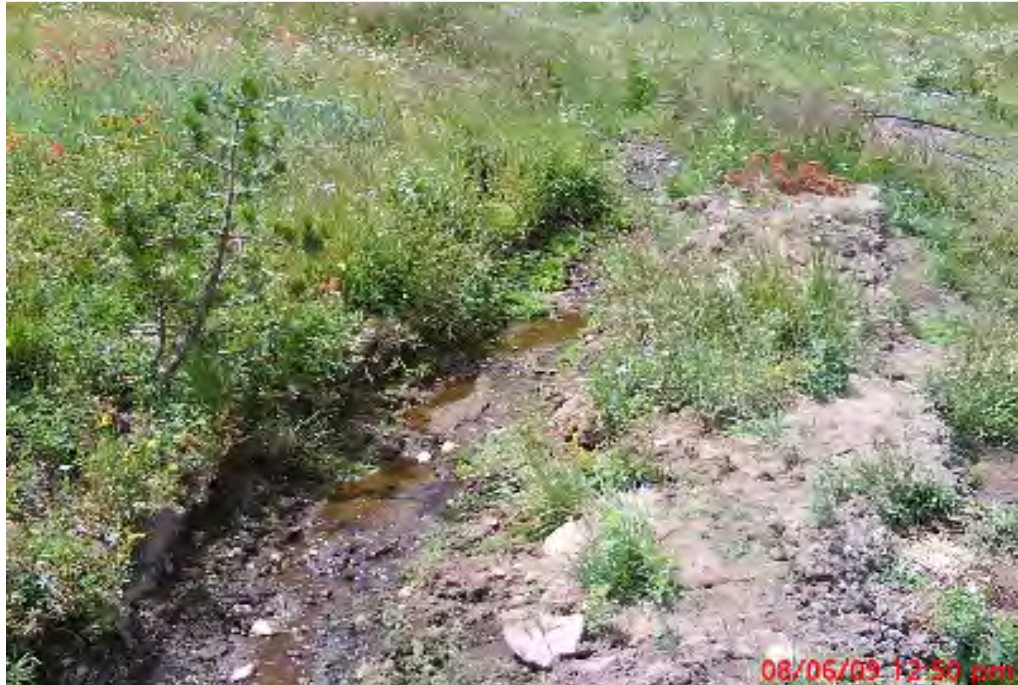
Figure 8
Runoff from Area II, Above the “Spring”

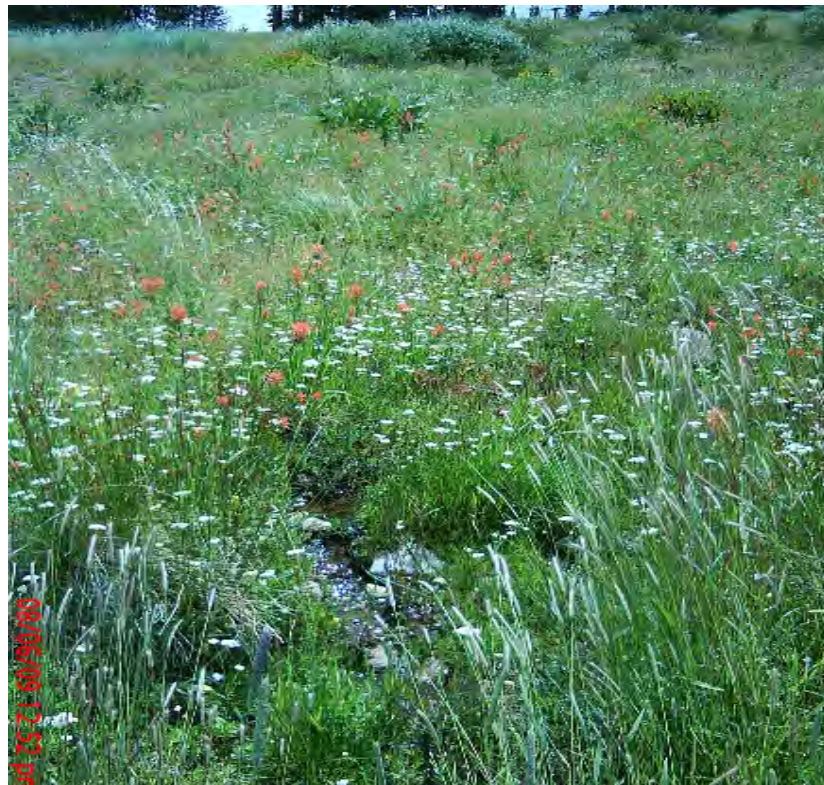
A small amount of natural spring seepage occurs near the bottom of Area II, Zone B. Donner Summit PUD personnel indicated that the spring existed prior to installation of the effluent application system. The flow is captured separately and piped below the effluent collection ditch, where it re-infiltrates the ground surface over a short distance (see Figures 9 to 11).

Figure 9
Wet Soil and Seepage from Spring Located Near Bottom of Area II, Zone A

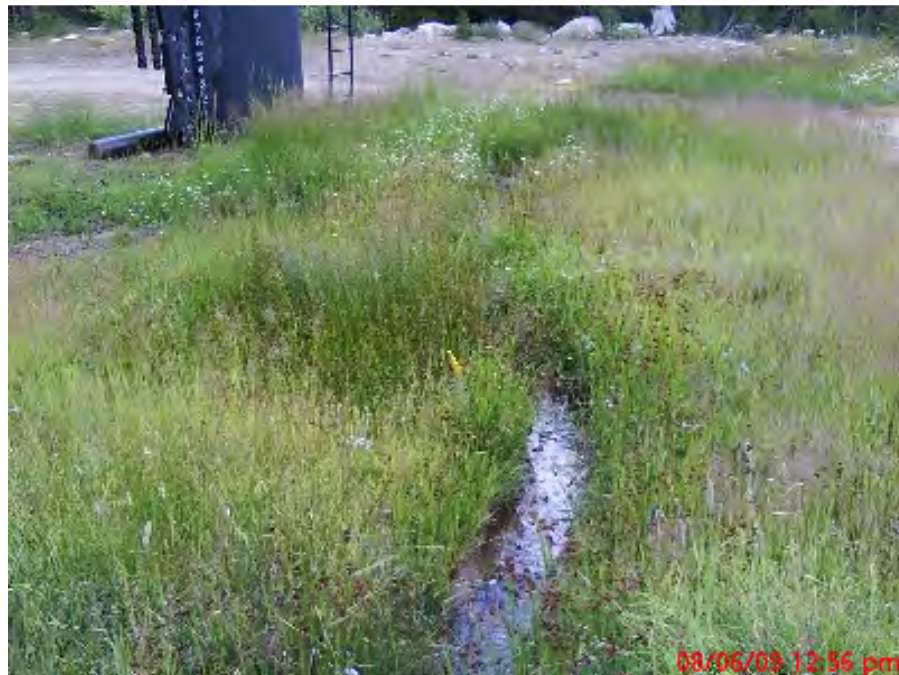
Figure 10
View of Spring Discharge Near Base of Area II, Zone A
(Flow is less than 5 gpm)

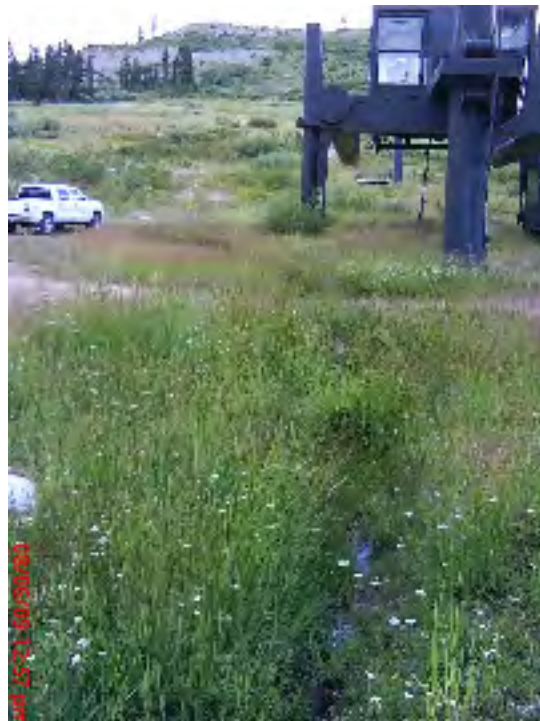
Figure 11
Spring Seepage Just Before it Enters Treeline at Base of Ski Hill

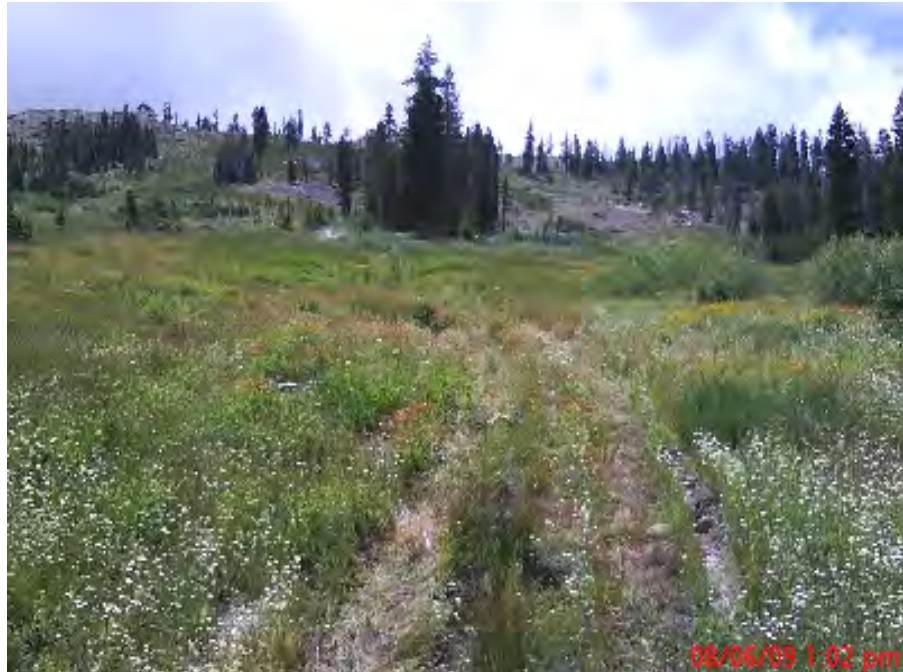
Figure 12
View of Western Application Zone III.
(Effluent is being applied near base of hill in background. No runoff was observed, although a small area of damp soils and willows is present below area being irrigated.)

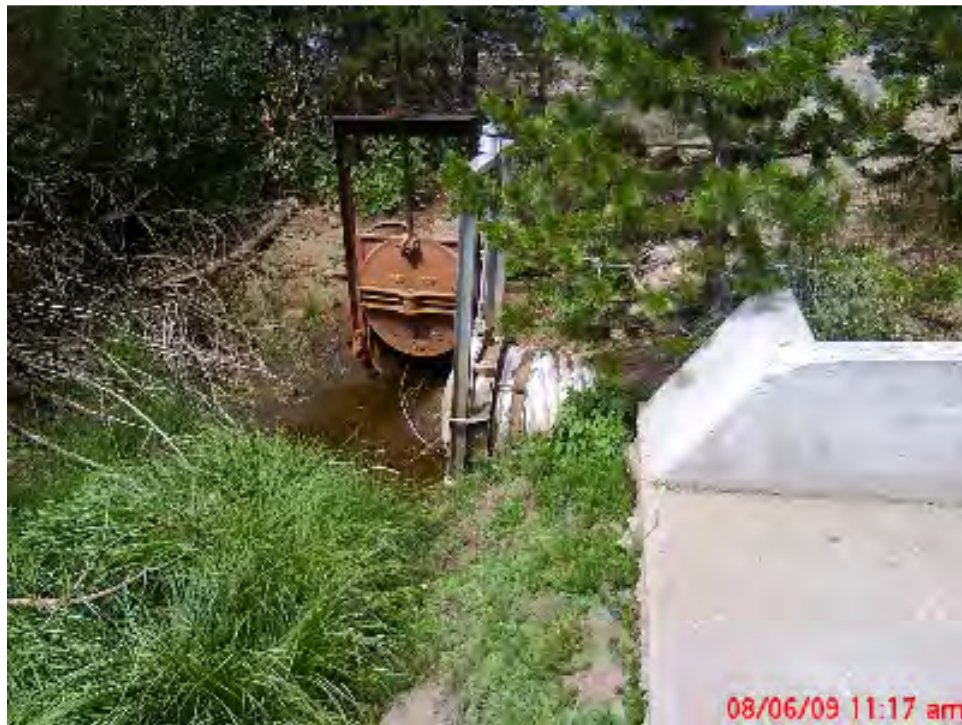
Figure 14
View of Runoff Collection Ditch just Before it Enters Pond
(Gate allows Spring runoff of snowmelt to enter an ephemeral stream channel.)

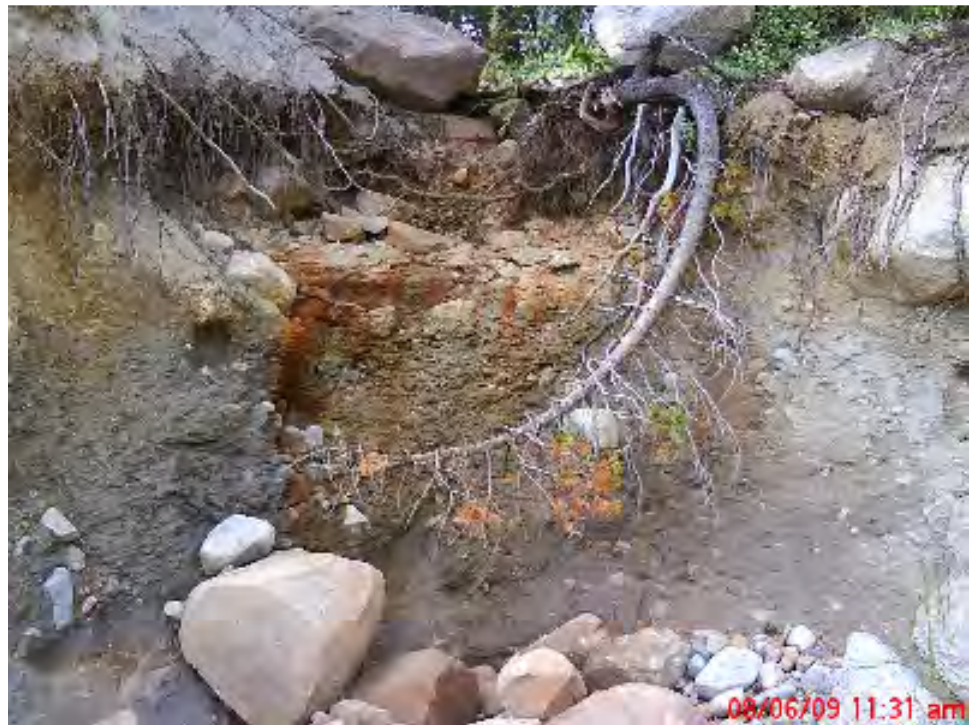
Figure 19
View of Glacial Moraine Deposits Located Next To Railroad Tracks
(Consists of angular granitic rock clasts in a dense, silty, sandy matrix. Permeability is likely fairly low. This exposure is located on the drainage which originates on the east side of the runoff recovery pond. Note the near-surface iron stain.)

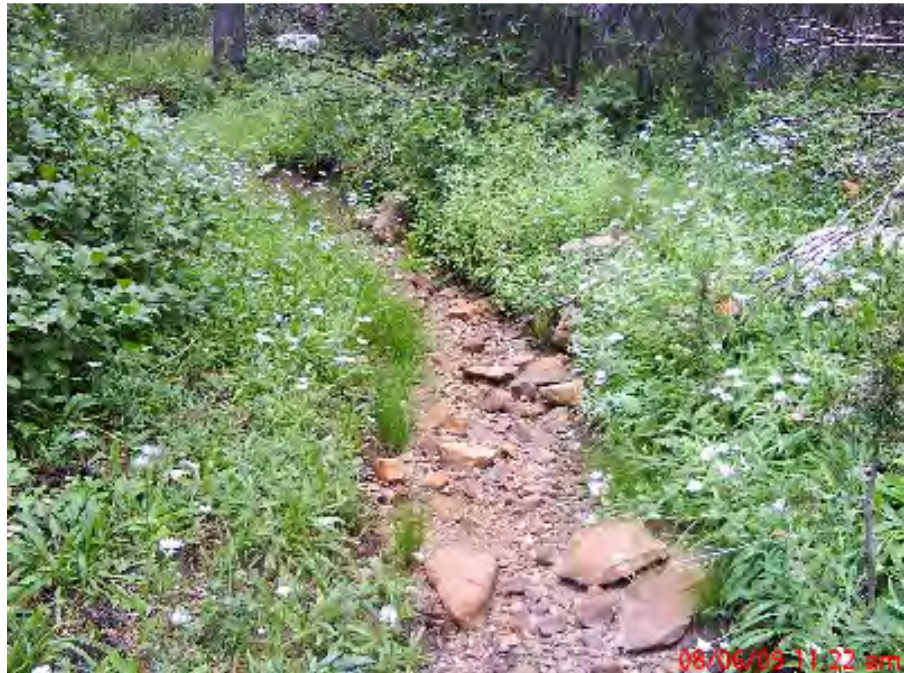
Figure 21
Dry Channel Located Below the End of the Runoff Collection Ditch Near
The Pond
(Notice iron-oxide stained rock)

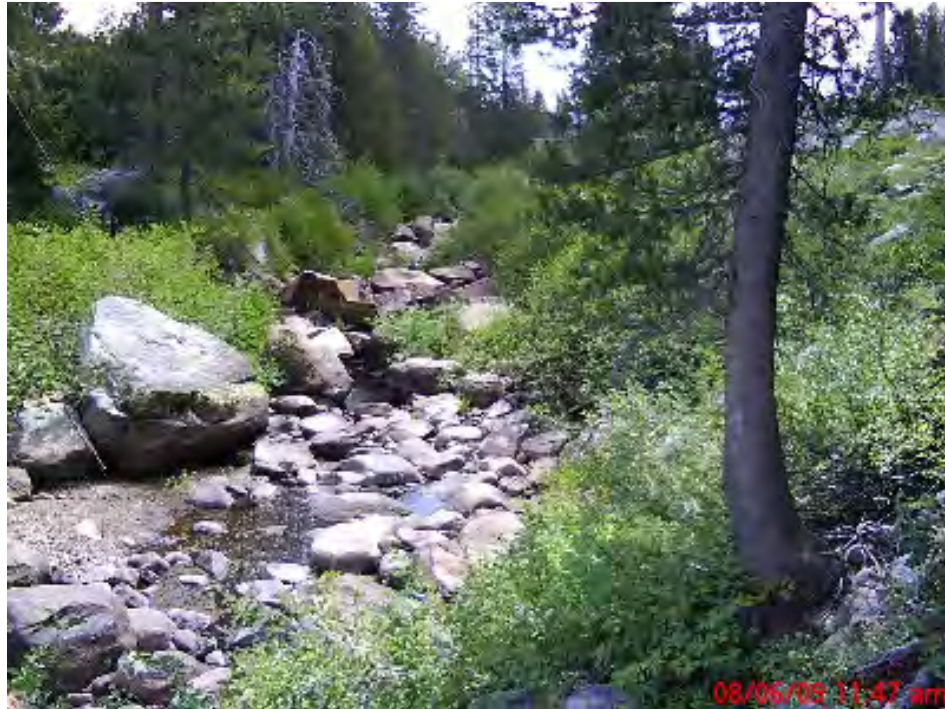
Figure 23
View of South Yuba river directly north of property
(water was essentially stagnant)

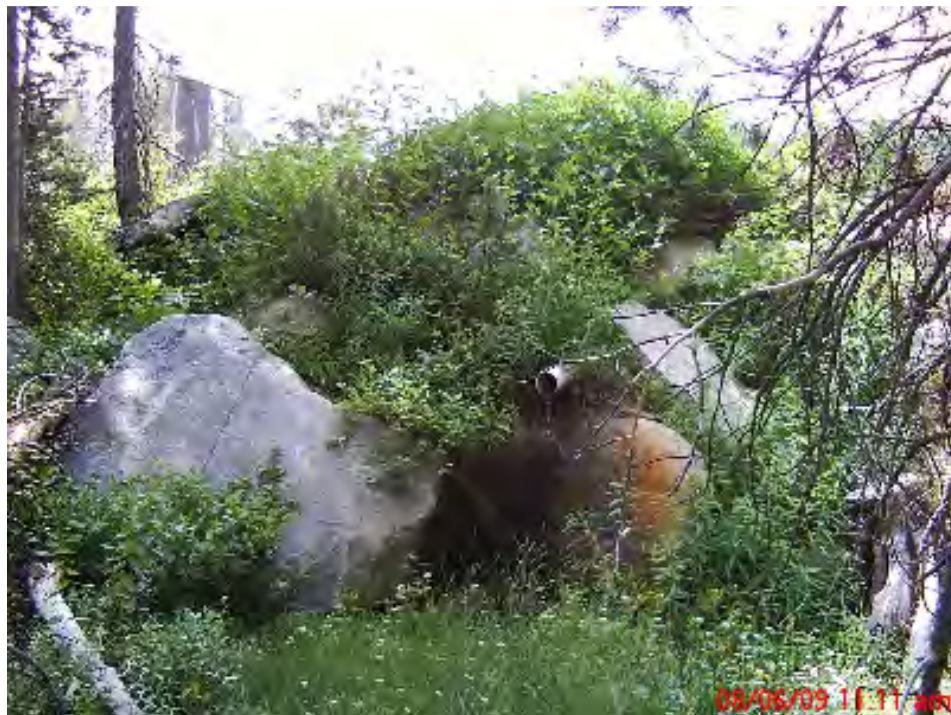
Figure 24
Trickle of Water From “Infiltration Pipe” Below Main Chair Lift

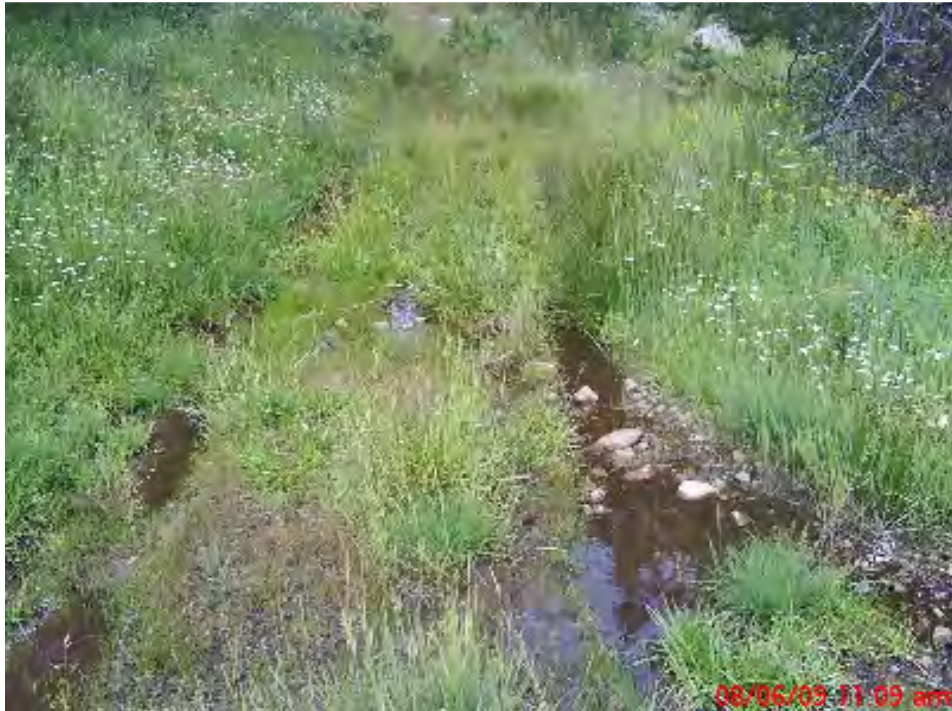
Figure 25
View of Spring Seepage on Pipeline Access Road Just Below Ski Slopes
(The flow appeared to be only one to two gpm.)

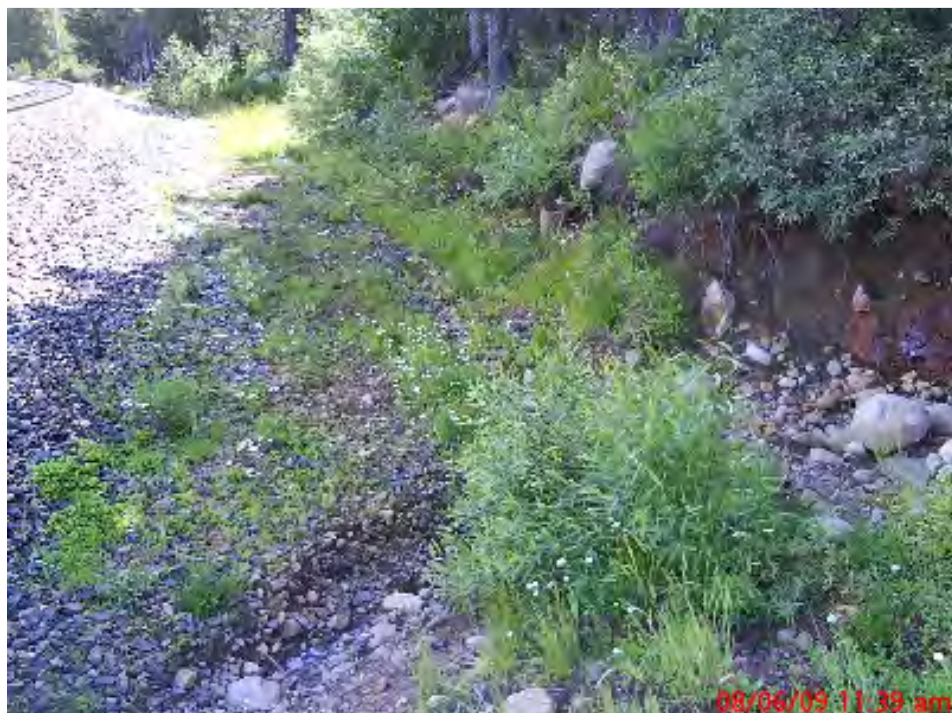
Figure 26
All Seepage Appears To Infiltrate Along The Railroad Tracks
