Donner Summit Public Utility District Groundwater Monitoring Study

January 2010

Prepared by
ECO:LOGIC

Groundwater Monitoring Study

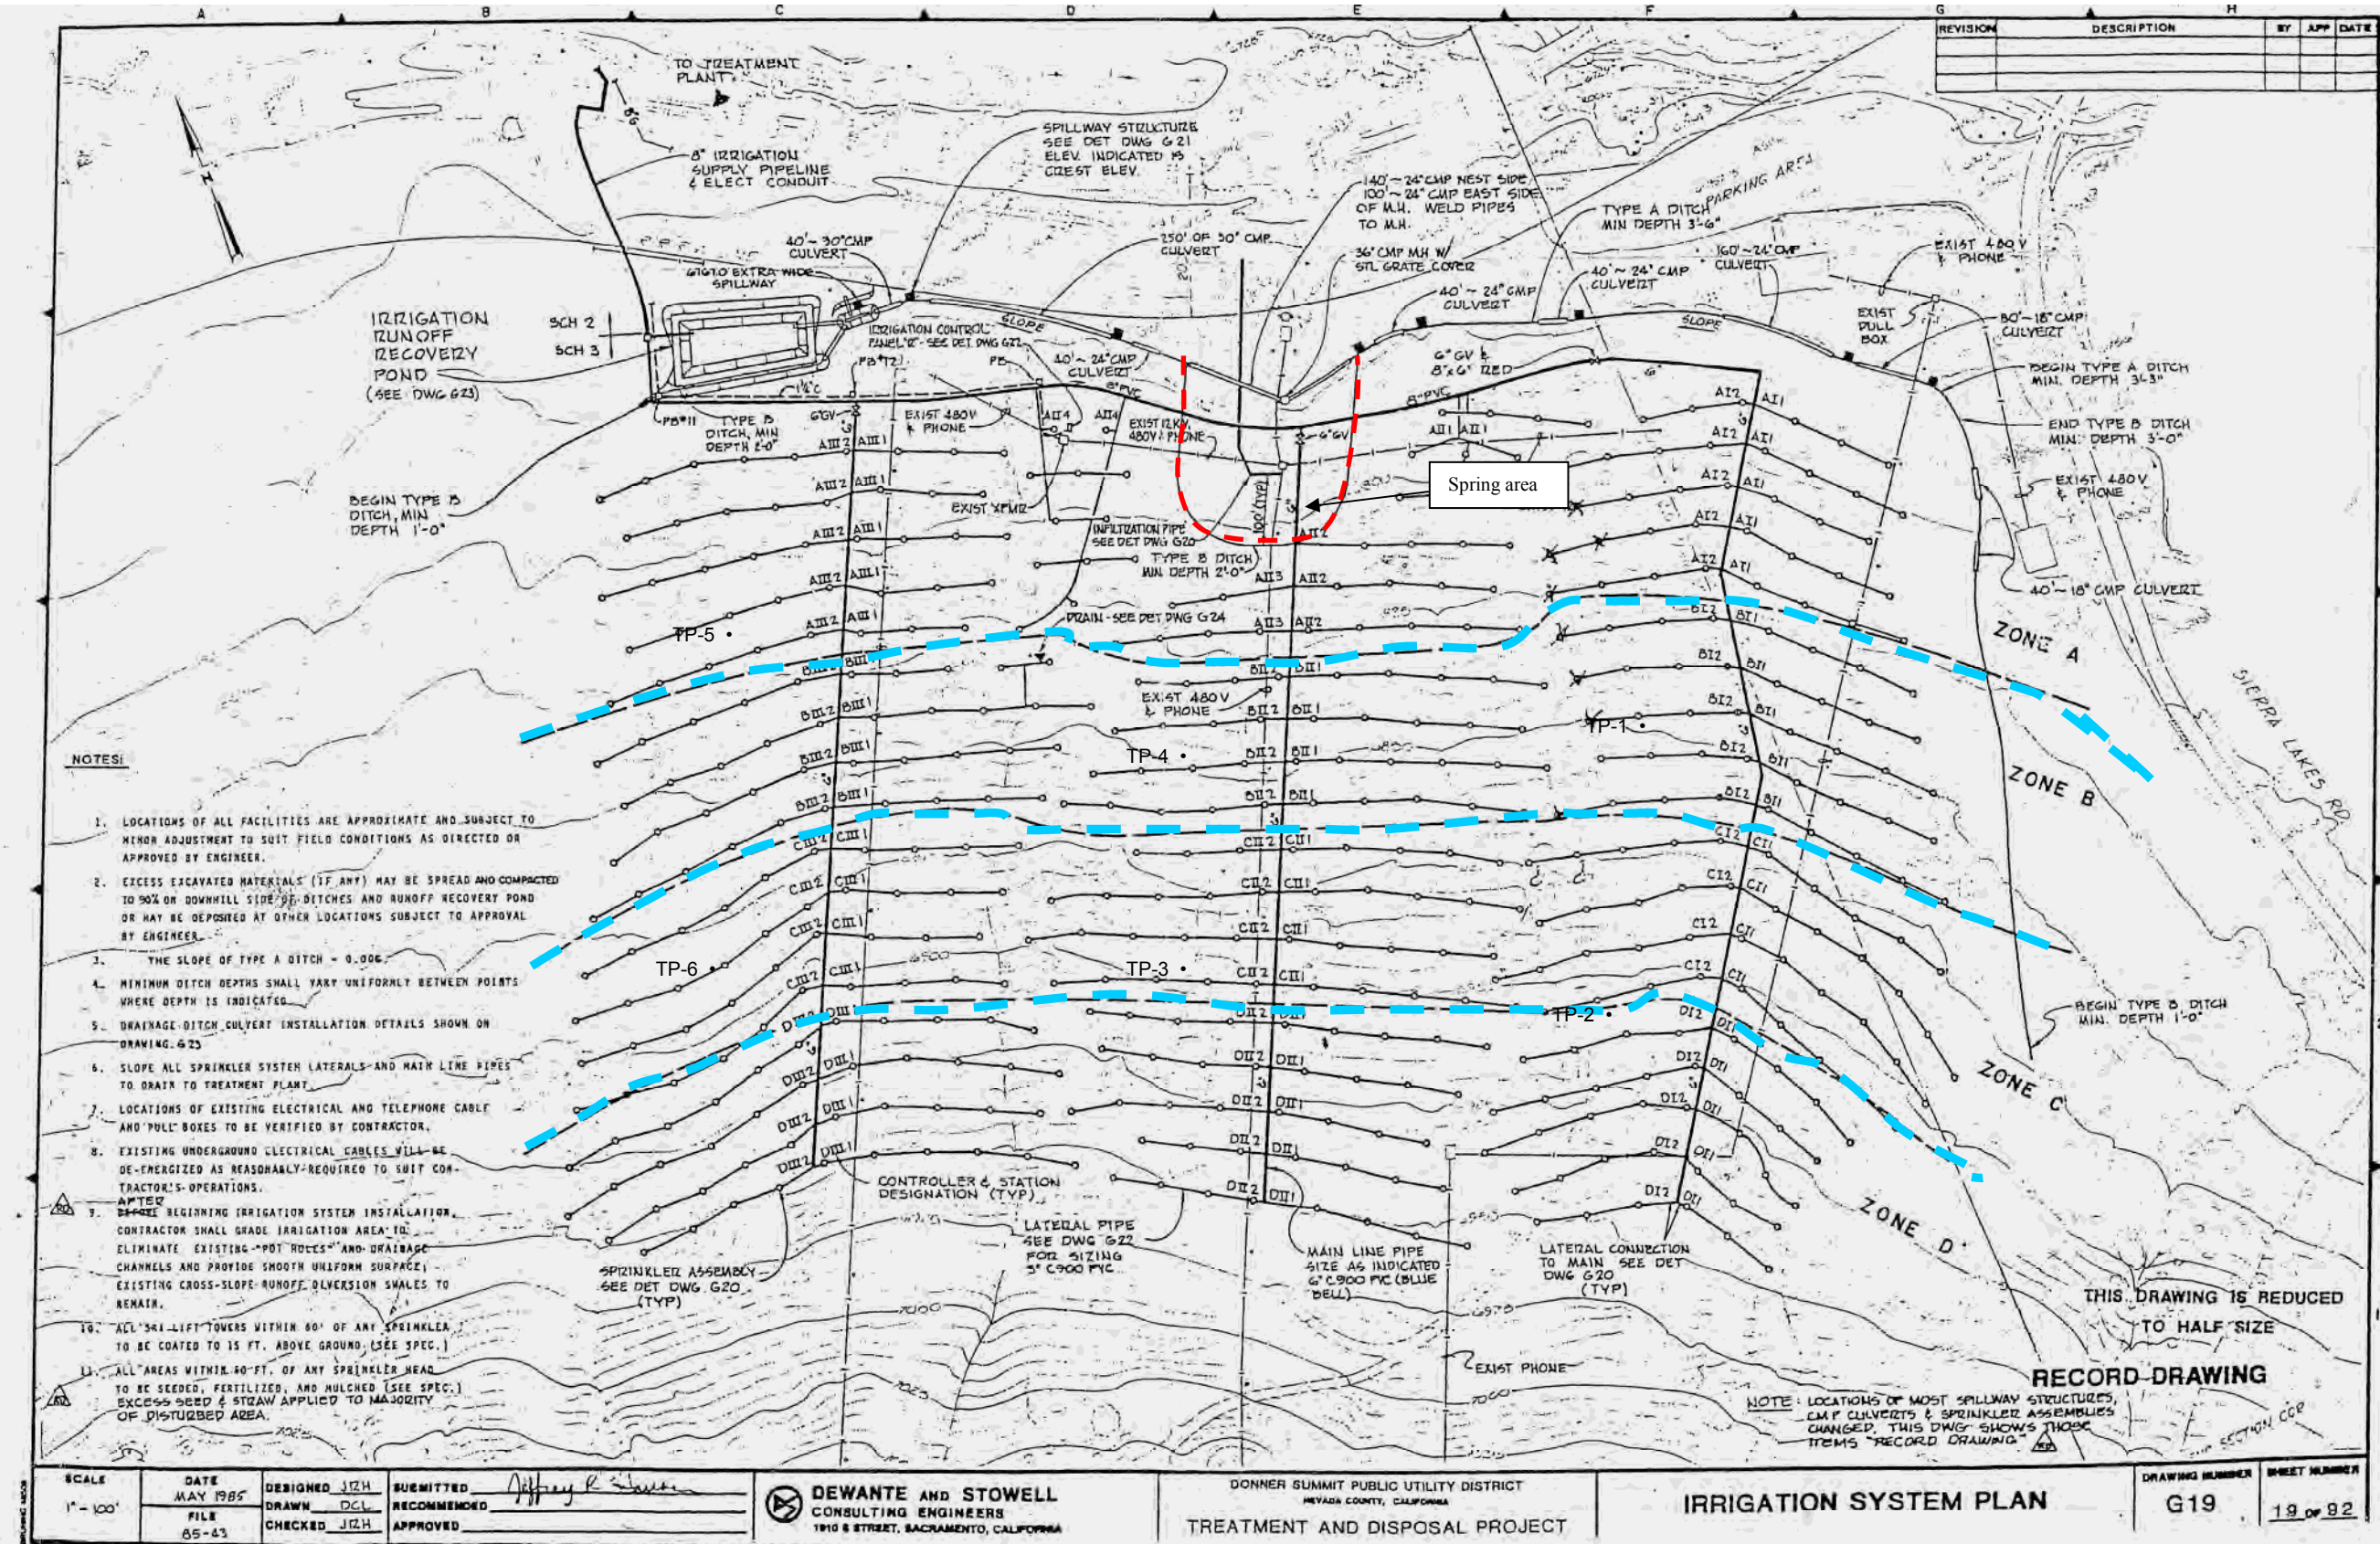
As shown in Figure 3, the irrigation area is comprised of three fields (labeled Areas I, II and III from east to west), which have largely been cleared of trees. As shown in Figure 2, each irrigation field has a central pressurized pipe running from the base of the slope up to the base of the rock outcropping area. Multiple irrigation pipes that parallel the slope contours branch off from each central pressurized pipe. Sprinklers (shown as small open circles on the pipelines in Figure 2) are connected to these irrigation pipes at regular intervals. Each of the three irrigation areas has been subdivided into four zones, labeled A, B, C and D, from the bottom of the slope to the top. Zones B, C and D are operated on a timer system which rotates through the zones on a daily basis to evenly distribute the application of effluent over the area so as to maximize plant growth and minimize any effluent runoff. Zone A sprinklers are not operated due to lower permeability soils in these zones. It is believed that vegetation growing in Zone A is tapping into soil moisture created by effluent irrigation of upslope Zones B, C, and D. If correct, Zone A serves to limit subsurface migration of effluent away from the application area.

Figure 2
Topographic Map of Soda Springs Ski Hill Showing the Layout of Irrigation Pipe, Irrigation Zones and approximate Test Pit location (TP-1)

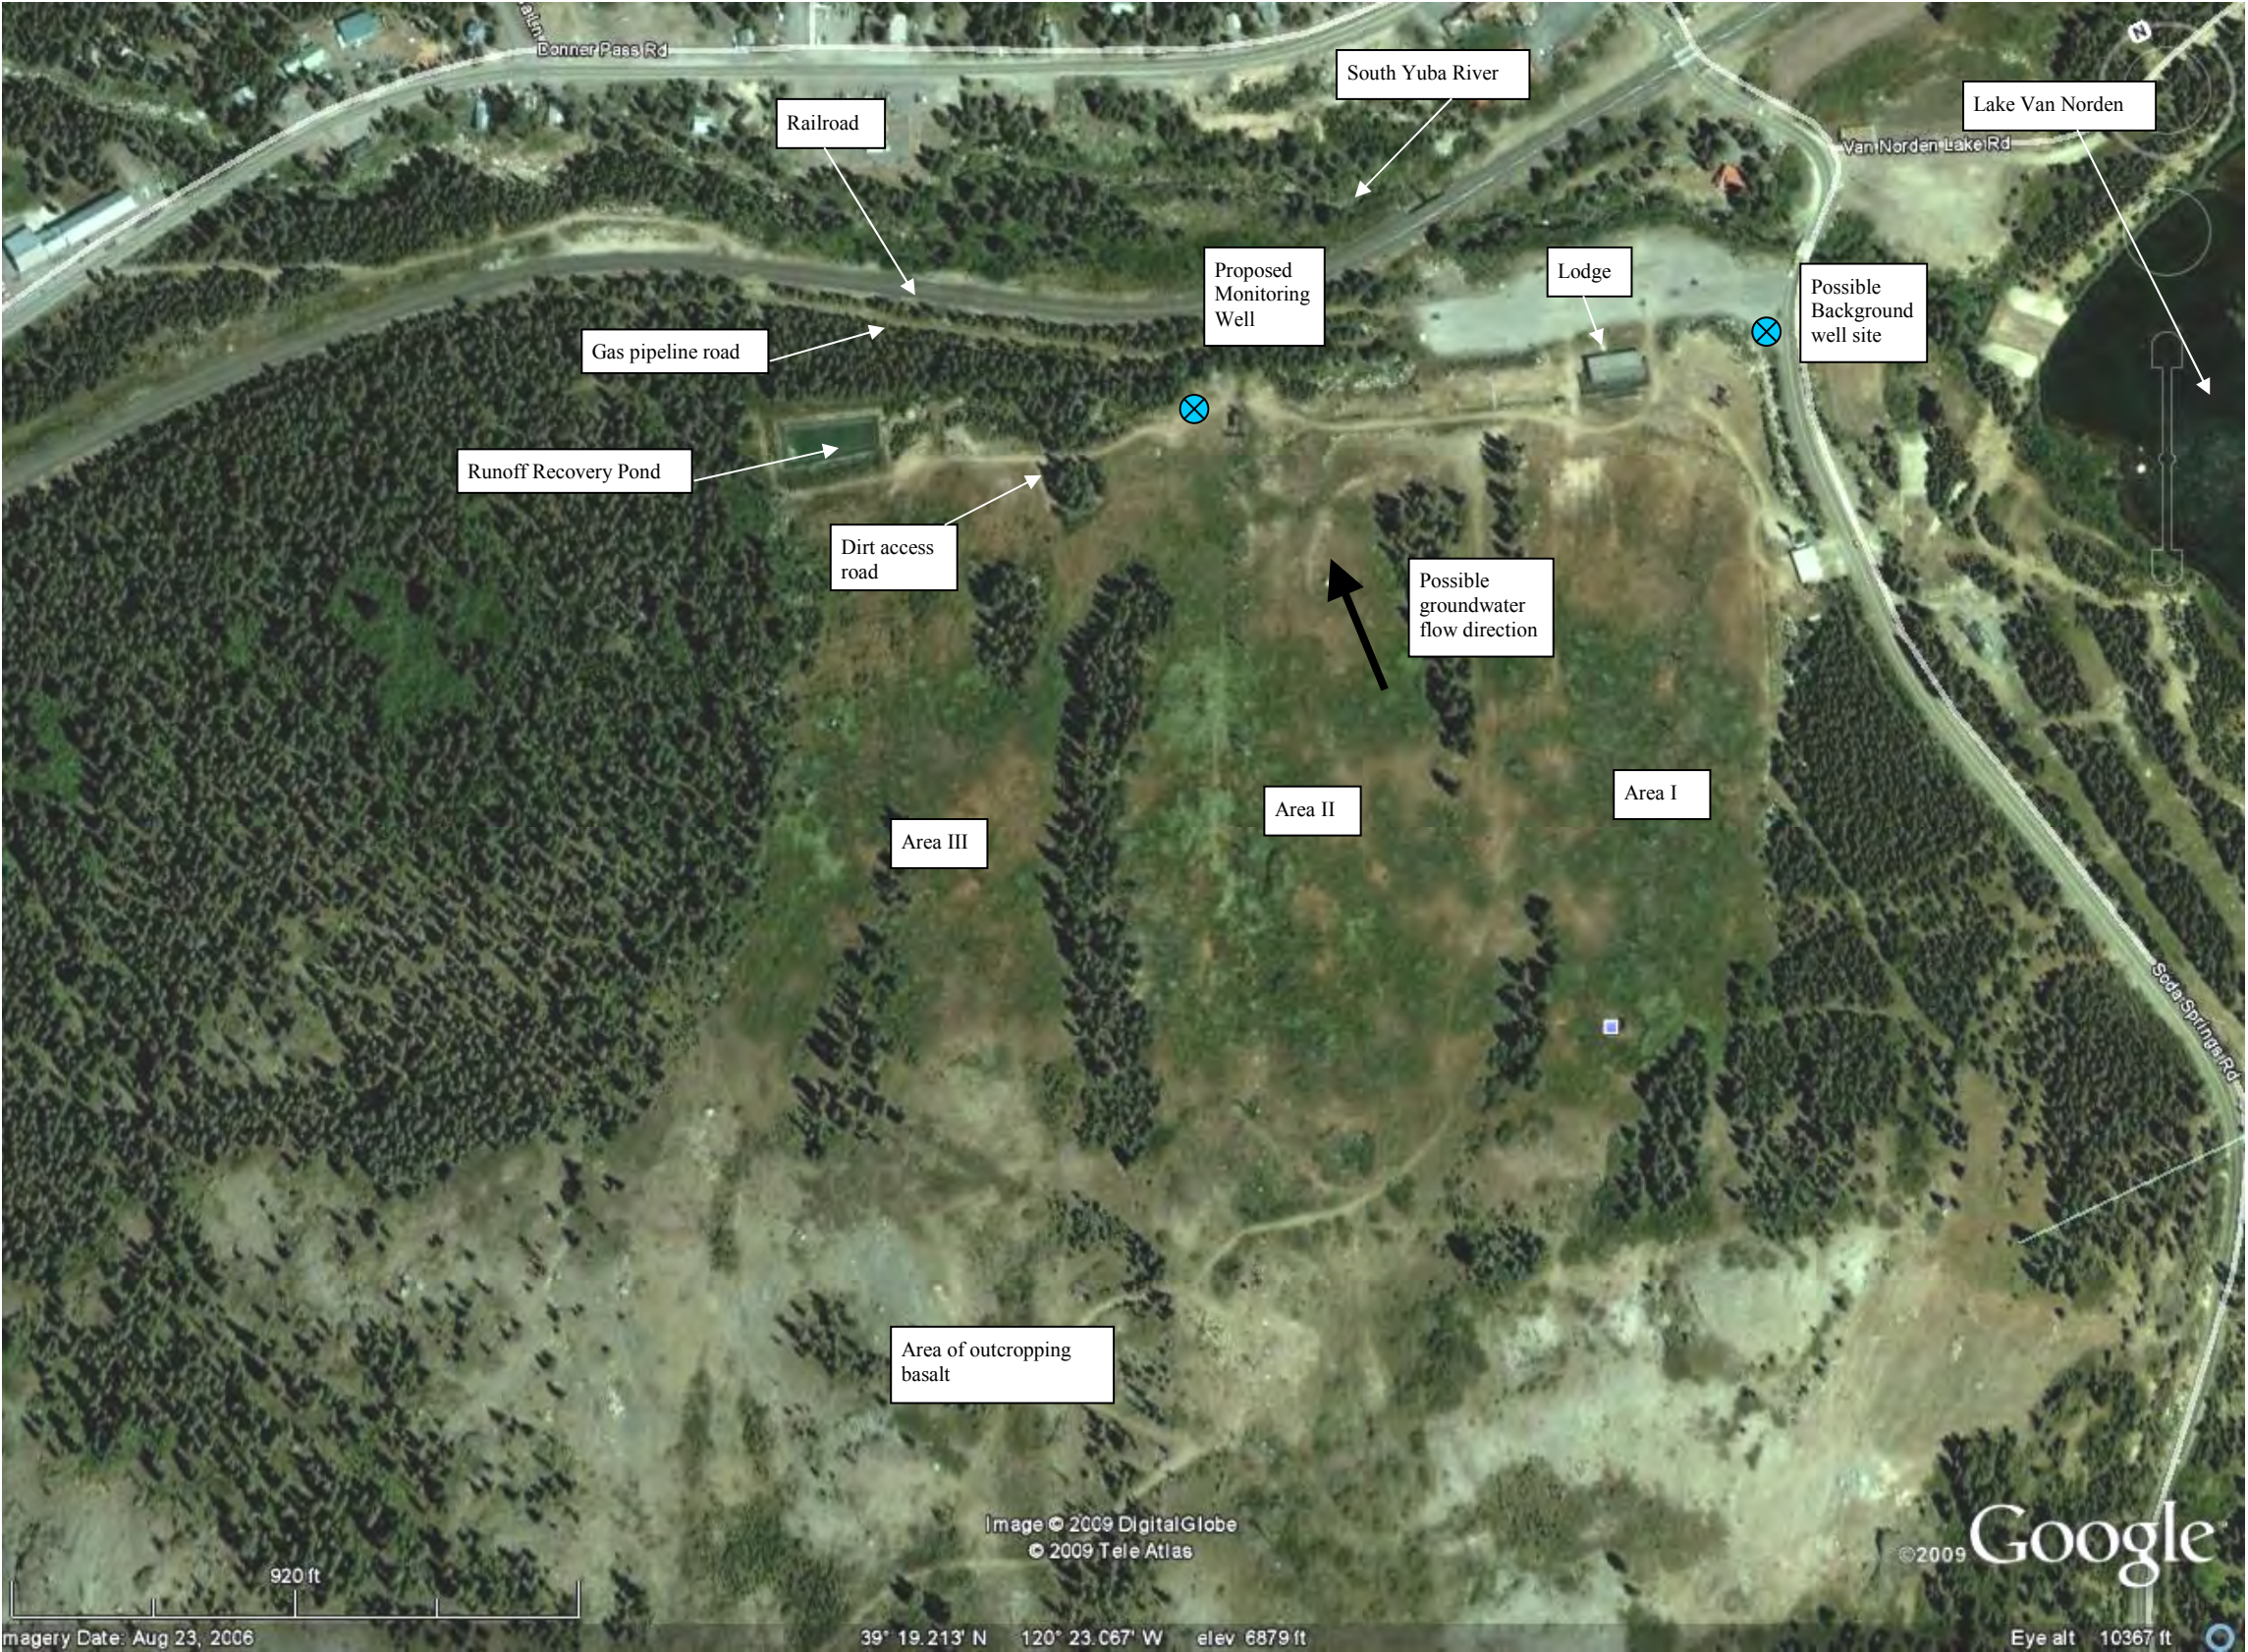
Figure 3
Aerial photograph of Soda Springs Ski Hill showing irrigated area (ski slopes with darker green color) and surrounding features.

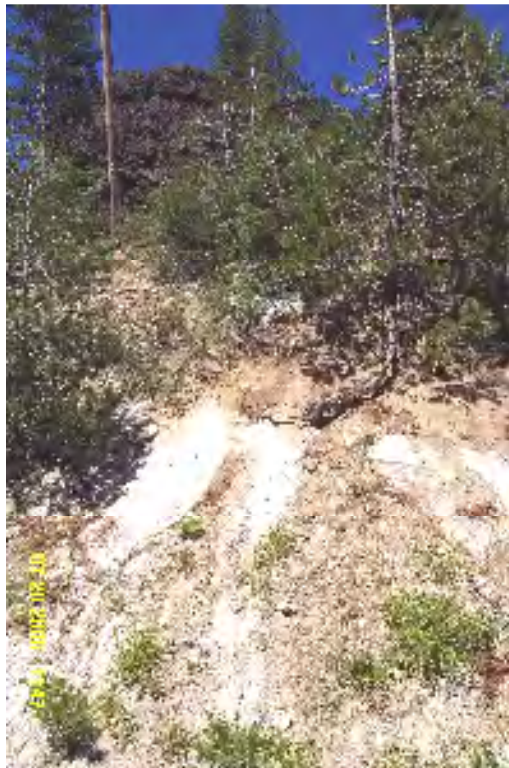
Figure 18
View of Weathered Tuffs Overlain by Basalt
(Photo taken along road on east end of Hill. Andesite is apparently absent here.)
