DONNER SUMMIT PUD LAKE ANGELA SUNNY DAY FAILURE INUNDATION STUDY

Dam #89.002, National ID CA00322

February 14, 2019

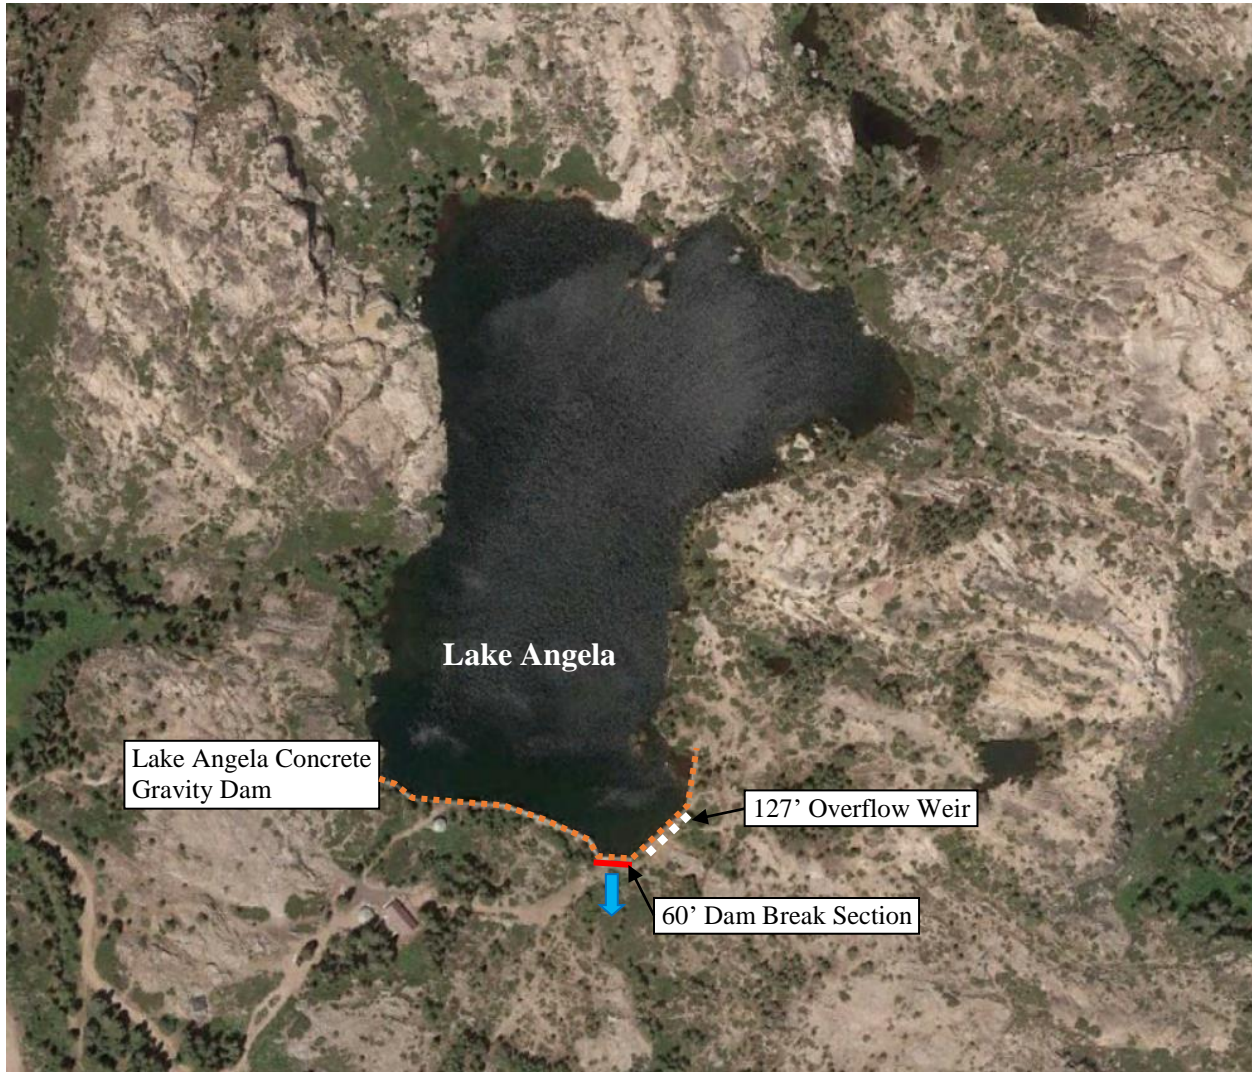
Figure 2. Dam Break Location

Lake Angela Dam is constructed of a concrete gravity dam with rock bolt anchors that extend the full height of the Dam to resist translational and overturning forces. The rock anchors are embedded into granite bedrock and anchor spacing along the Dam varies between 4 to 10 feet. The concrete dam encompasses the southern portion of the lake. On the eastern portion of the Dam there is a small manual sluice gate that operates as the reservoir's spillway. On the same east portion of the dam structure, the Dam section is modified with a rectangular notched overflow weir that is approximately 127-ft long and 3-inches lower than top of the Dam. The southern-most section of the Dam with an outlet structure was selected to break due to the potential for releasing the greatest volume of water and maximum inundation limits. See Figure 2 below for the analyzed break location.

The breach parameters for a concrete gravity dam were determined by using FEMA’s Federal Guidelines for Inundation Mapping of Flood Risks Associated with Dam Incidents and Failures (FEMA P-946, July 2013). FEMA’s document highlights recommendations from USACE, FERC, and NWS to use a breach width of multiple concrete monoliths with vertical sides due to the vertical sections of poured concrete monoliths. The southern most portion of the Dam was chosen for failure at the outlet location. The section is approximately 60 feet in length. This section can be viewed below in Figure 3 and above in Figure 2.

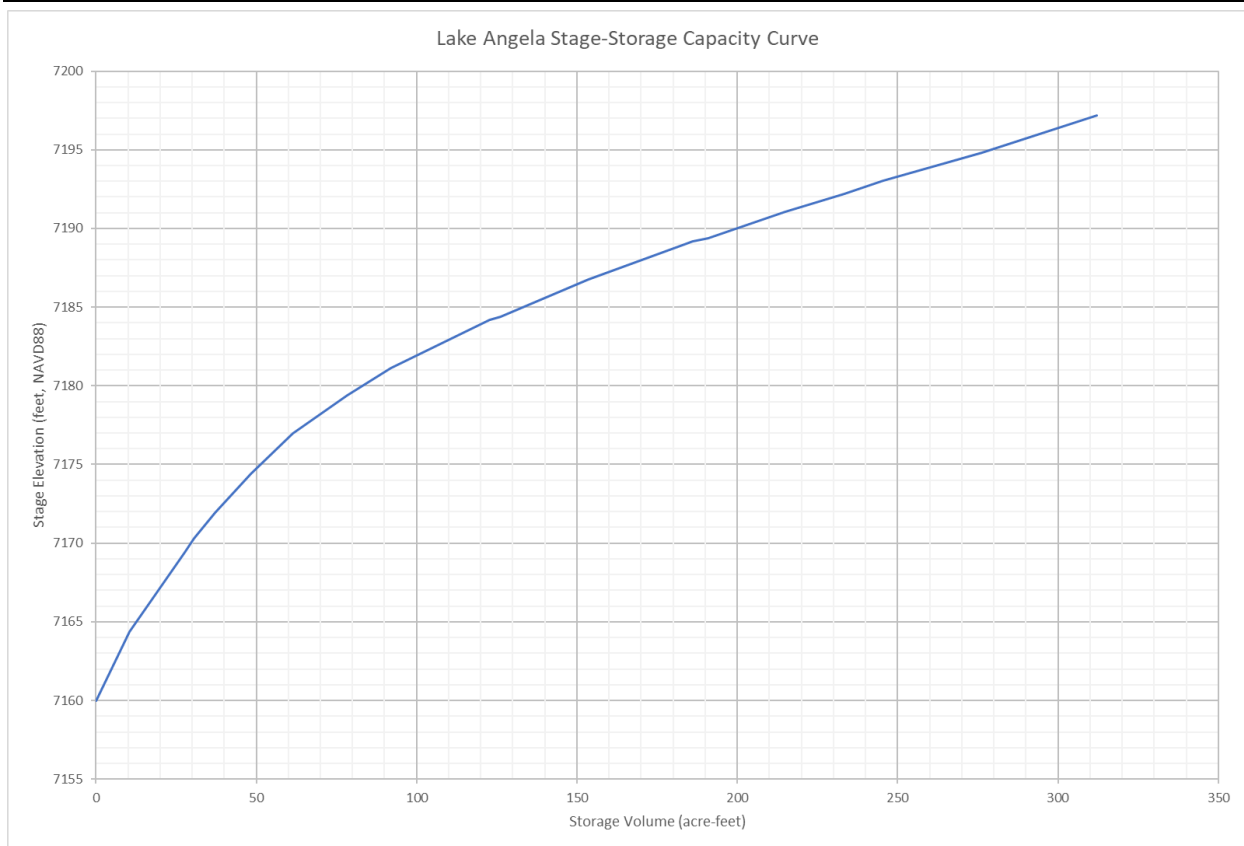
Figure 5. Lake Angela Stage-Storage Curve

Figure 5 shows Lake Angela’s stage-storage curve.

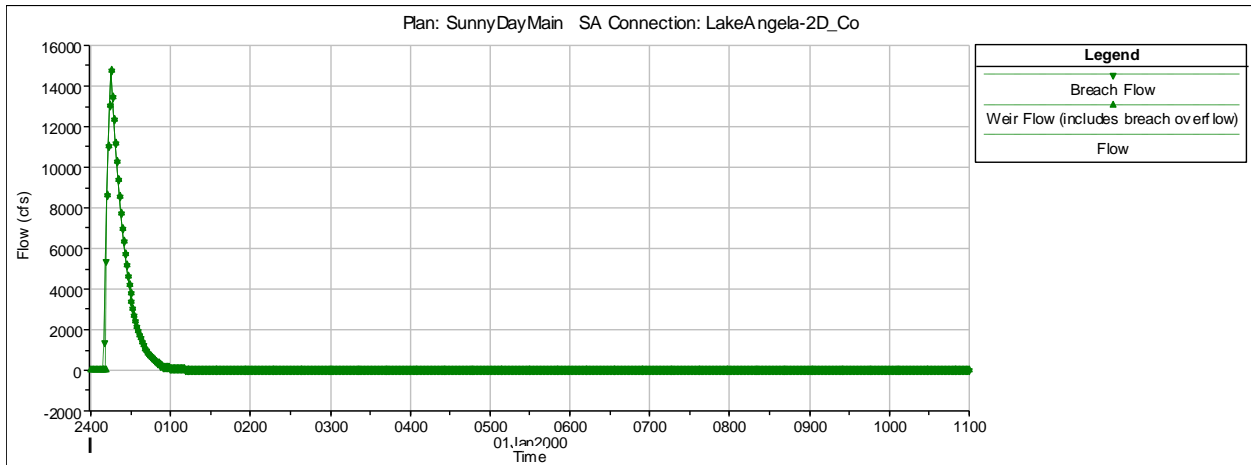
Each breach scenario was set to start at time t=10 minutes. Figure 7 shows the Lake Angela Dam breach hydrograph.

Figure 7. Lake Angela Breach Hydrograph (Max flow = 14,750 cfs, Volume Released = 278 acre-ft)
