#### **RE: Donner Summit Public Utility District Biostimulatory Substances Study**

Photo Essay Report No. 3 South Yuba River Biostimulation Photo Essay Report

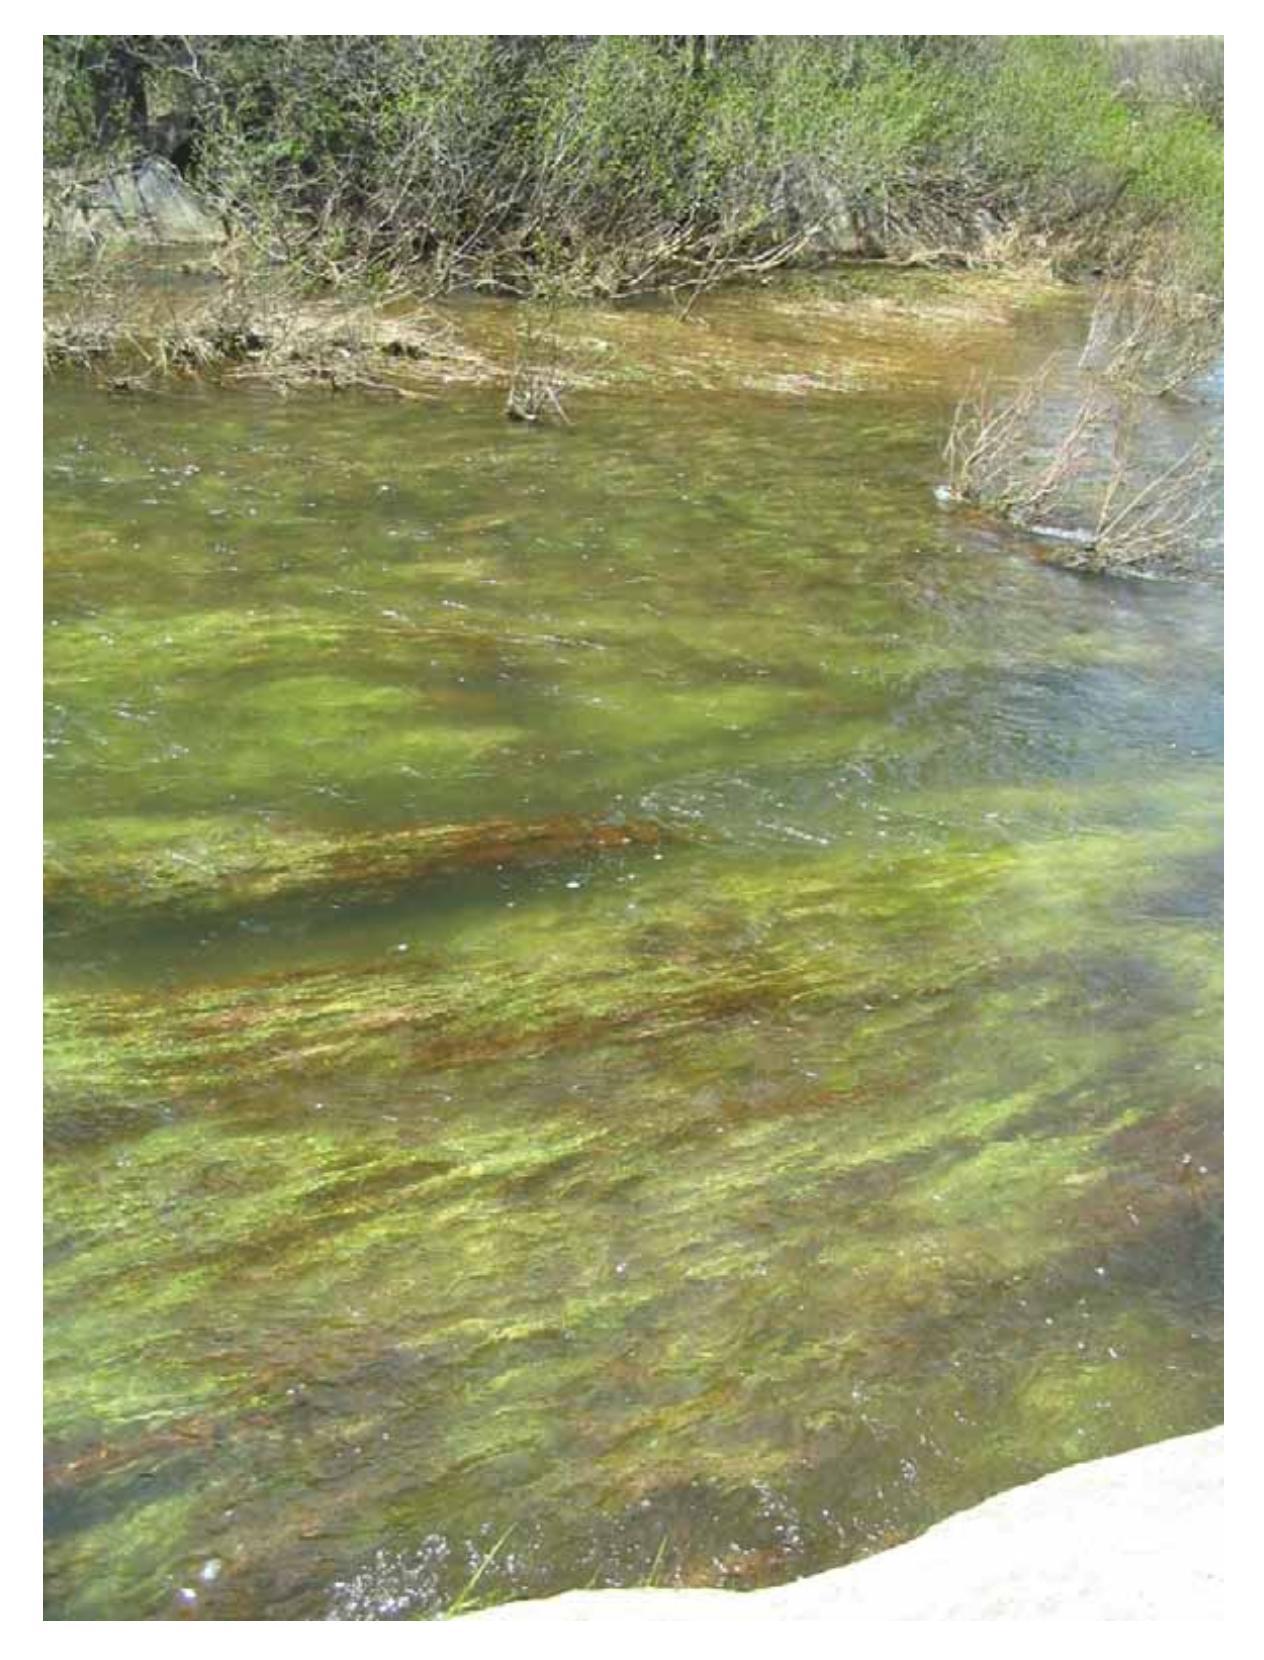
Image 17 (A)

Images 17 (A), 18 (A), 19 (A), and 20 (A) were taken just downstream of Lake Van Norden. Submerged macrophytes are abundant, here. The water has a green cast, presumably from suspended algae growing in Lake Van Norden. Filamentous algae were not evident in the river, on the dam spillway, or on the in-lake face of the dam at the spillway.

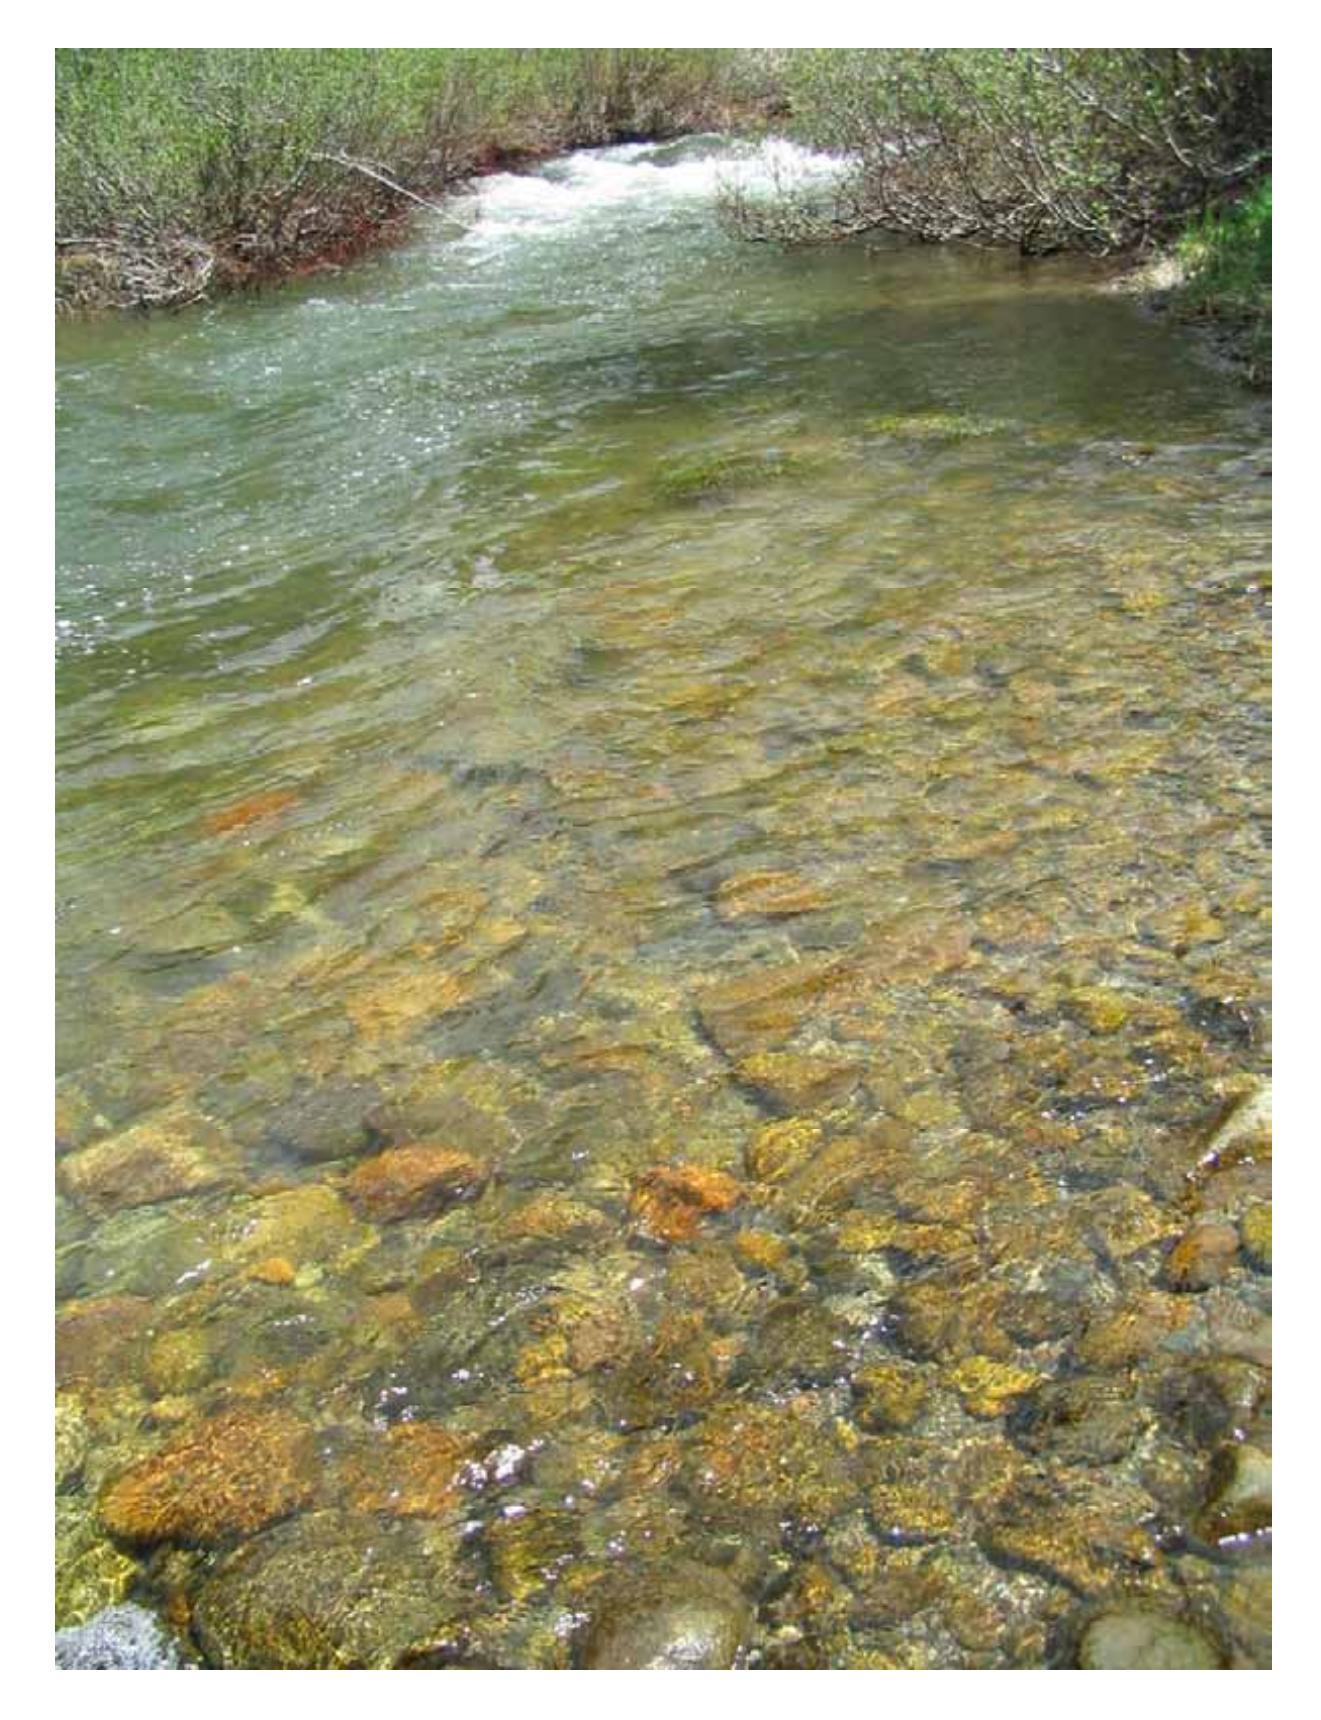
Image 26 (D)

Image 26 is the gravel bar where effluent enters the SYR. Effluent is entering the SYR roughly in the area shown I the center of the image. No filamentous growths are evident. The submerged macrophytes in the upper center of Image 26 correspond to the exposed macrophytes on the effluent discharge gravel bar shown in Images 9 and 10 (Section 2). Small lavender butterflies were observed in the woods, but there were no large butterflies, or a concentration of small butterflies on the dry-moist areas of gravel in this area suggesting that the effluent was entering the river exactly at this point. Effluent probably is entering at this point; however, there was no confirmation from the butterflies at this early date. Growths were first evident in this location at lower flows in June/July 2008.

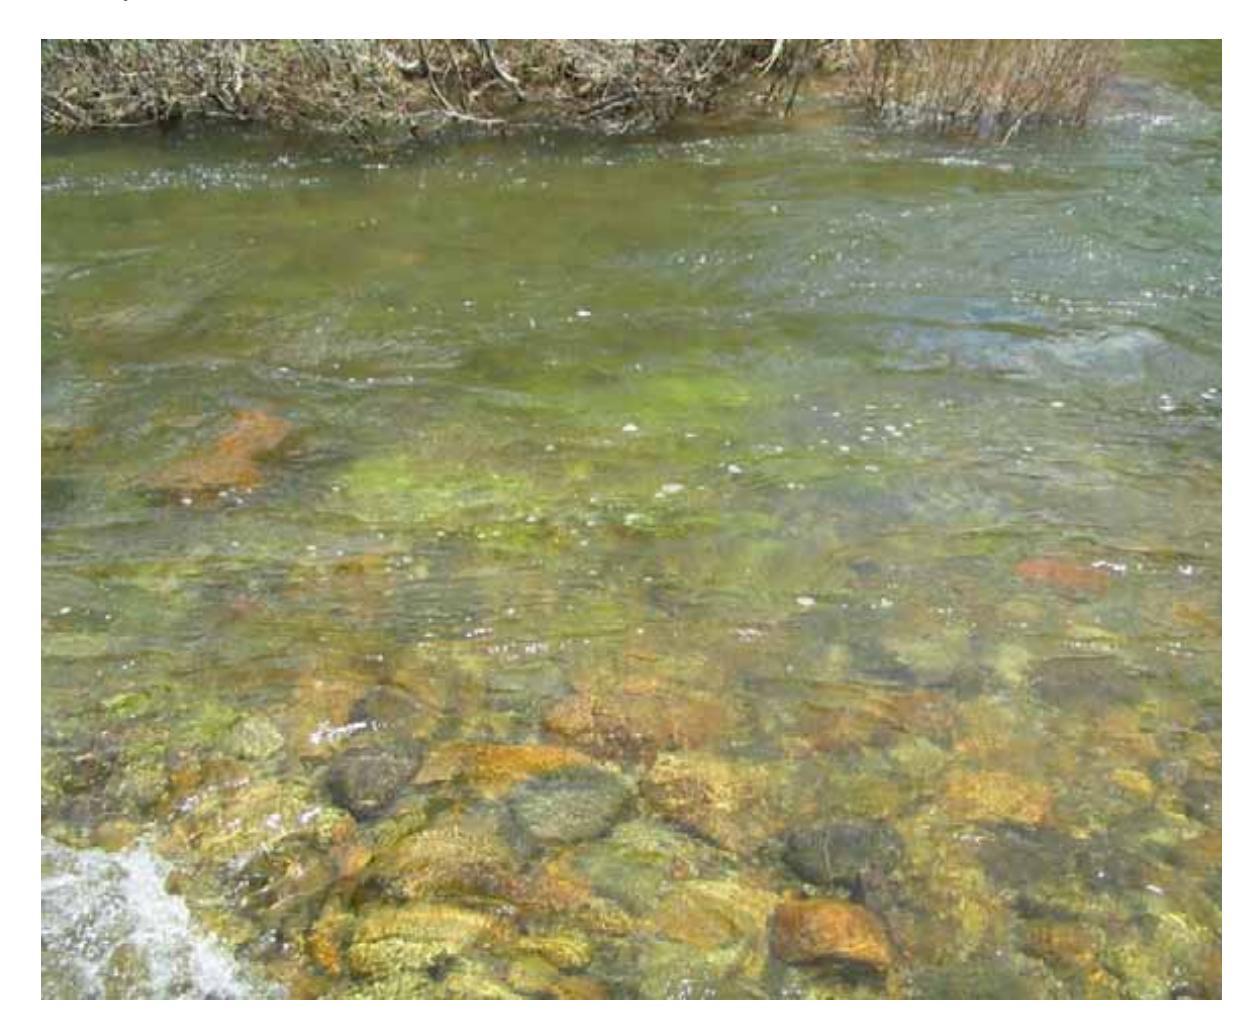
Image 27 (D 50% E)

Image 27 is just downstream of the effluent discharge gravel bar, at the bend in the river which is the head end of the first pool downstream of the effluent discharge point. With higher SYR flows, it was thought that effluent may enter the river from the gravel bar at this more downstream location (i.e., the effluent flows in the gravels parallel to the SYR for awhile before entering into the river proper at this bend). In any event, at this location the effluent is thought to be in the river and at highest concentrations in the immediate foreground of Image 27 based on river hydraulics. Some macrophytes are evident at mid-photo. No filamentous algae growths were evident in this location at this time. Filamentous algae growths were evident here in June/July 2008.

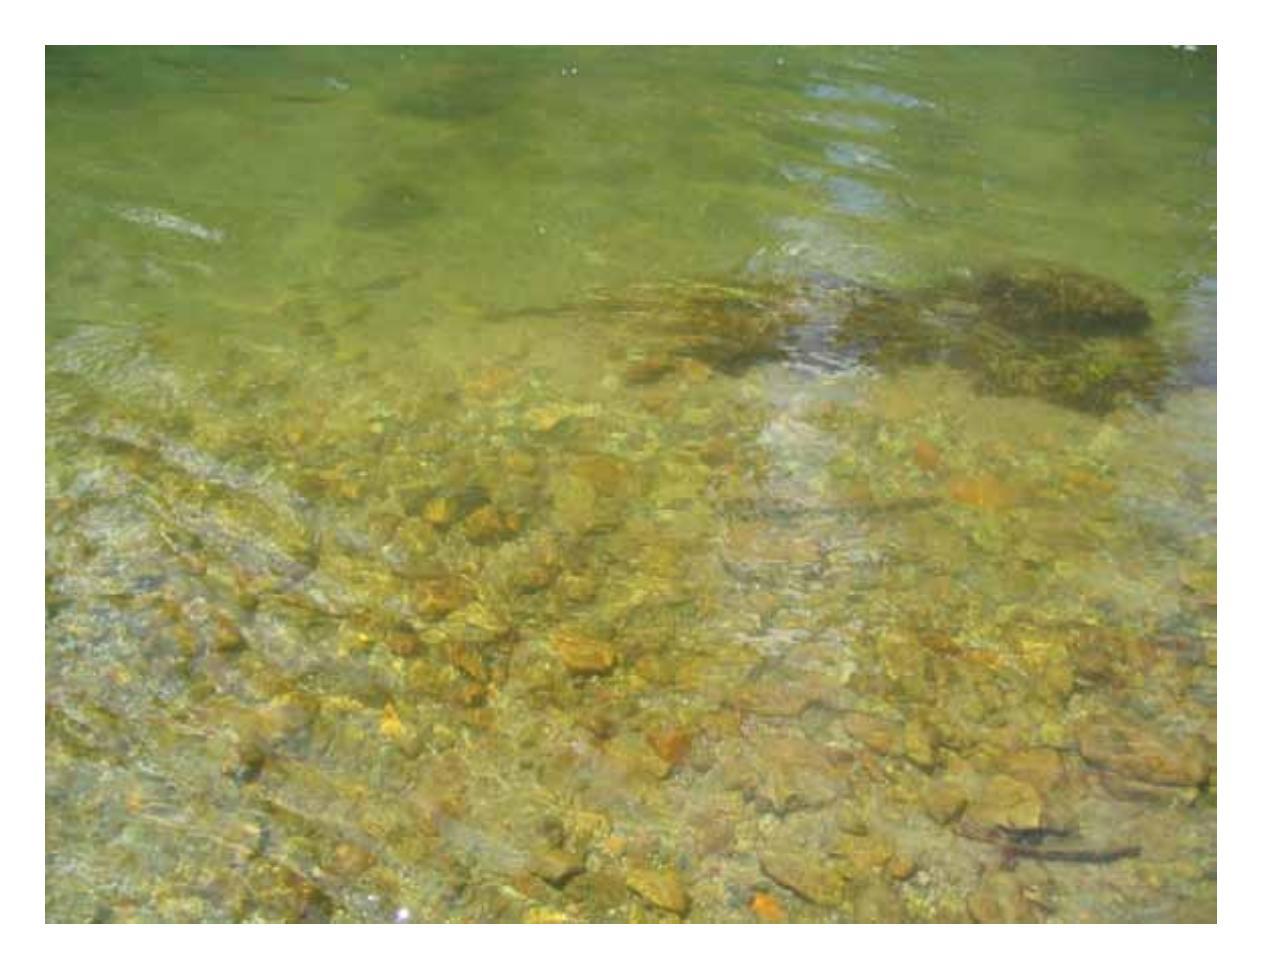
Image 28 (E)

Images 28 and 29 are further downstream in the first pool on the "effluent side" of the river. No filamentous algae growths are evident at this time. Growths were evident in this location in June/July 2008. Some macrophytes are present.

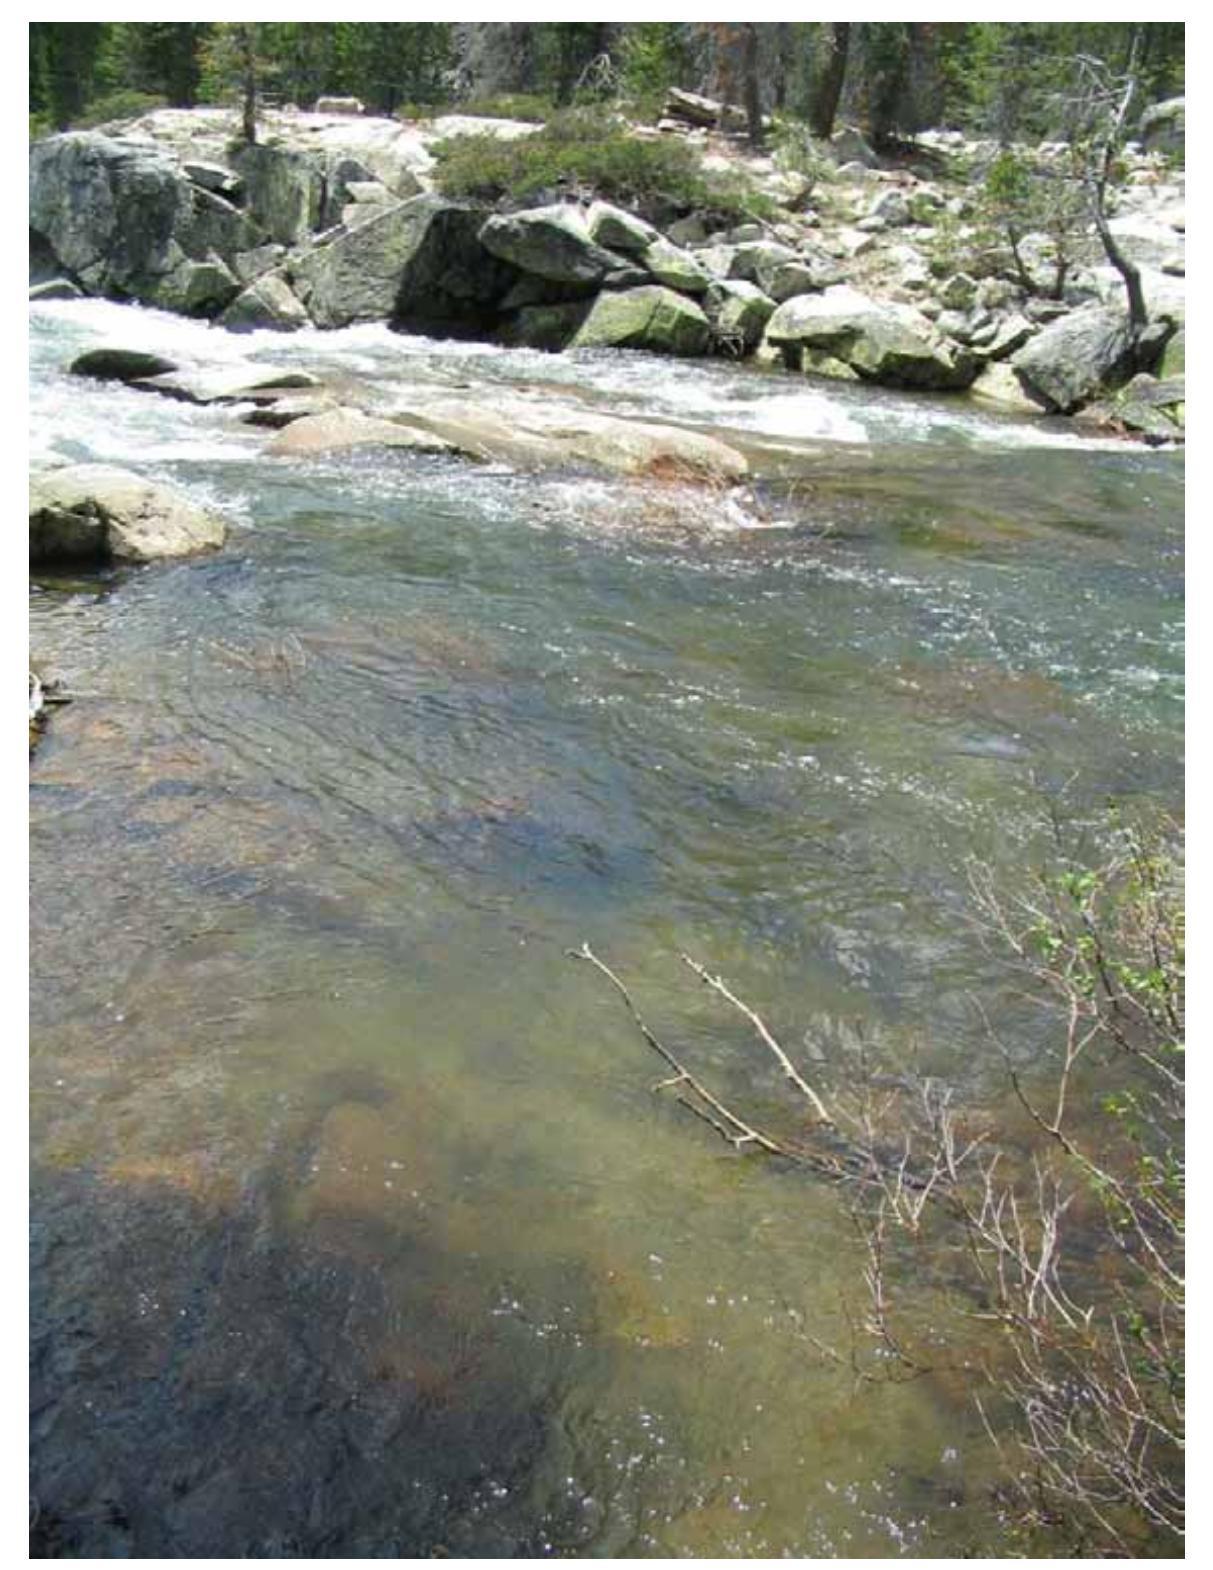
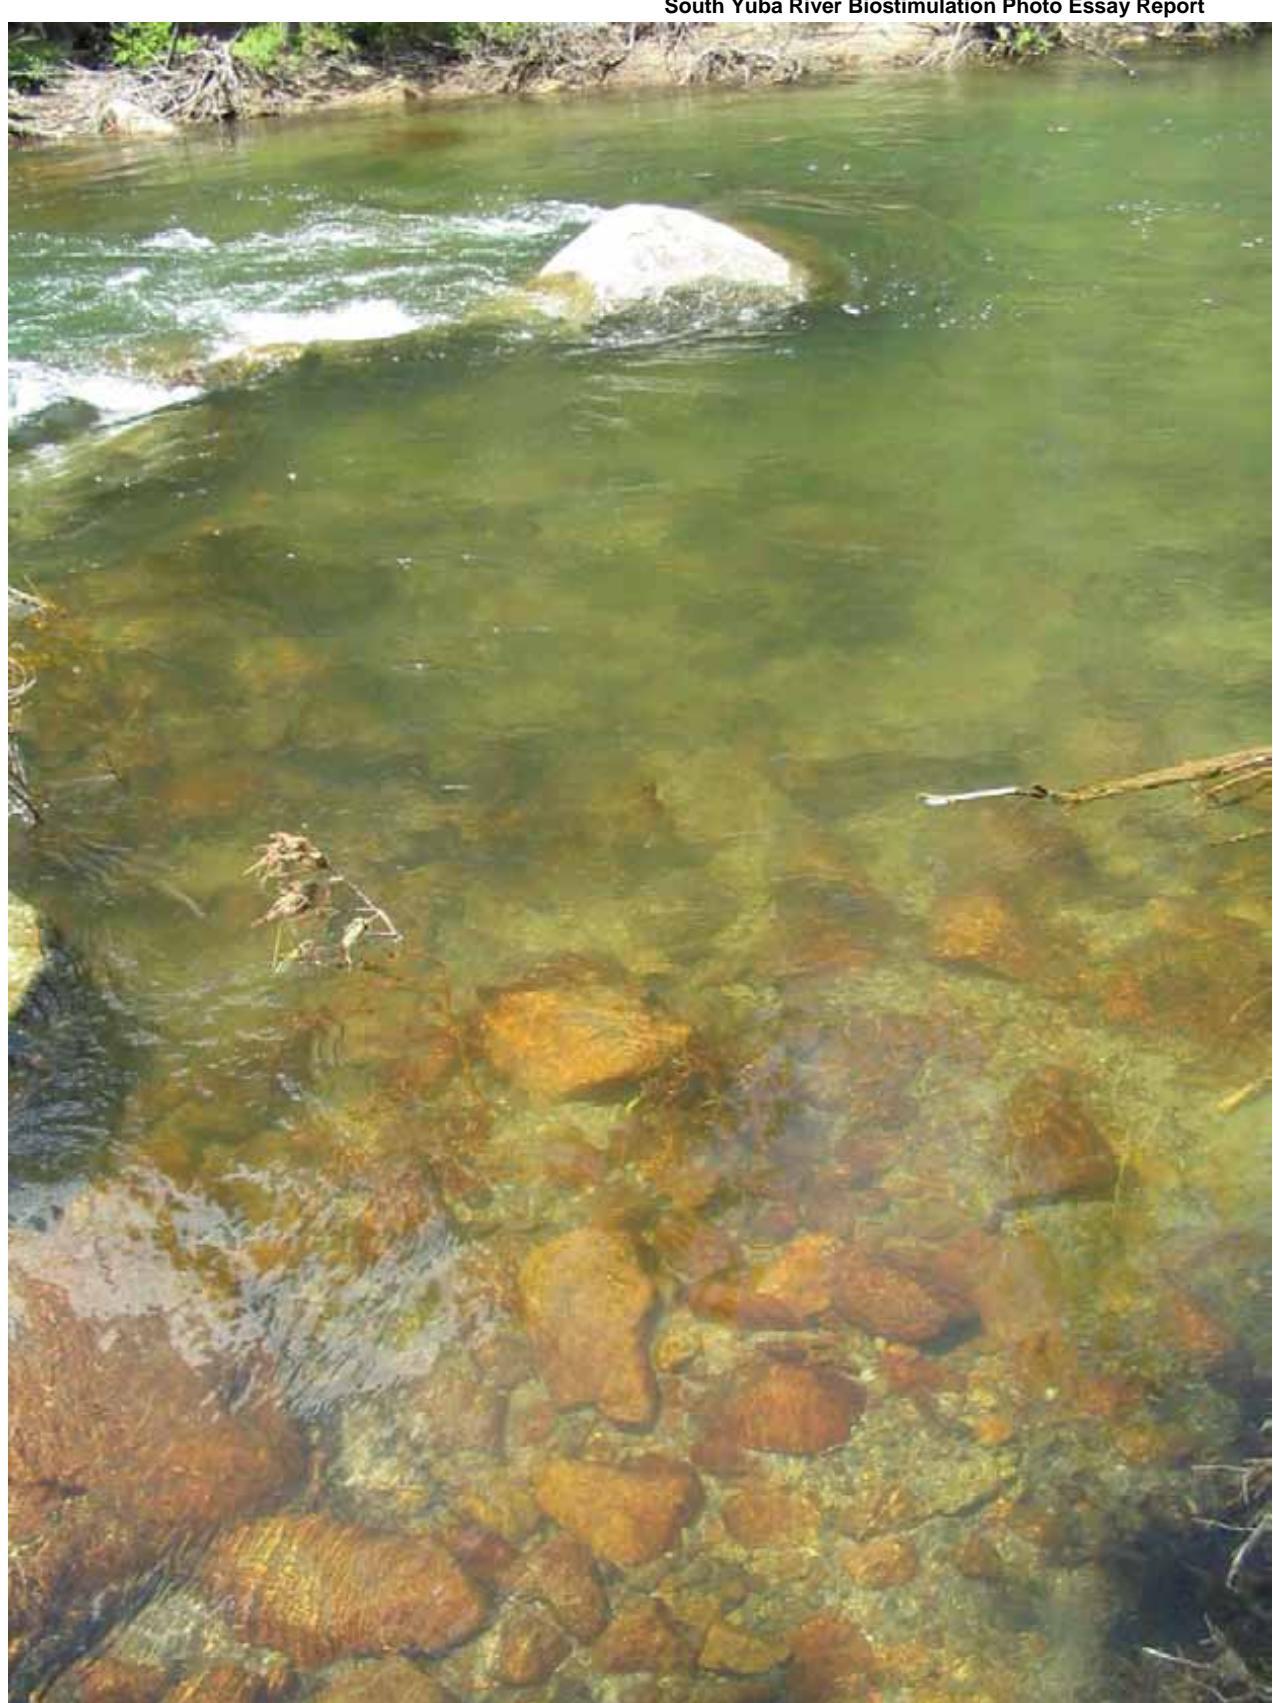
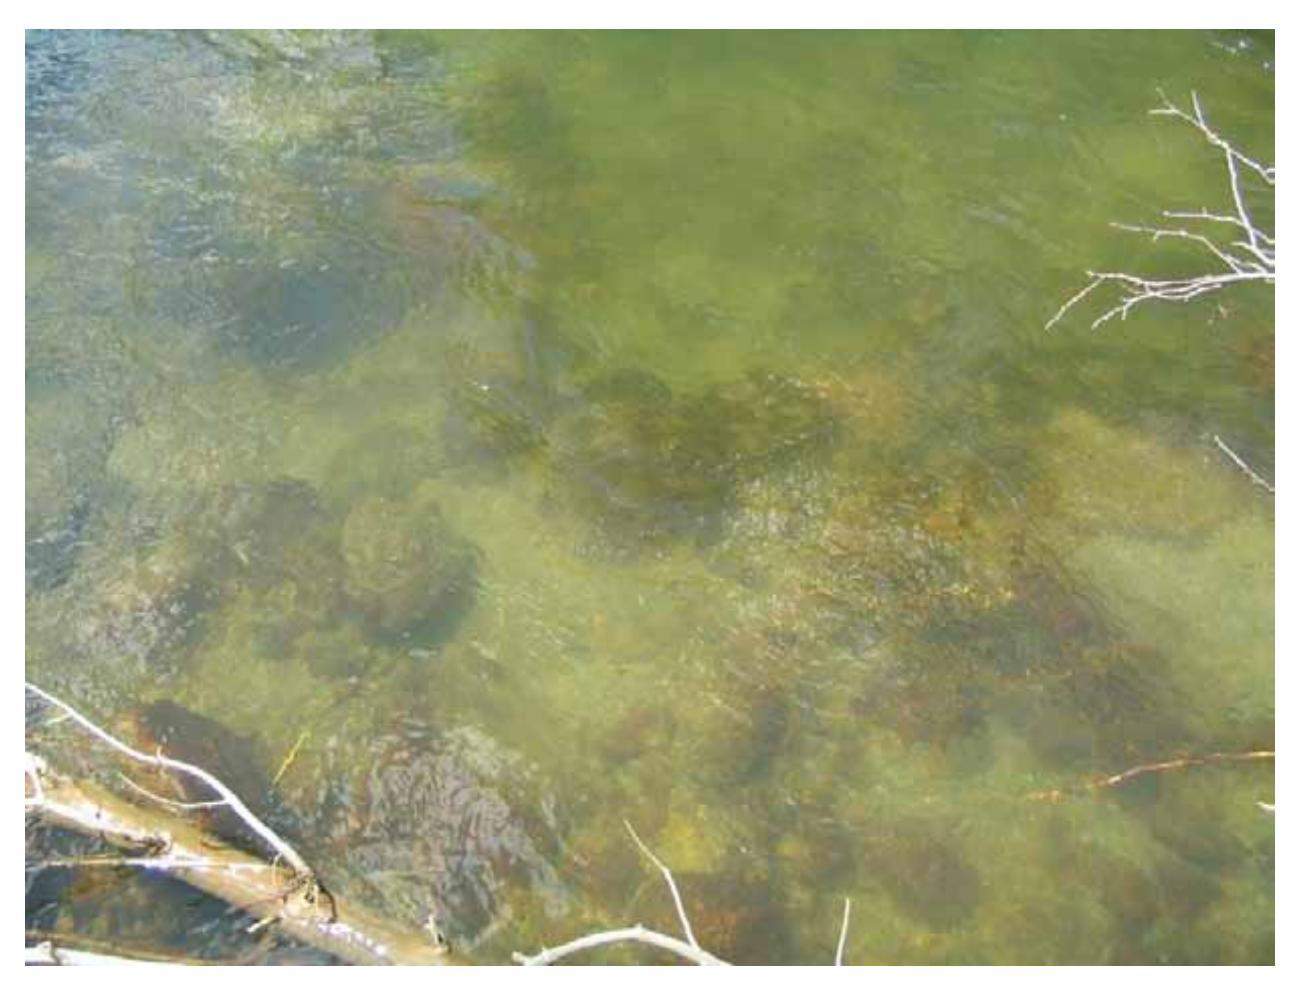
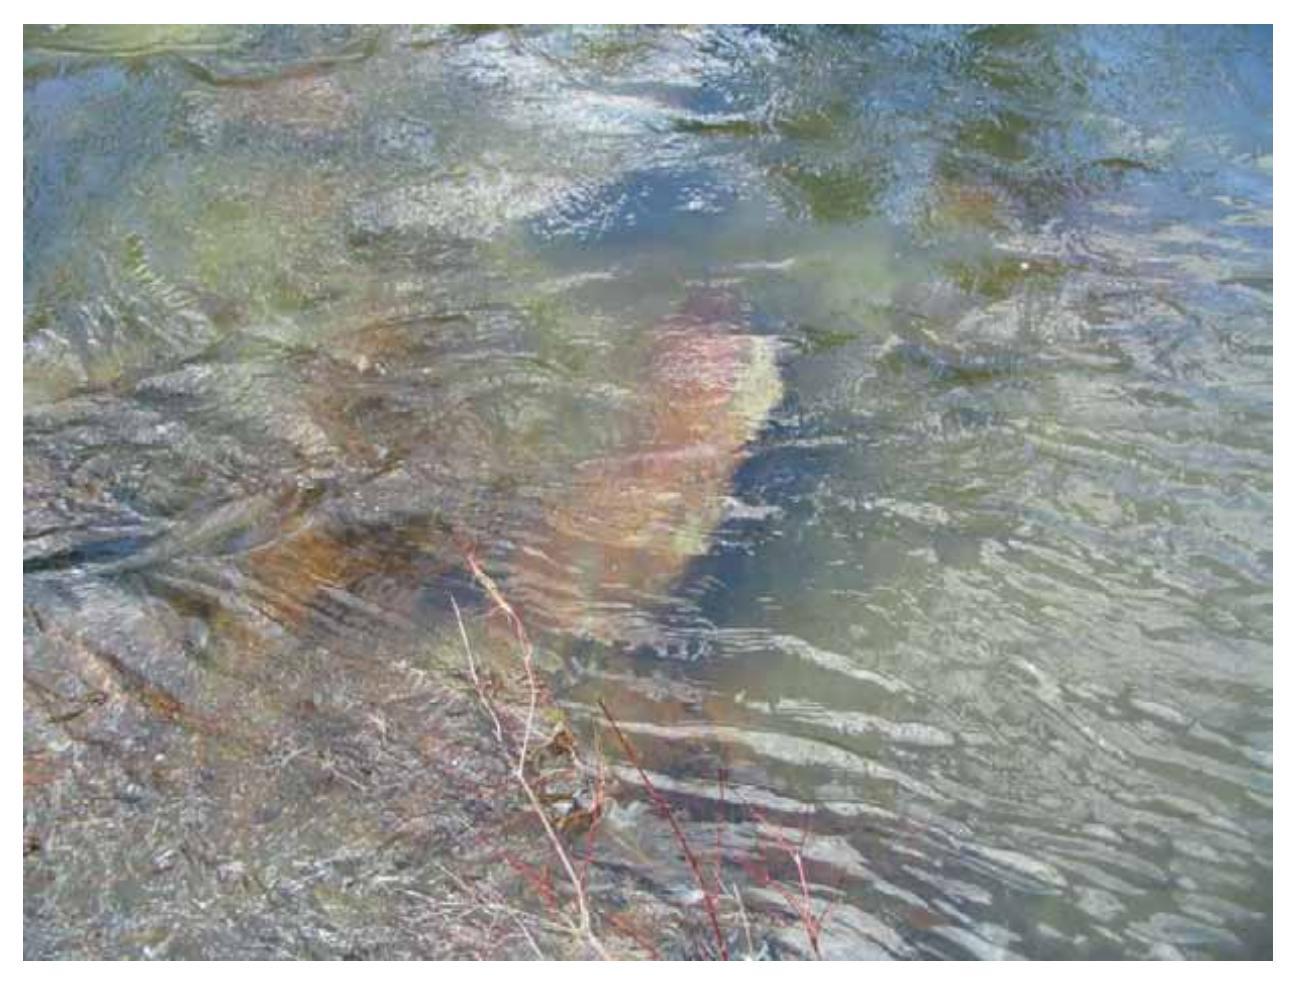
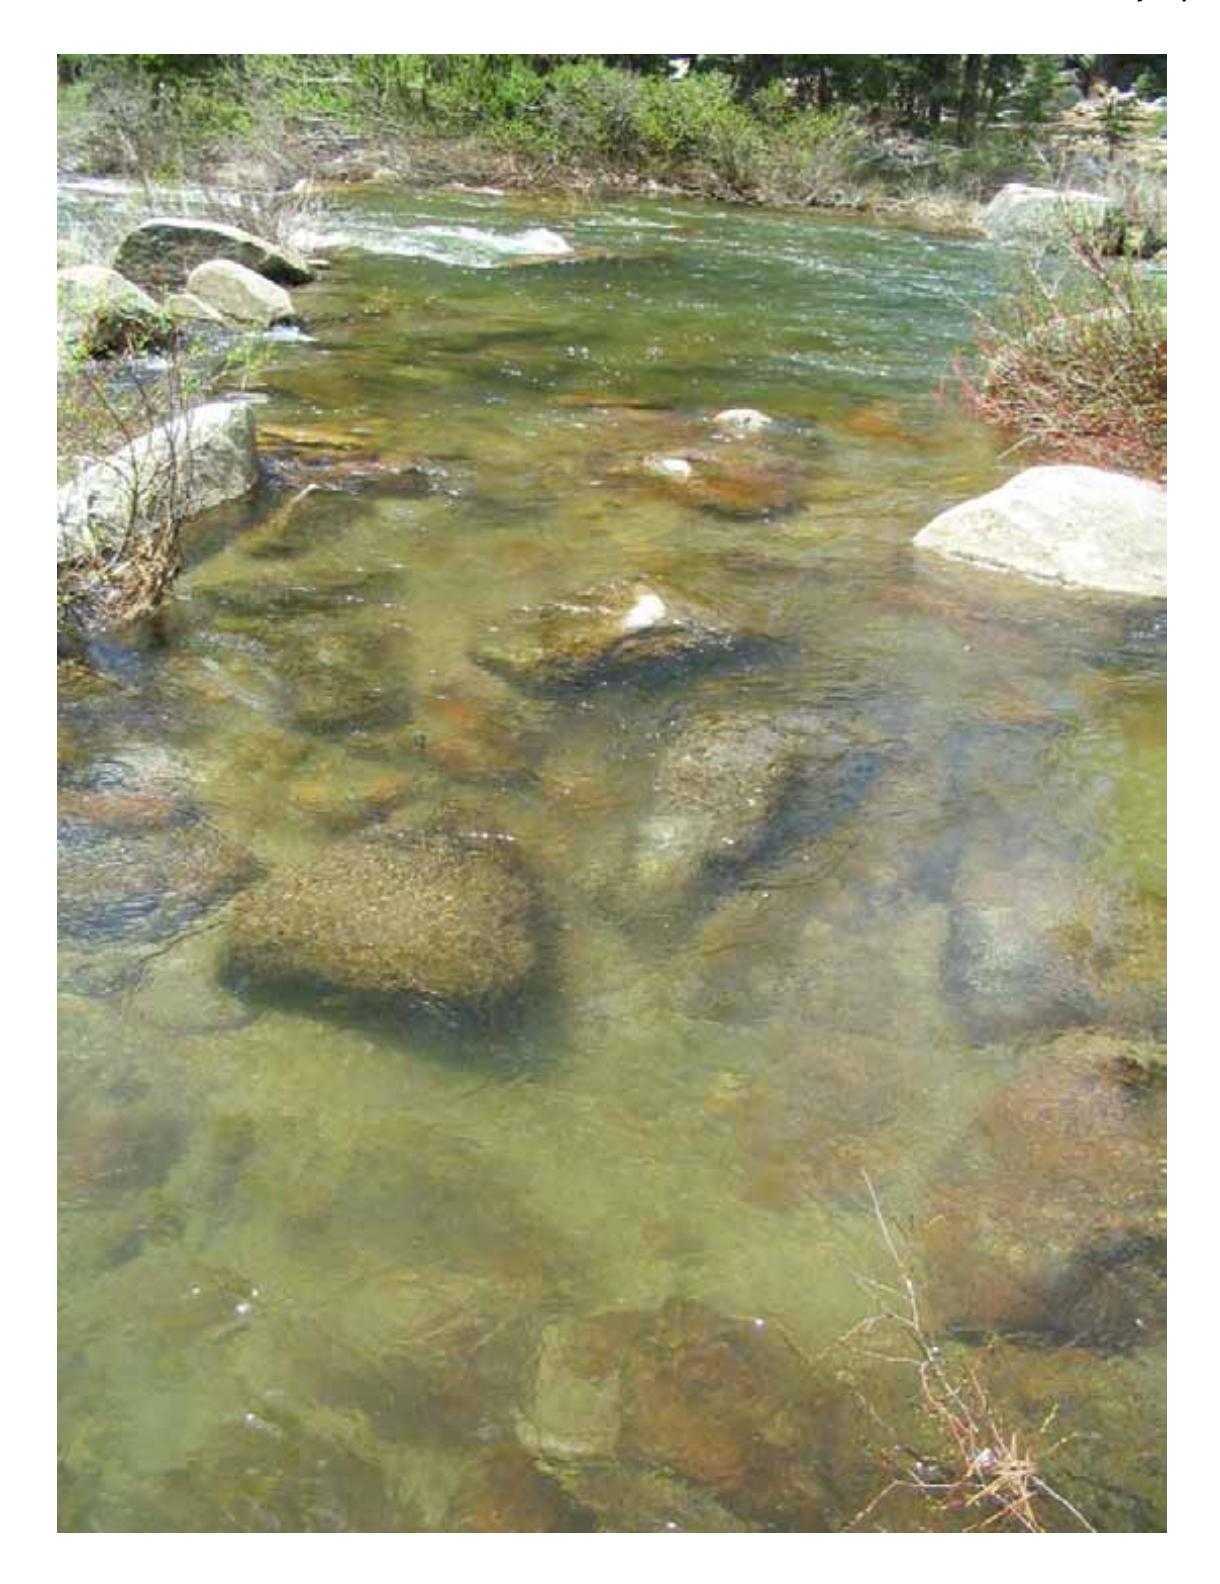
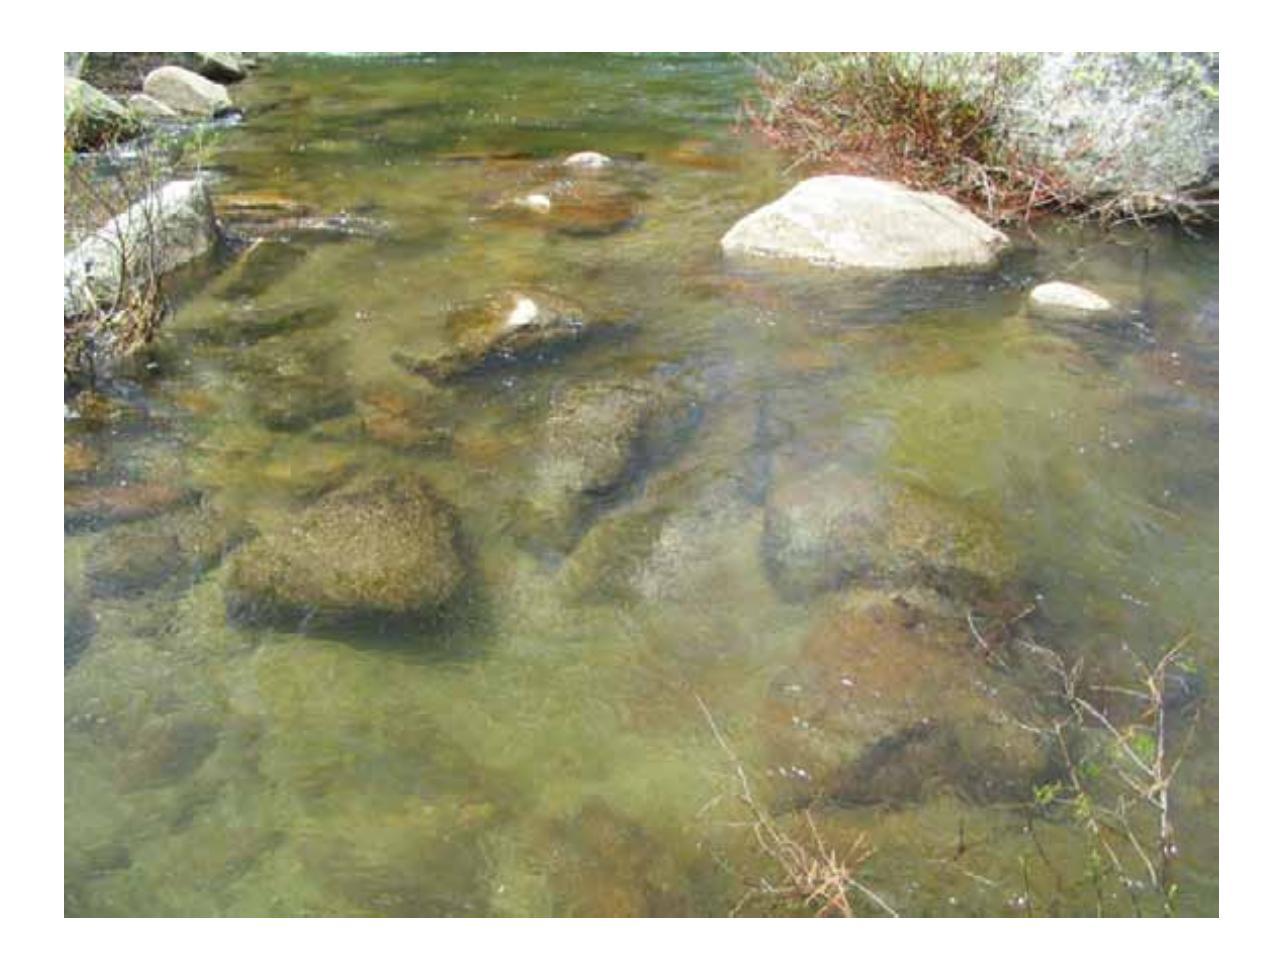
Images 30 through 35 are from the vicinity of R2 where the filamentous growths were very heavy in June/July 2008. As shown in the images, as of 31 May 2009, no filamentous algae growths are evident.

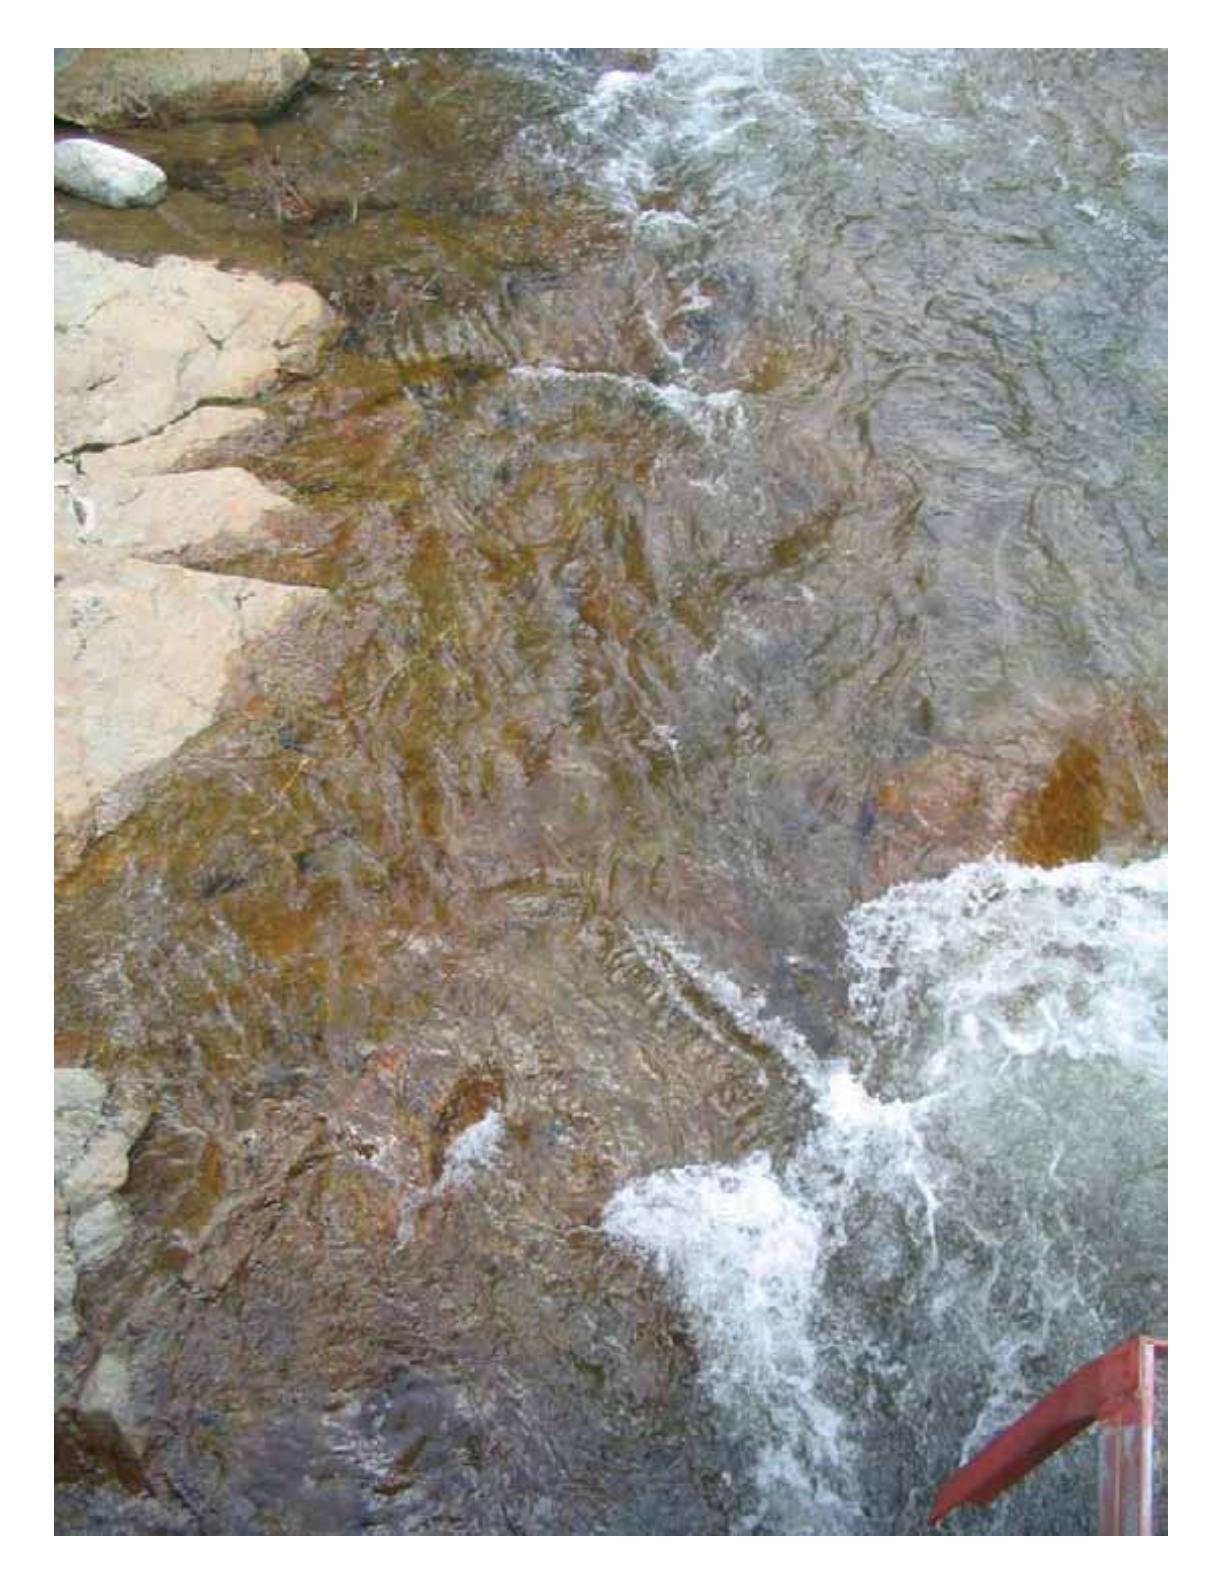
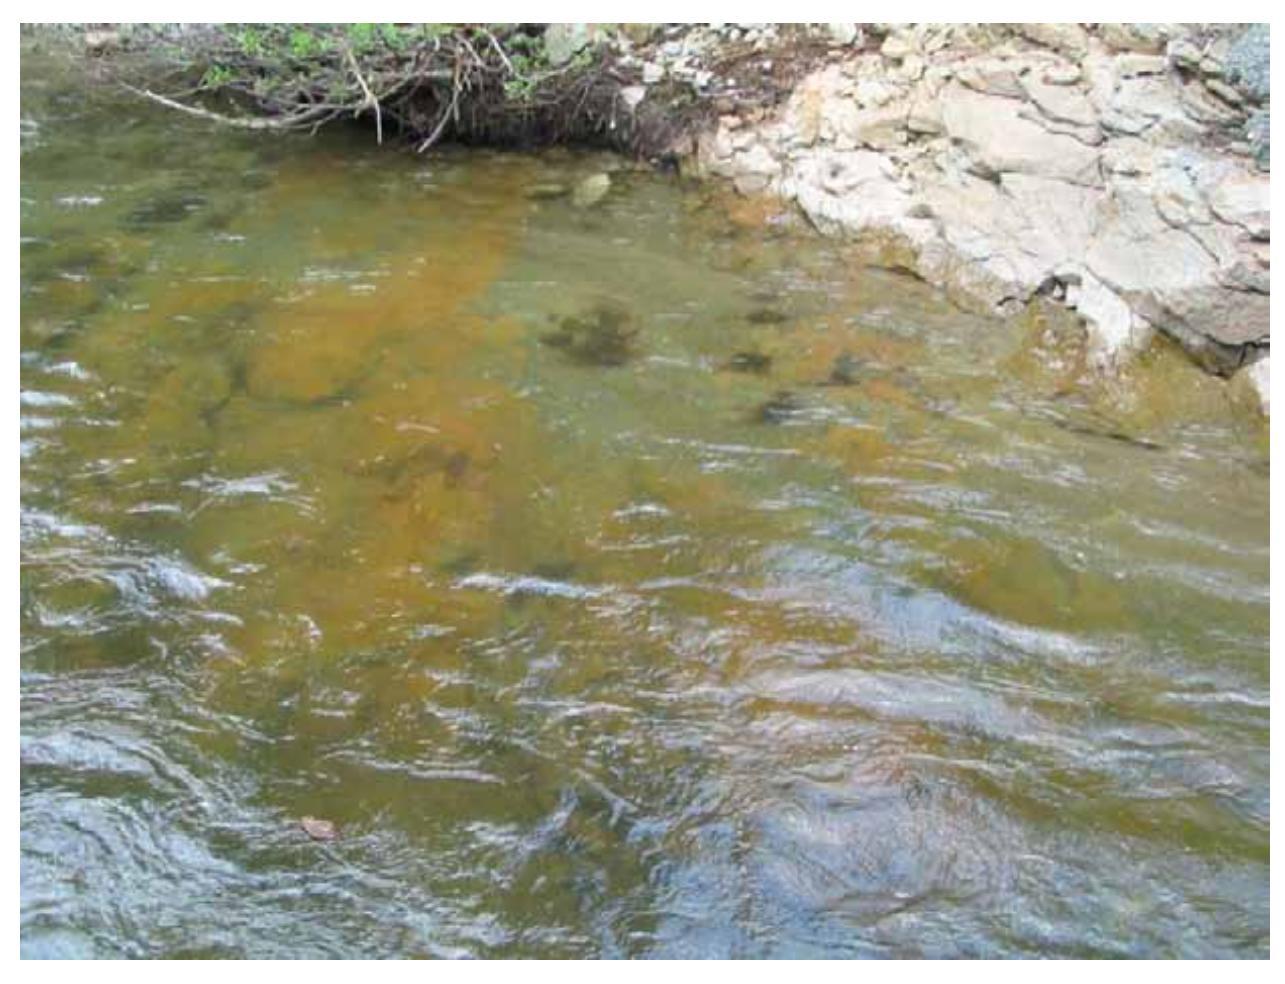
Images 36 and 37 are the SYR at the Kingvale bridge. Again, no filamentous algae growths were evident, here, or at more downstream location on 31 May 2009: Hampshire Rocks, Rainbow Lodge, or Cisco Grove.

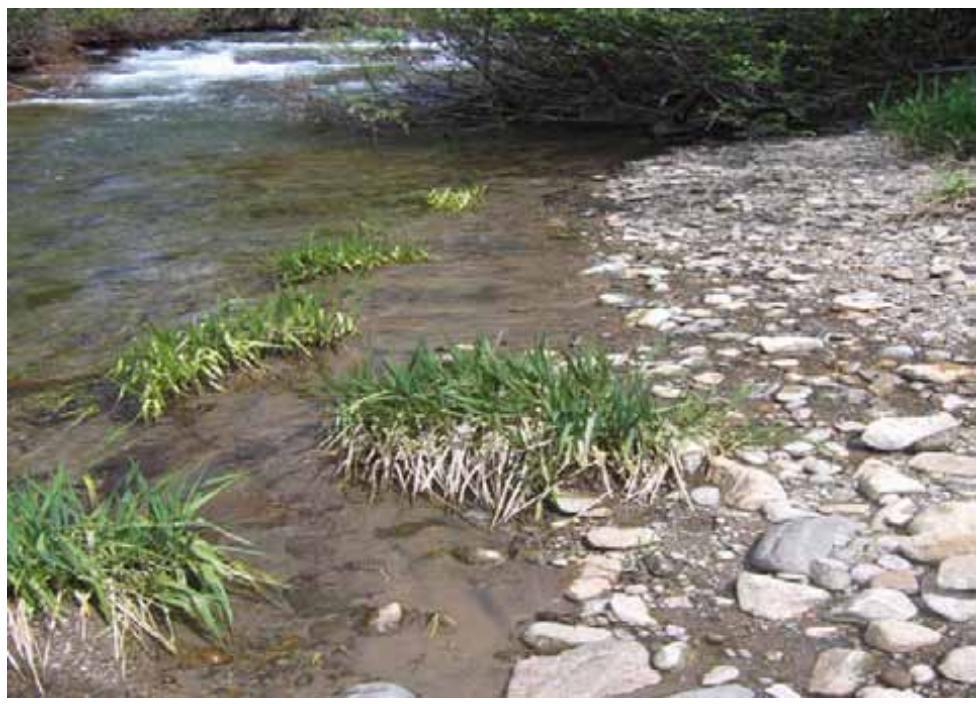
#### Image 44 (D)

Image 44 is looking upstream at the gravel bar from which the effluent emerges into the river. The exposed macrophytes in Image 44 are the same as those submerged in Image 26; thus, showing the extent to which SYR stage has receded since 31 May 2009.

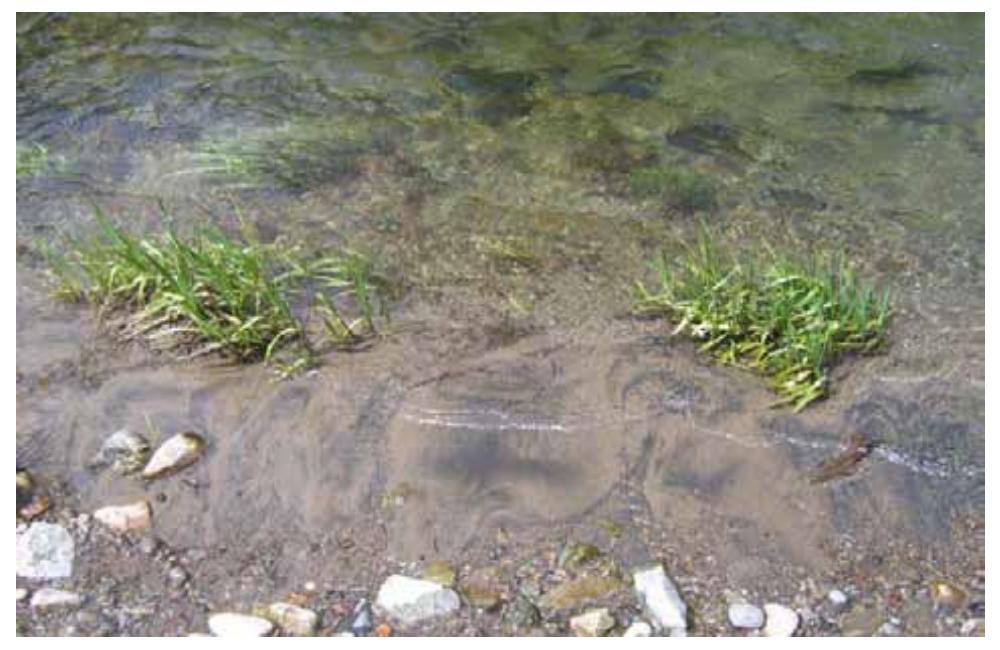
Image 45 (D)

Image 45 is a close-up showing the small sandbars (with black iron deposits) where the effluent enters the river (and pushes sand from the gravel bar that was deposited, there, by the river under higher river stage conditions). The effluent does not appear to cause any biostimulation at the immediate effluent discharge point under good solar exposure conditions where effluent concentrations and biostimulation potential, in theory, would be greatest. If biostimulation were to occur, it would be expected in the less sandy, deeper water just beyond the macrophytes shown in Image 45.

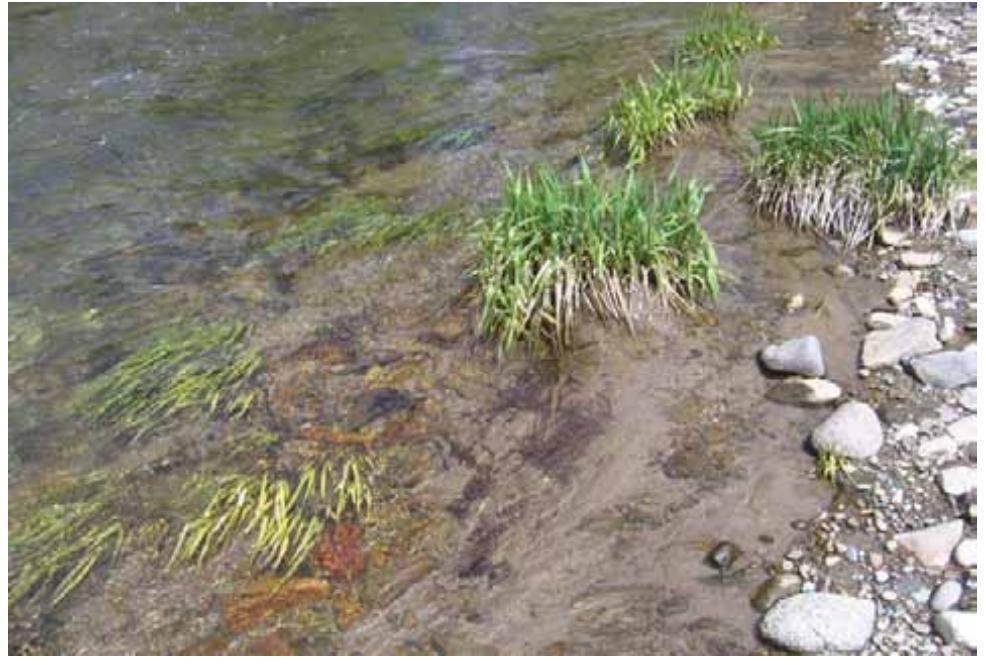
Image 46 (d 50% E)

Image 46 is immediately downstream of the effluent discharge area. The effluent is still concentrated on the right side of Image 46, and is flowing in and amongst the macrophytes. No filamentous algae growths are evident. In the "mixing zone" shown in Image 46 there are stable rocks present (the orangish objects in the water) which could support filamentous algae growth.
