#### **RE: Donner Summit Public Utility District Biostimulatory Substances Study**

Photo Essay Report No. 3 South Yuba River Biostimulation Photo Essay Report

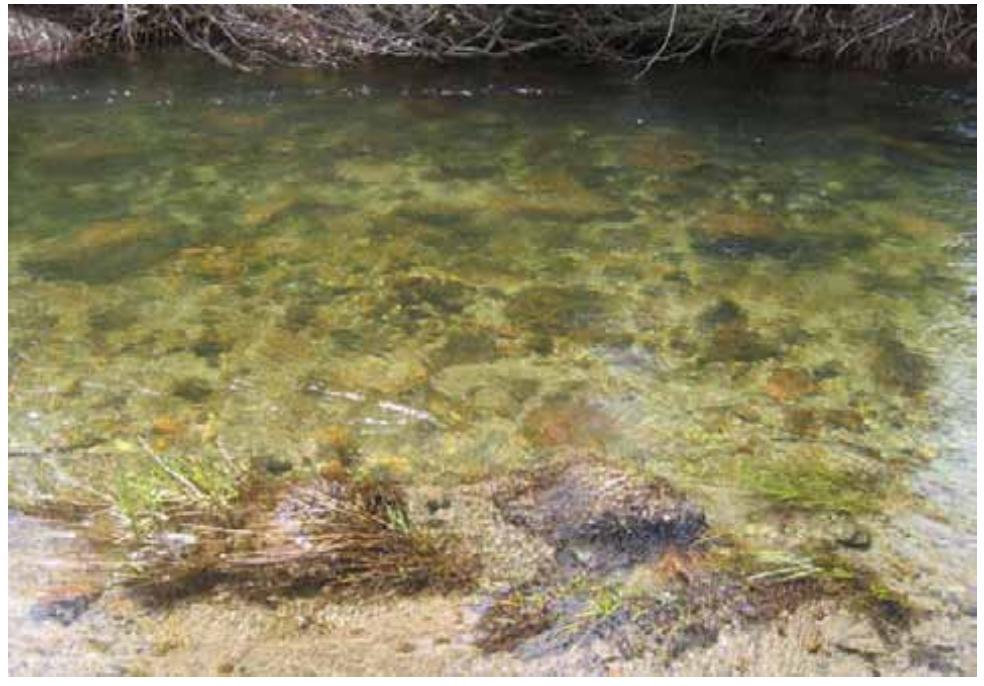
Image 47 (E)

Image 47 is the effluent side of the river in the first pool just downstream of the river bend. Last year dead residues of filamentous algae were very evident on the rocks just beyond the clumps of emerging vegetation. This vegetation was on the river bank at the time of last year's survey 2 July 2008; and, by this time the algae had grown and were in an advanced state of decay. As evident in the image, sands and other fines tend to be deposited on the inside, downstream bank of this river bend, as is typical.

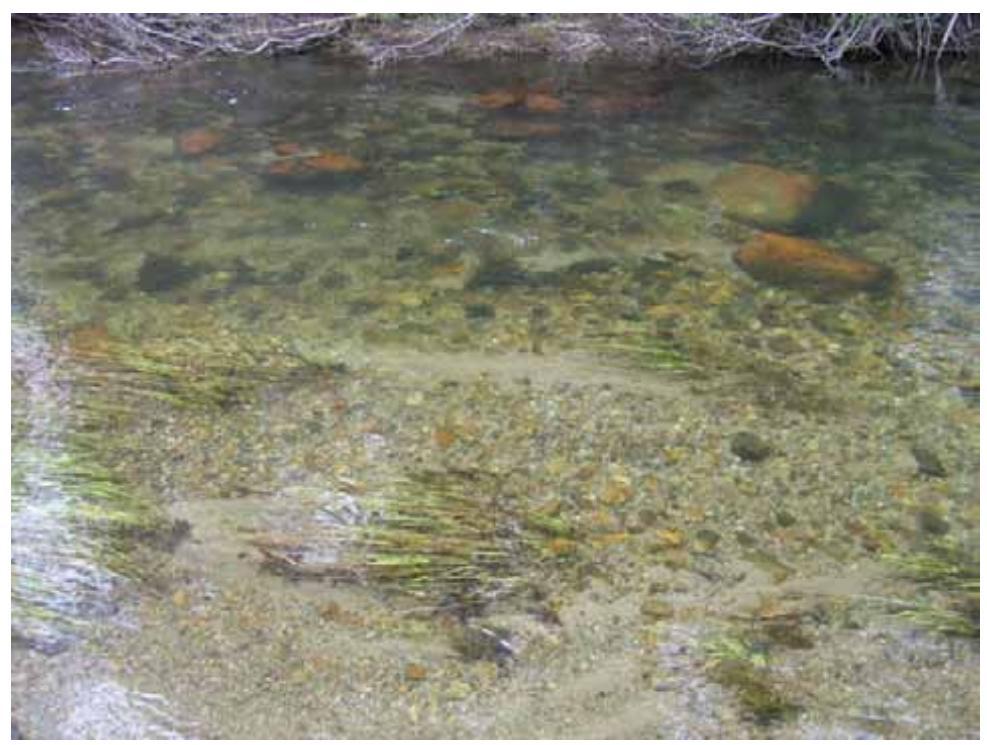
Image 48 (E)

Image 48 is just downstream of Image 47 on the effluent side of the river. Again the river bottom is completely free of any evidence of filamentous algae growths.

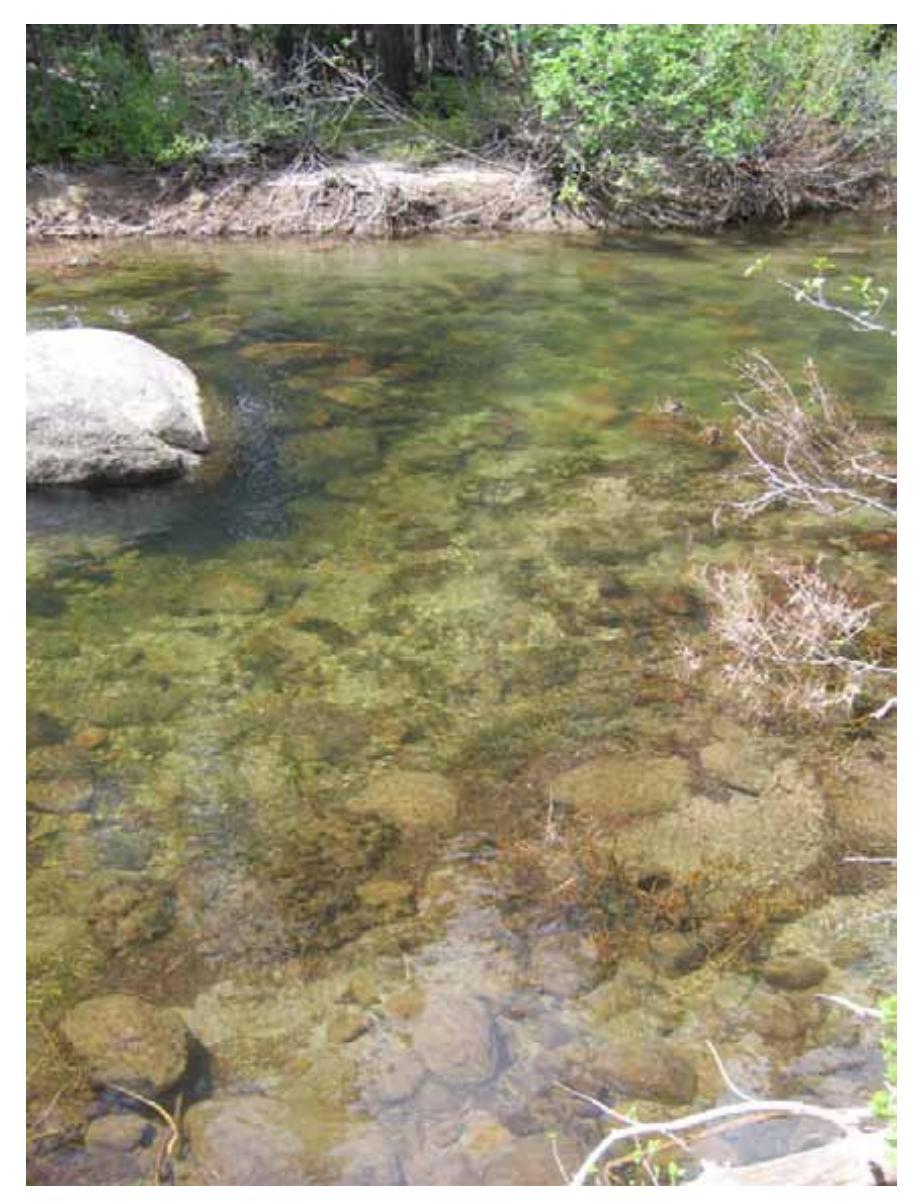
Image 49 (E 50% F)

Image 49 is the back end of the first pool below the effluent discharge point. Decaying filamentous algae growths were very evident last year at this location. No growths are present. The deposition of sands and silts is evident in the tan area in the foreground.

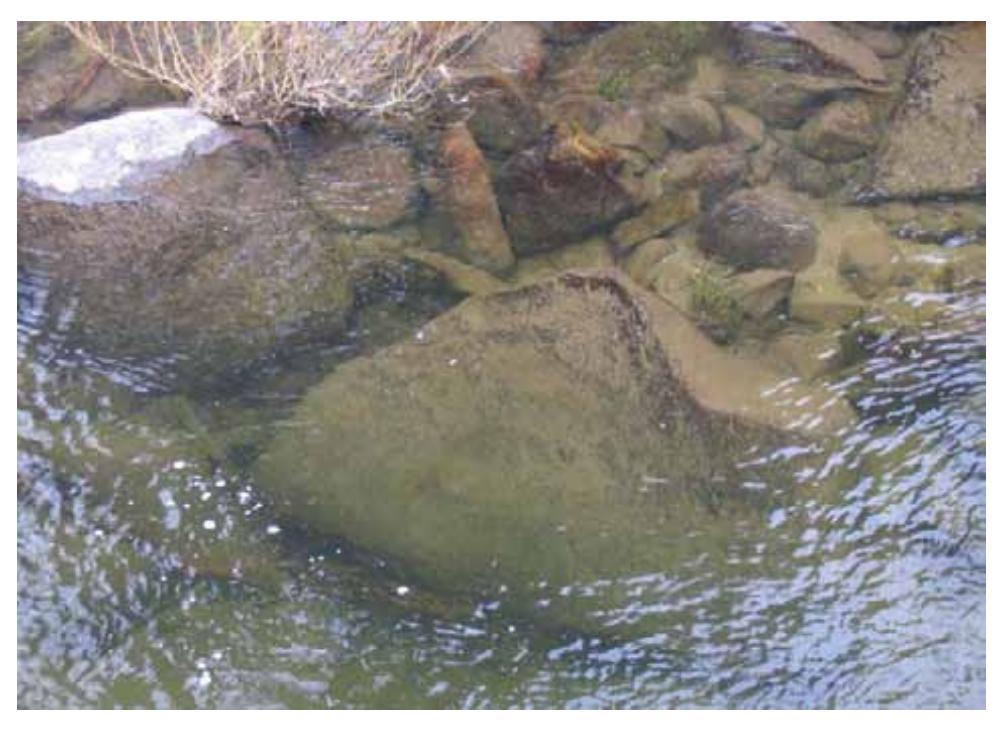
Image 54 (J)

Image 54 is from the Highway 40 bridge west of Kingvale. As shown, silt deposition is evident on rocks; filamentous growths are not evident. The greenish color is from the water, its depth, and green reflection from riparian vegetation.

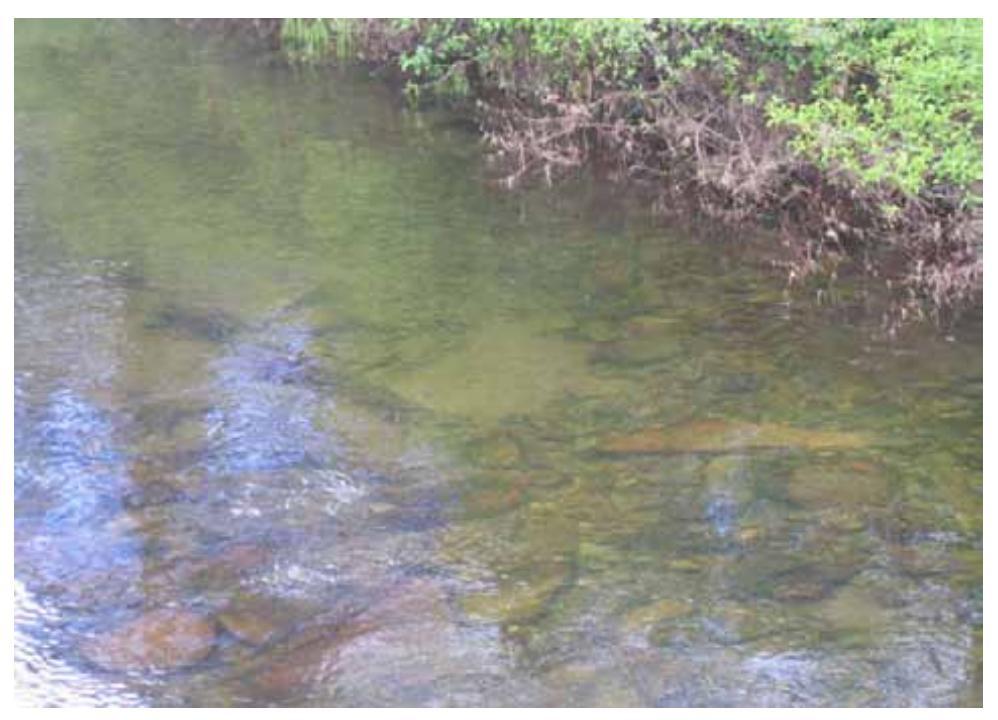
Image 55 (K)

Image 55 is from the old concrete bridge located between Highway 40 and I-80. There is minor silt deposition, and no filamentous growths. Solar exposure, stream, and substrate conditions are favorable for filamentous algae at this location. Color from reflection is very evident (white clouds, blue sky, and green vegetation).

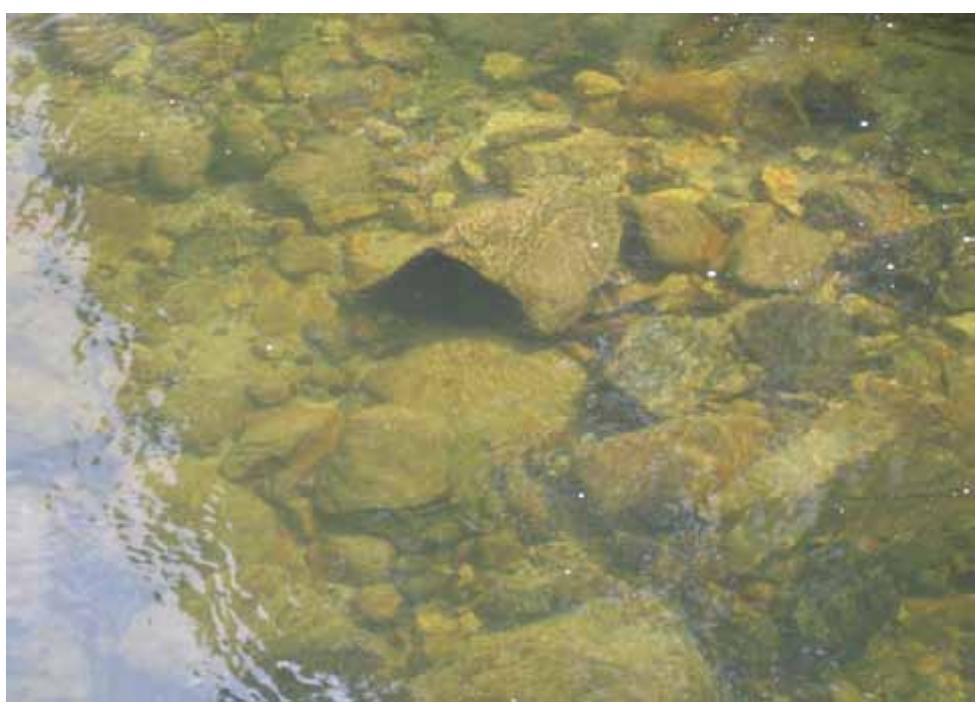
Image 60 (N)

Image 60 is at the Big Bend bridge. Some silt on the rocks is evident giving them a tan tint. Filamentous algae are not present.

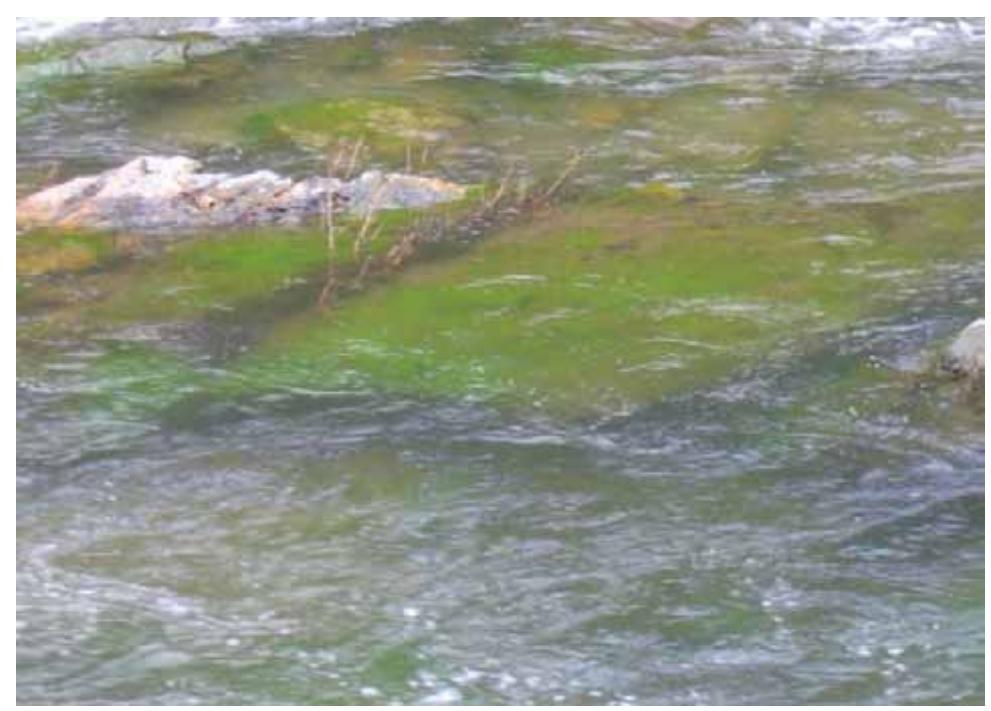
Image 61 (O)

Images 61 and 62 are just downstream of the I-80 crossing between Cisco Grove and Rainbow Lodge. The solar exposure, substrate, stream conditions, and canyon-like conditions (i.e., canyon glare) make this site ideal for attached algae. As shown, filamentous algae were present in the river.

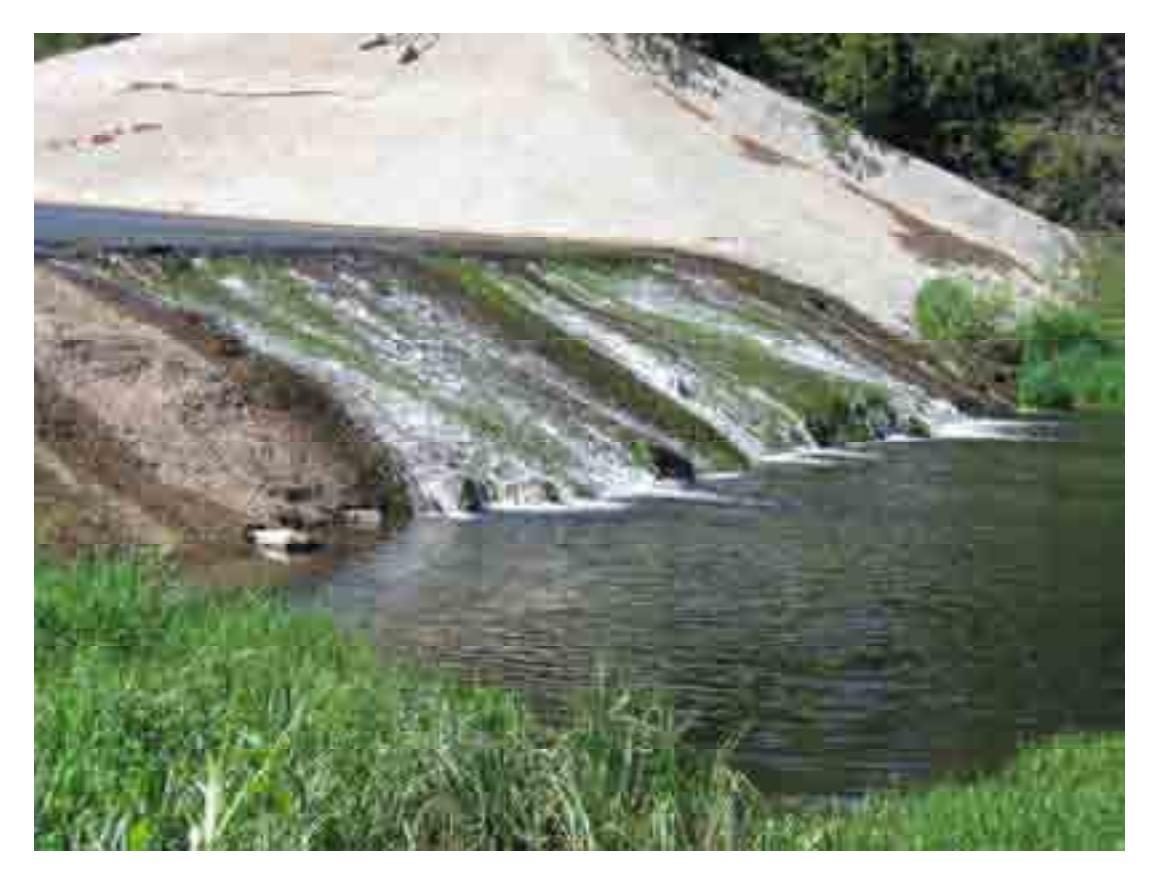
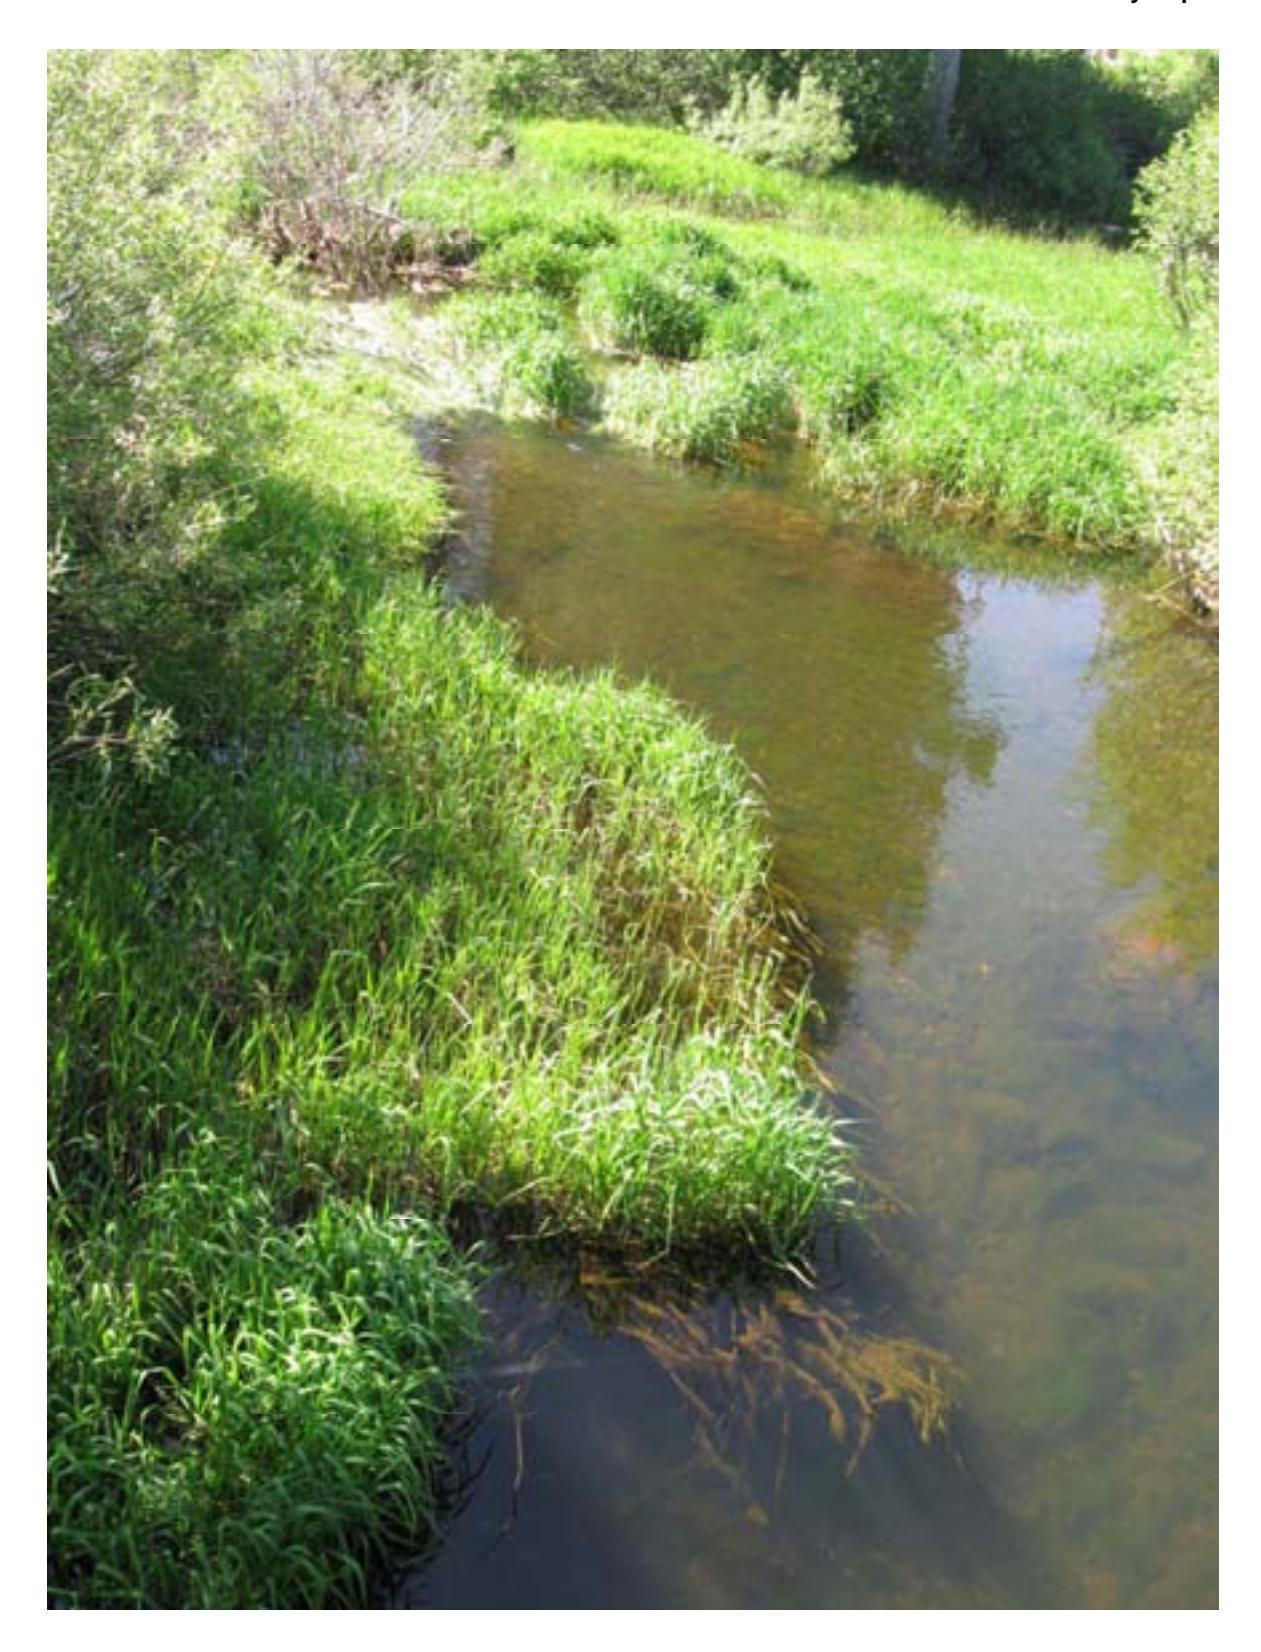
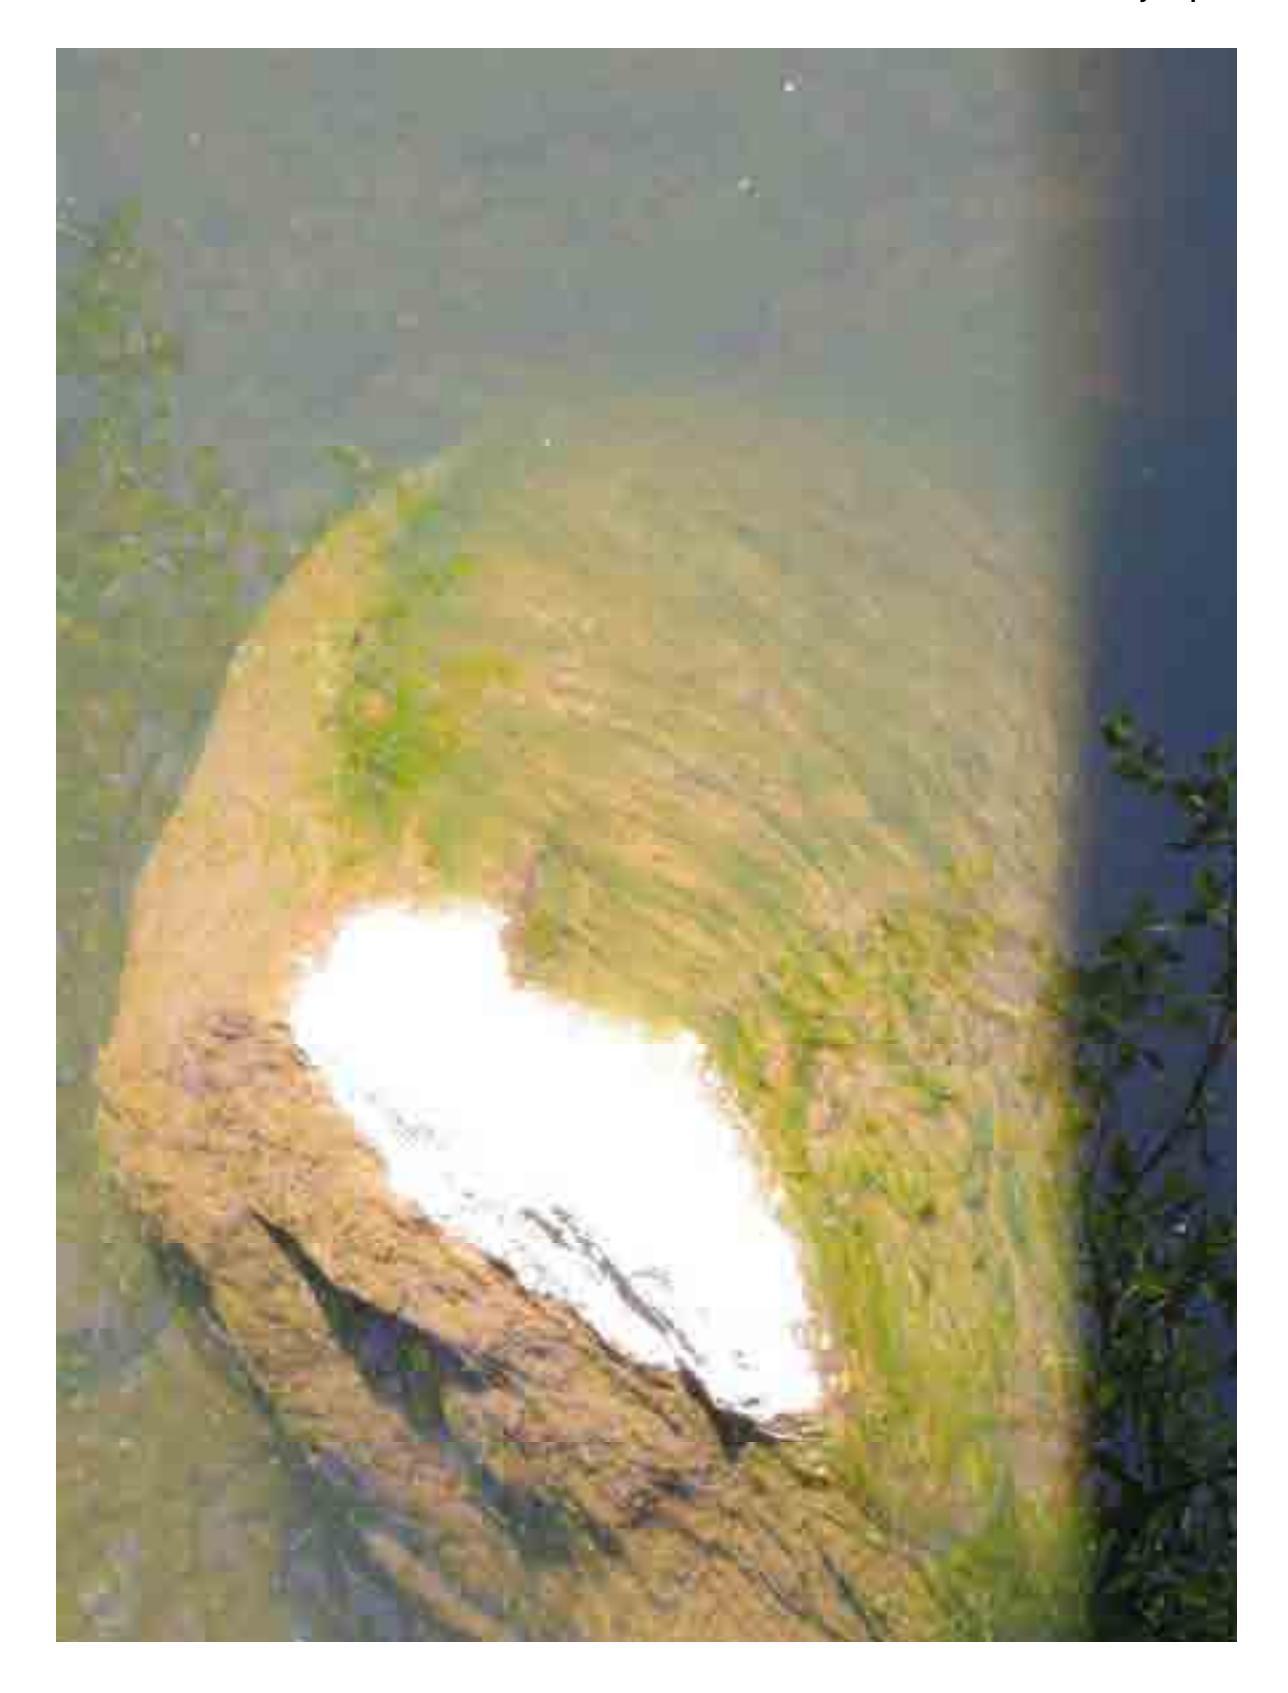
Filamentous green algae were evident on the Lake Van Norden spillway crest and face as shown in Images 99 and 100. Filamentous algae were also evident in the river at this location in various states of vitality and decay, see Images 101 and 102.

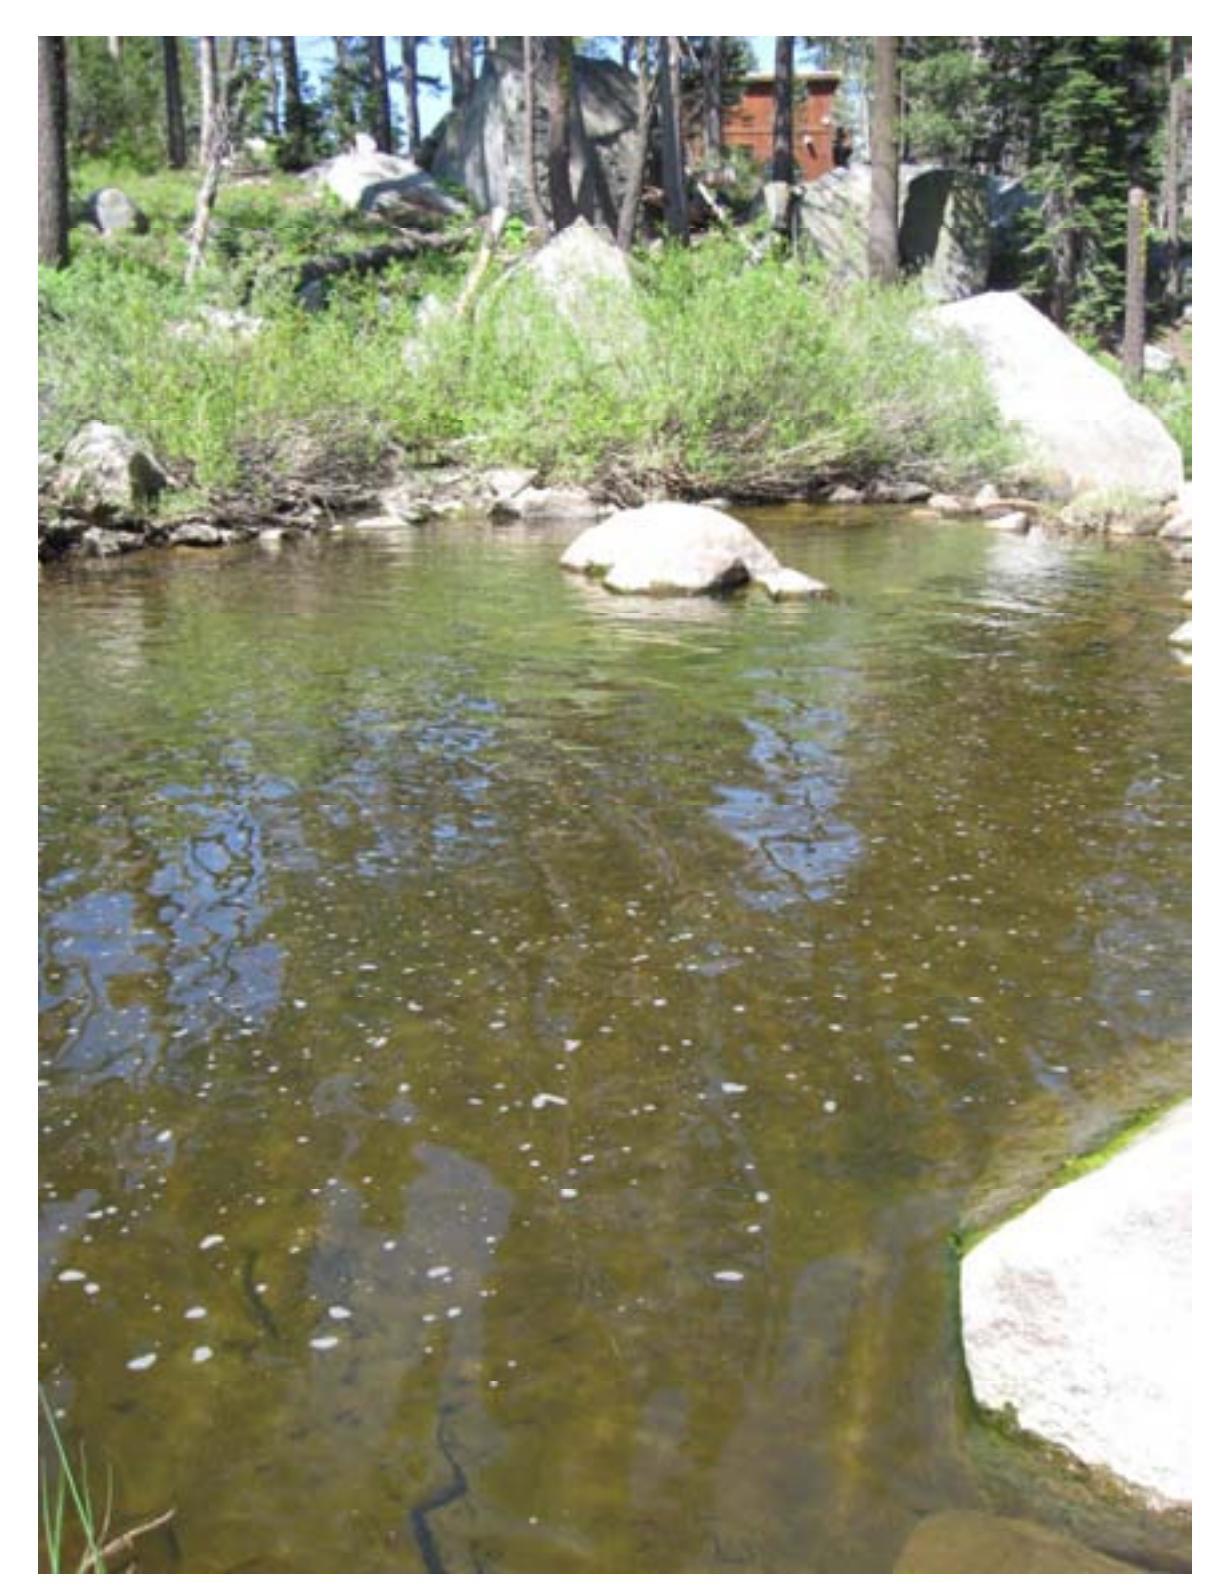
Image 103 (B)

At the I-80 crossing of the SYR downstream of Soda Springs, the rocks were covered with brown fuzzy films, see Image 103. Green filamentous algae were evident at the air/water interface of some rocks, see Images 104 and 105. These are the shallow water green filamentous algae noted in previous surveys.

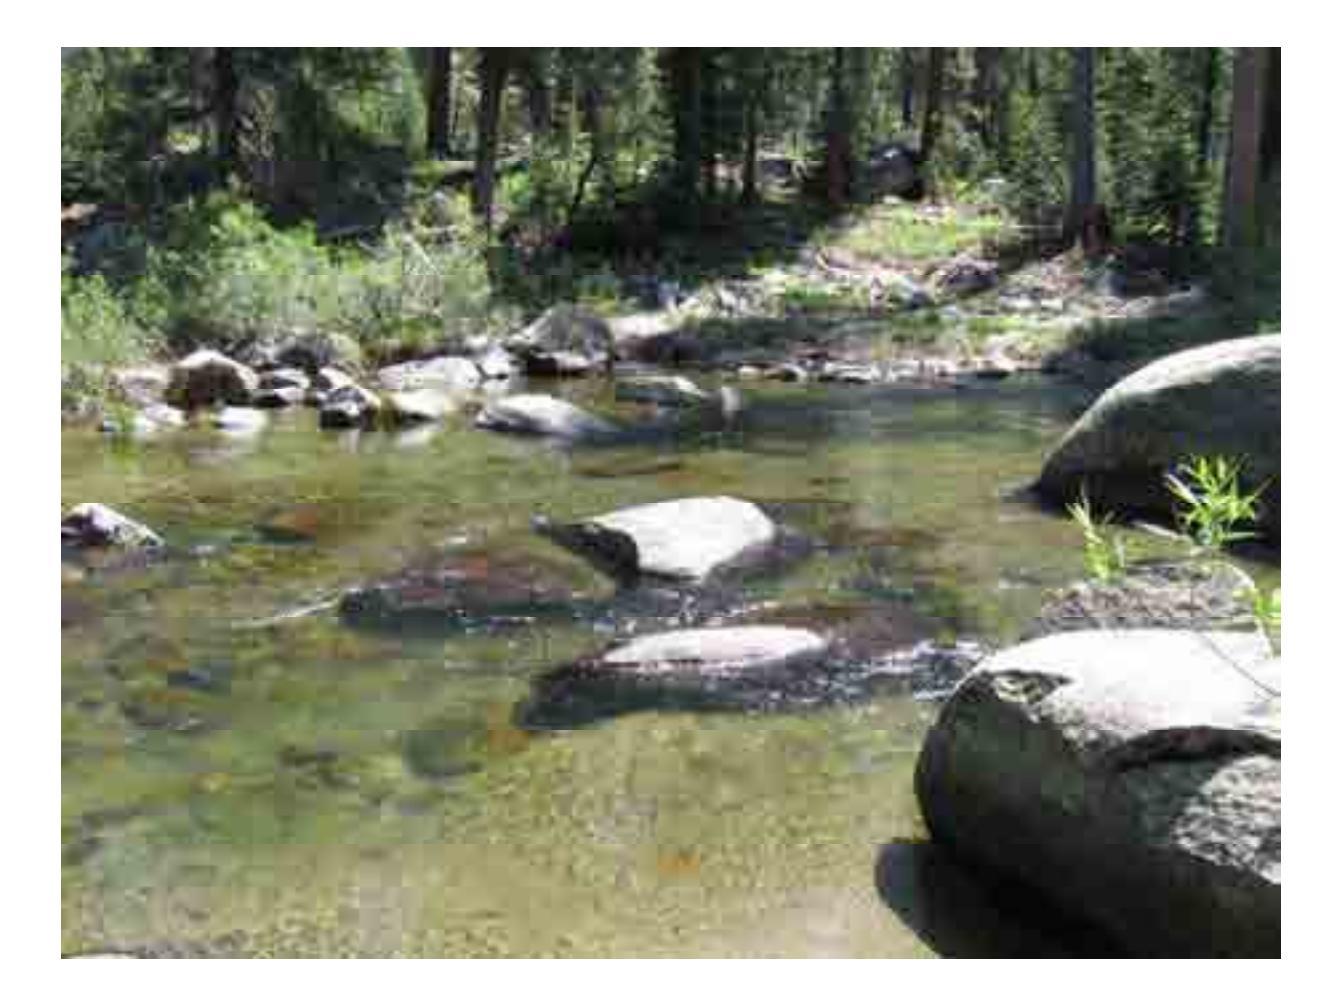
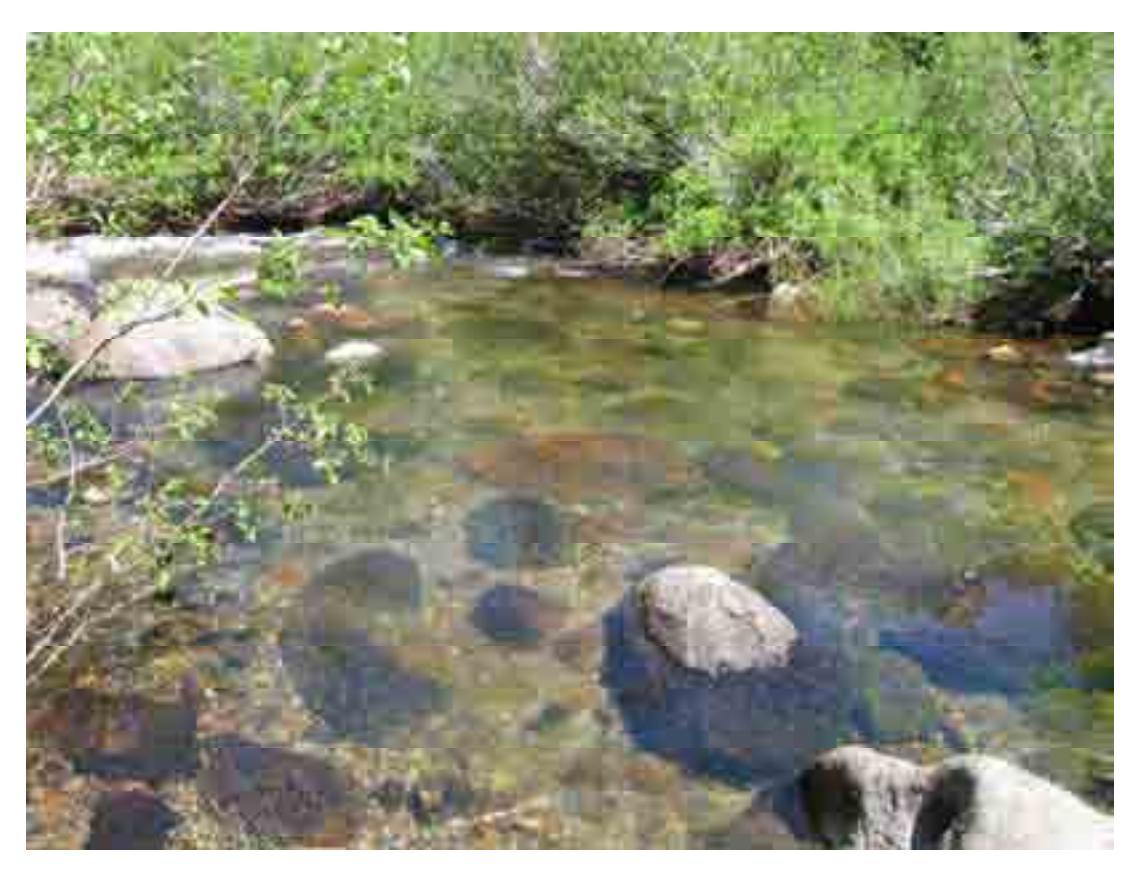
Immediately upstream of the effluent discharge point, the river rocks are generally clean (see Images 106 and 107), with relatively minor amounts of filamentous green algae being present on some rocks, such as shown on the rocks in the lower right-hand corner of Image 107. Image 108 is a close-up of these rocks showing the nature and extent of these growths in greater detail.

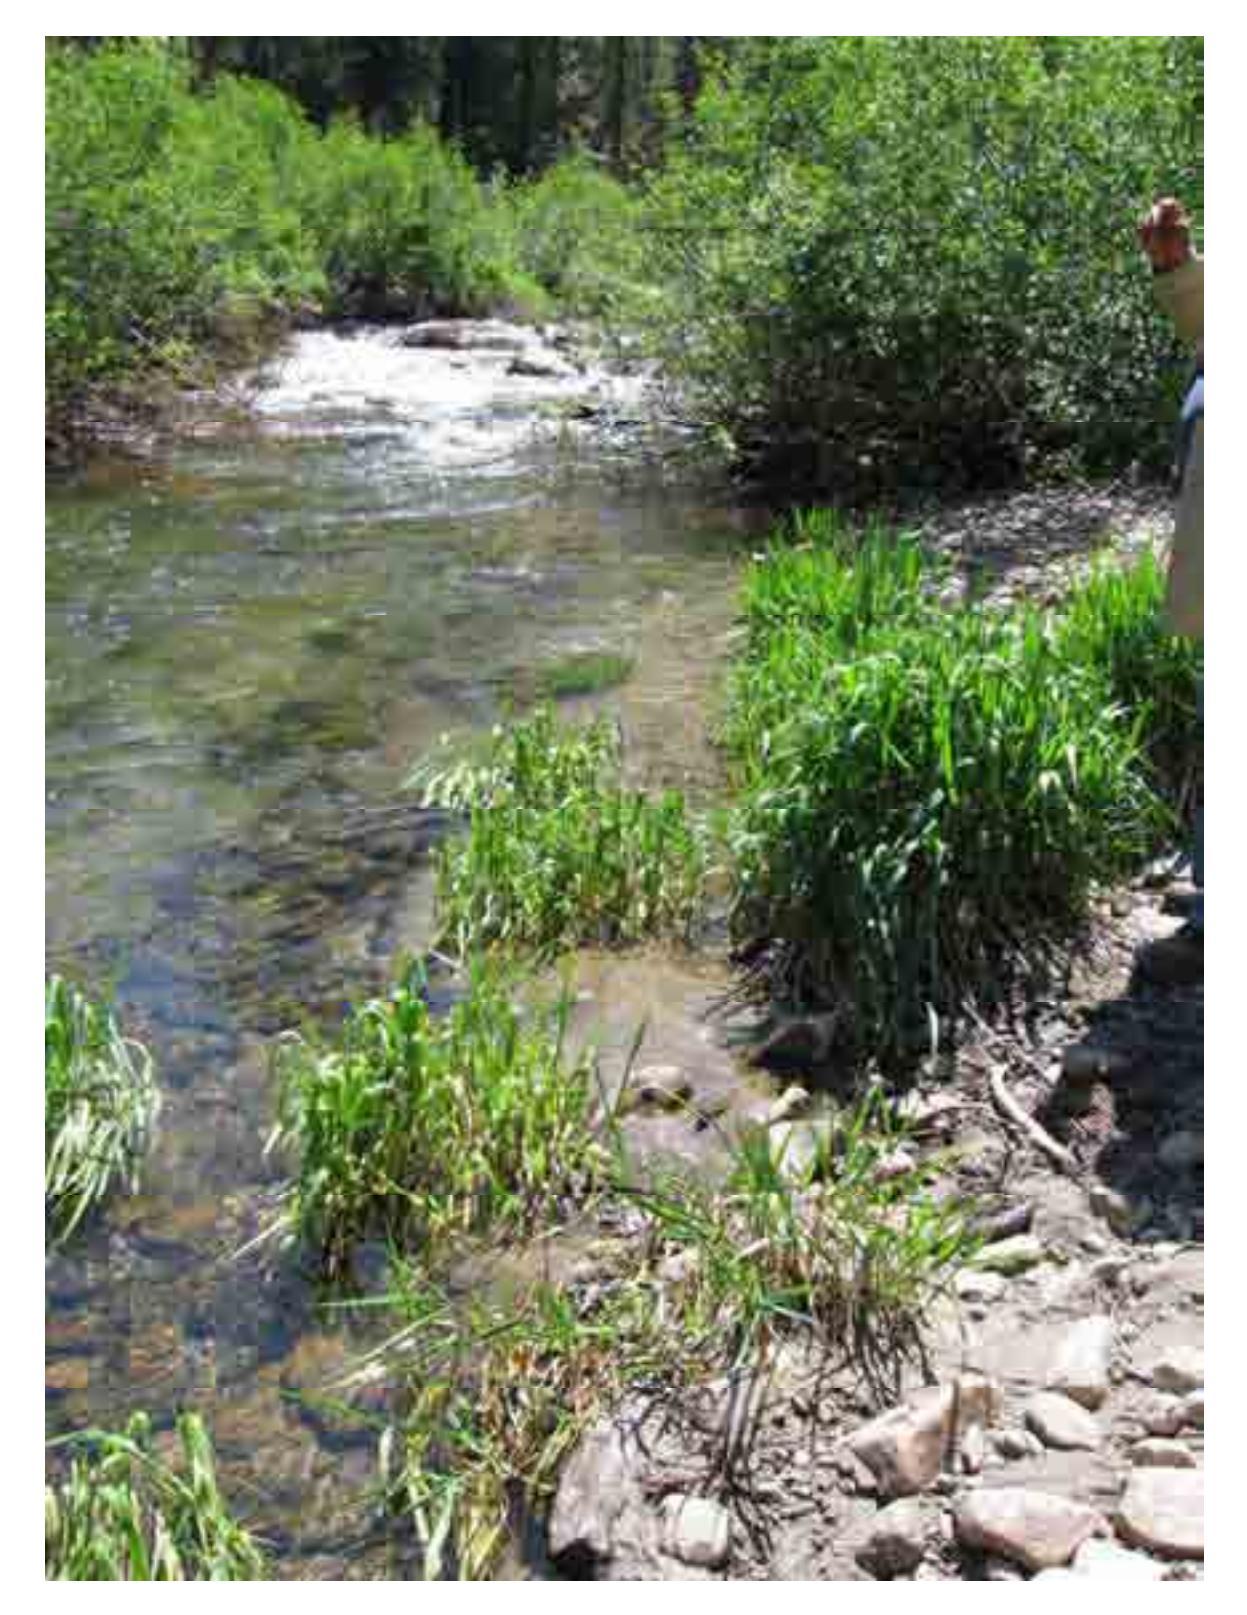
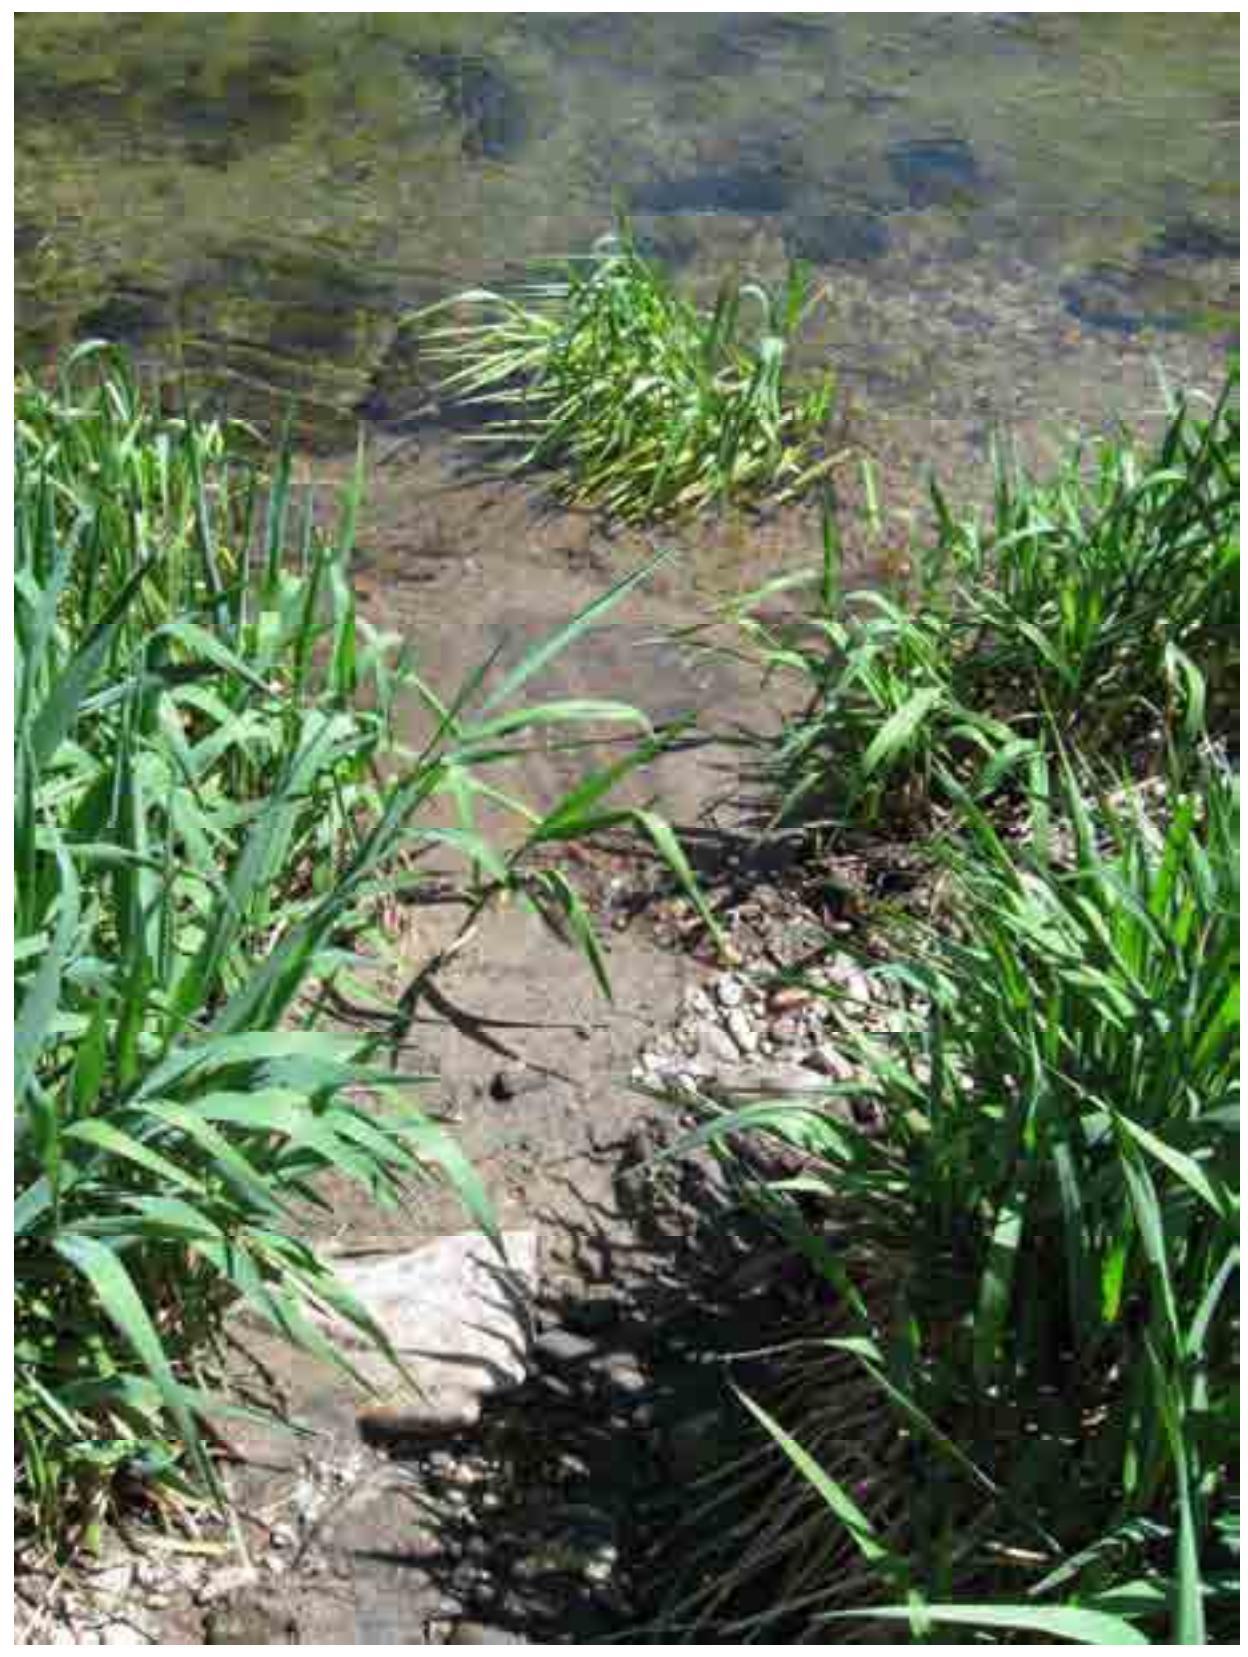
Image 109 shows the effluent discharge point in the SYR. Image 110 is a close-up of one of the sandbars denoting where effluent is leaving the gravel bar and entering the river. As shown, at the immediate effluent discharge point there are no filamentous algae or other signs of biostimulation.

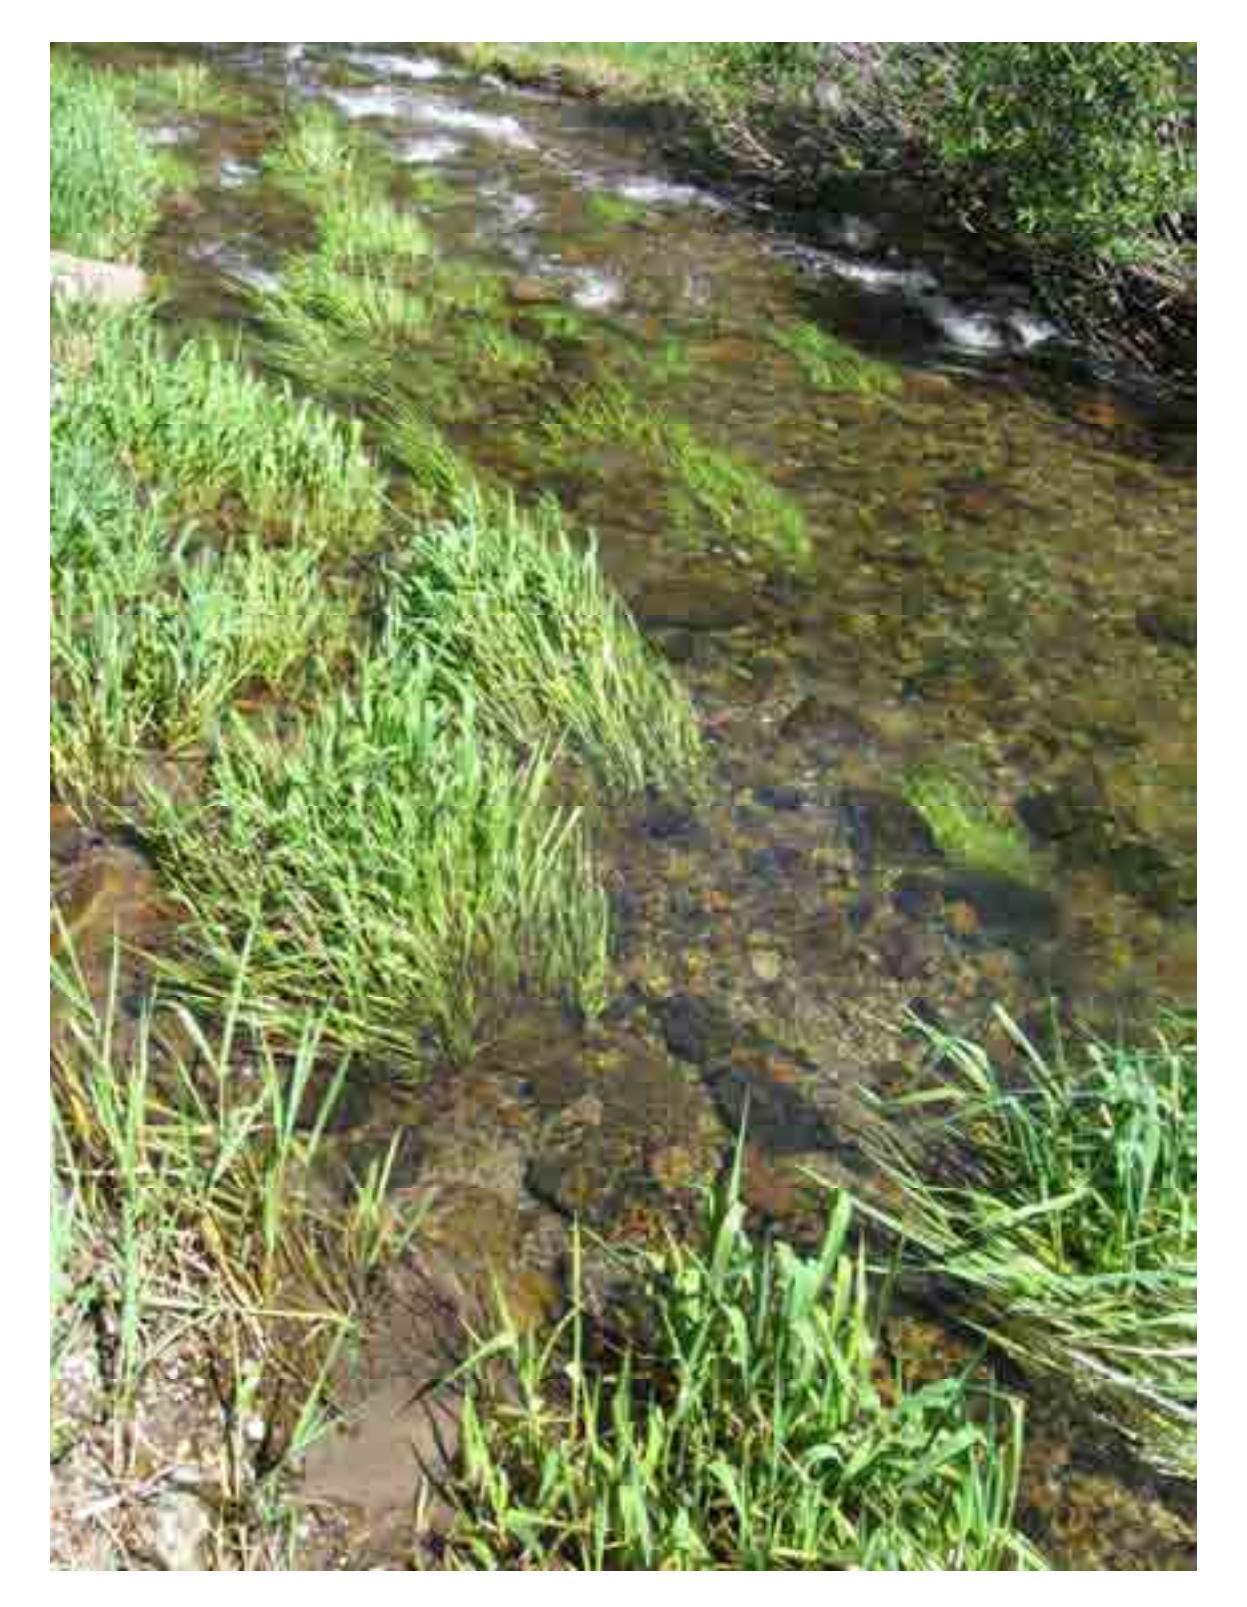
Image 111 (D)

Image 111 shows the SYR immediately downstream of the effluent discharge point. The effluent is still concentrated in the river water in the foreground of the image. As shown in Image 111, there are no filamentous growths, and the rocks are of diverse colors denoting the absence of any films on the rocks in both the foreground (effluent present in these waters) and the background (effluent absent from these waters).
