#### **RE: Donner Summit Public Utility District Biostimulatory Substances Study**

Photo Essay Report No. 3 South Yuba River Biostimulation Photo Essay Report

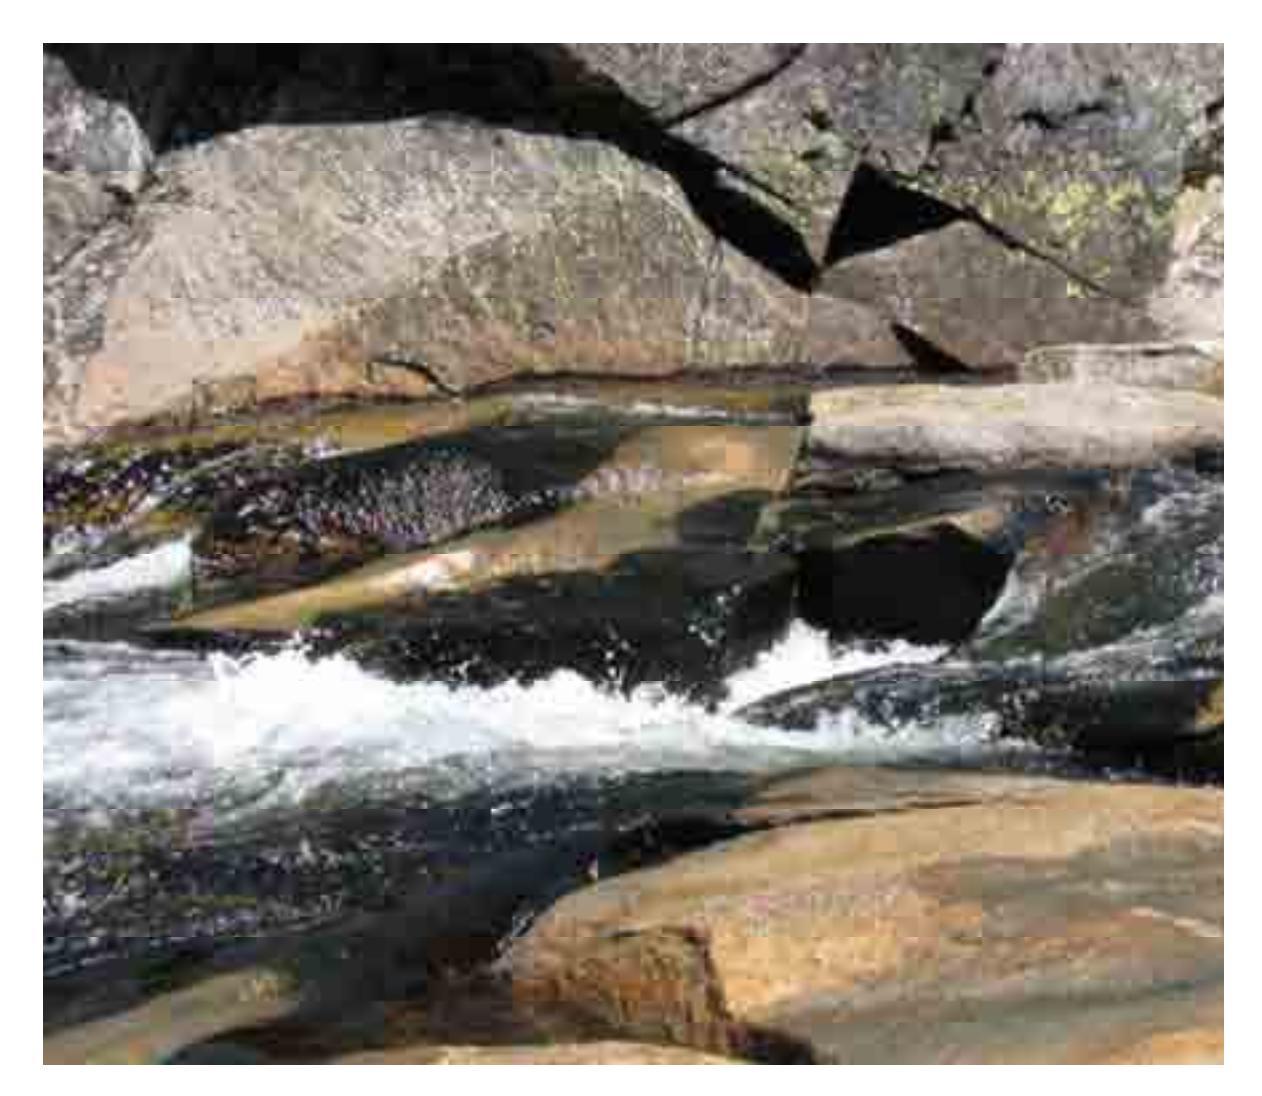
Image 113 (E)

Image 112 (E)
At DSPUD SYR monitoring station R2 (aka, Dinette Set Rock), the black-brown growths were very evident as a result of the reduced flows, see Image 113. Where exposed by decreasing river flows, these growths died to form grayish-white residuals (center of Image 114) on the tannish boulders. When dried by the sun, these residuals turn into the white crush shown in the lower right-hand corner of Image 114. With Image 114 as a guide, in Image 113 some dried crust can be seen on the rock in the center foreground. Grayish residues are also present.

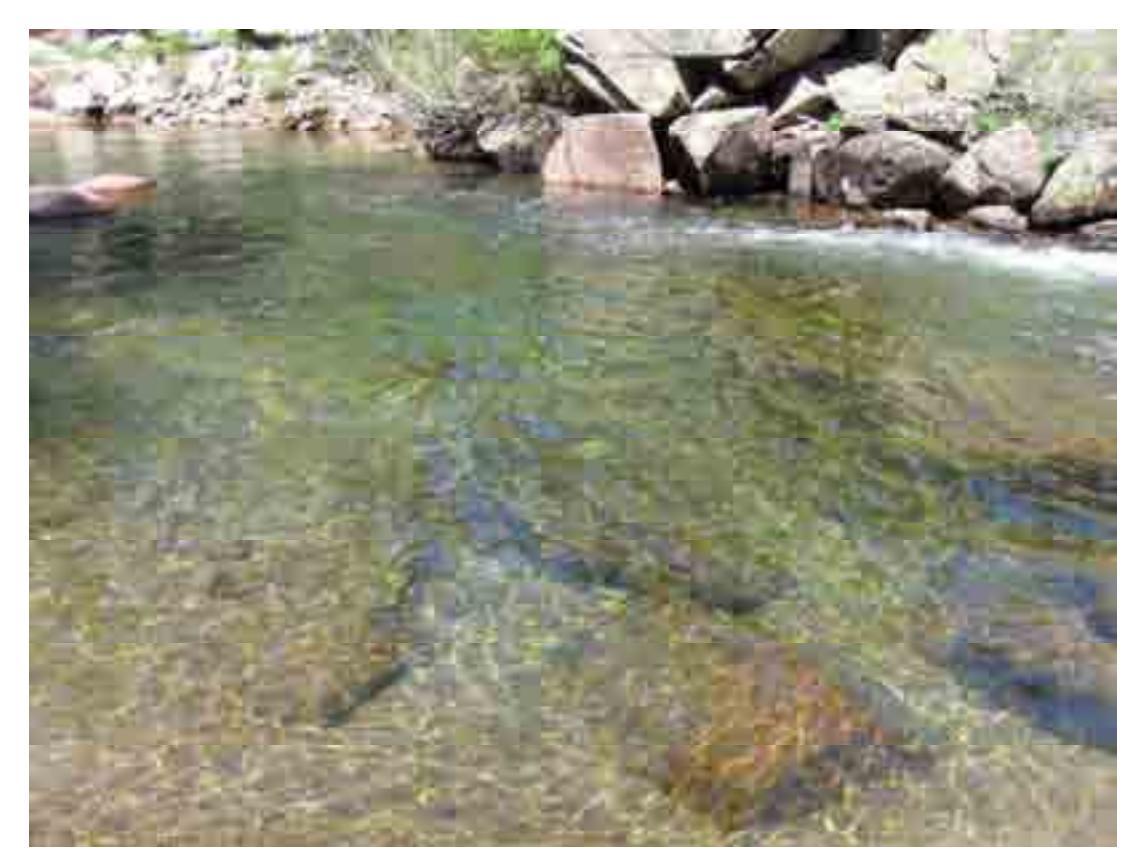
Image 115 (E)

The pools at R2 were generally free of films and filamentous algae as shown in Image 115. Small amounts of filamentous green algae were visible on rocks in these pools.

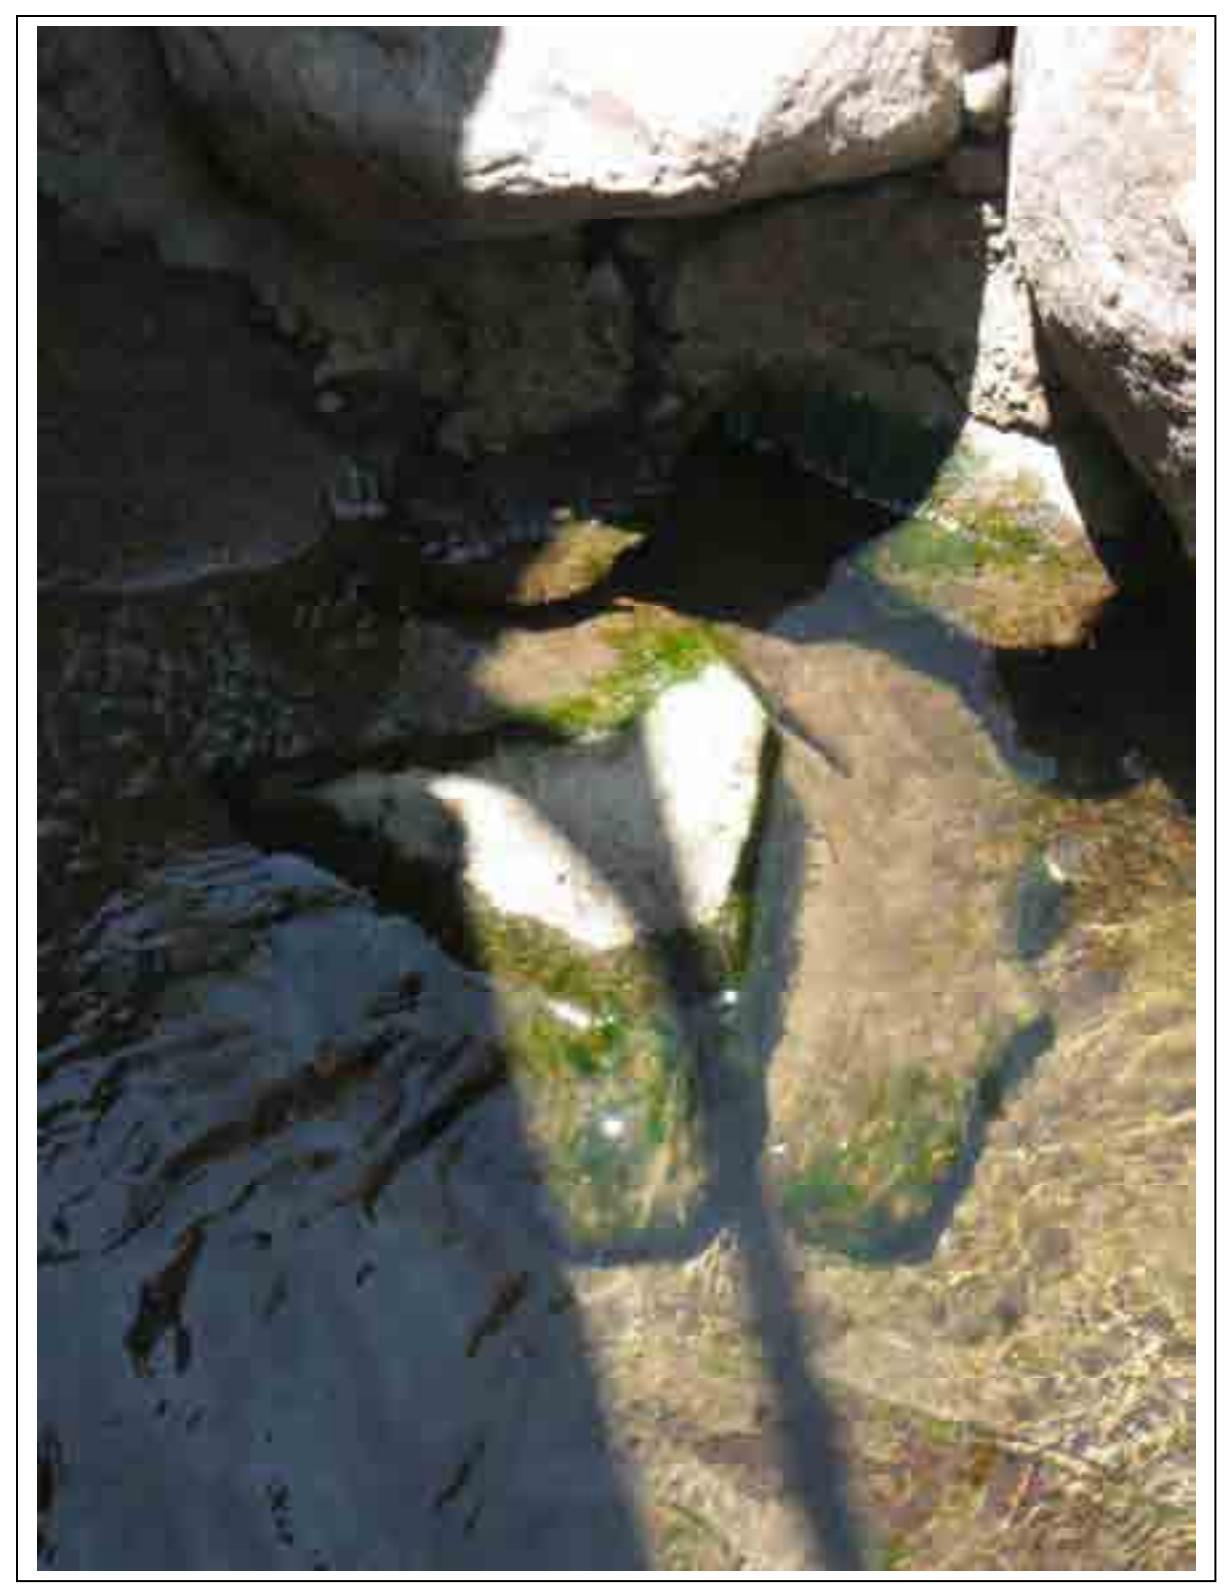
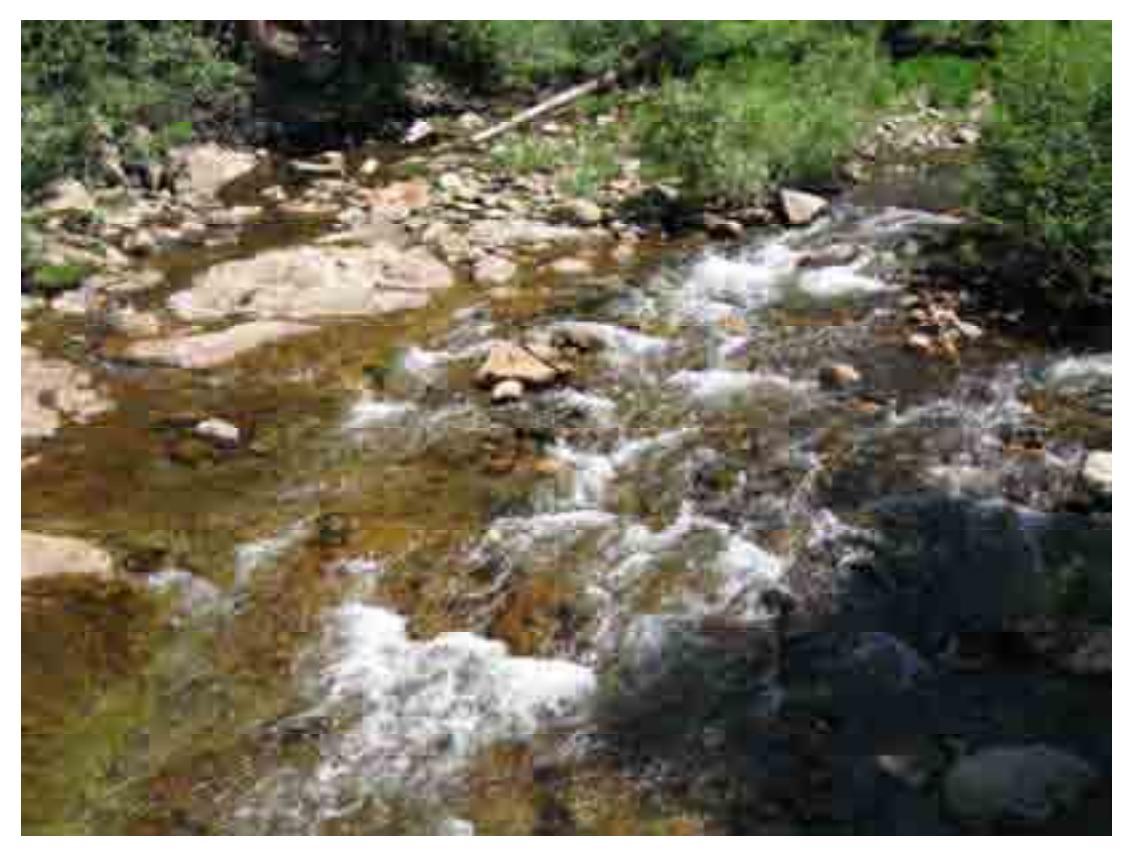
At the Kingvale bridge, some filamentous green algae were visible on the downstream side of the bridge (see Image 116). However, the SYR at this location was generally free of filamentous green algae as shown by Image 117.

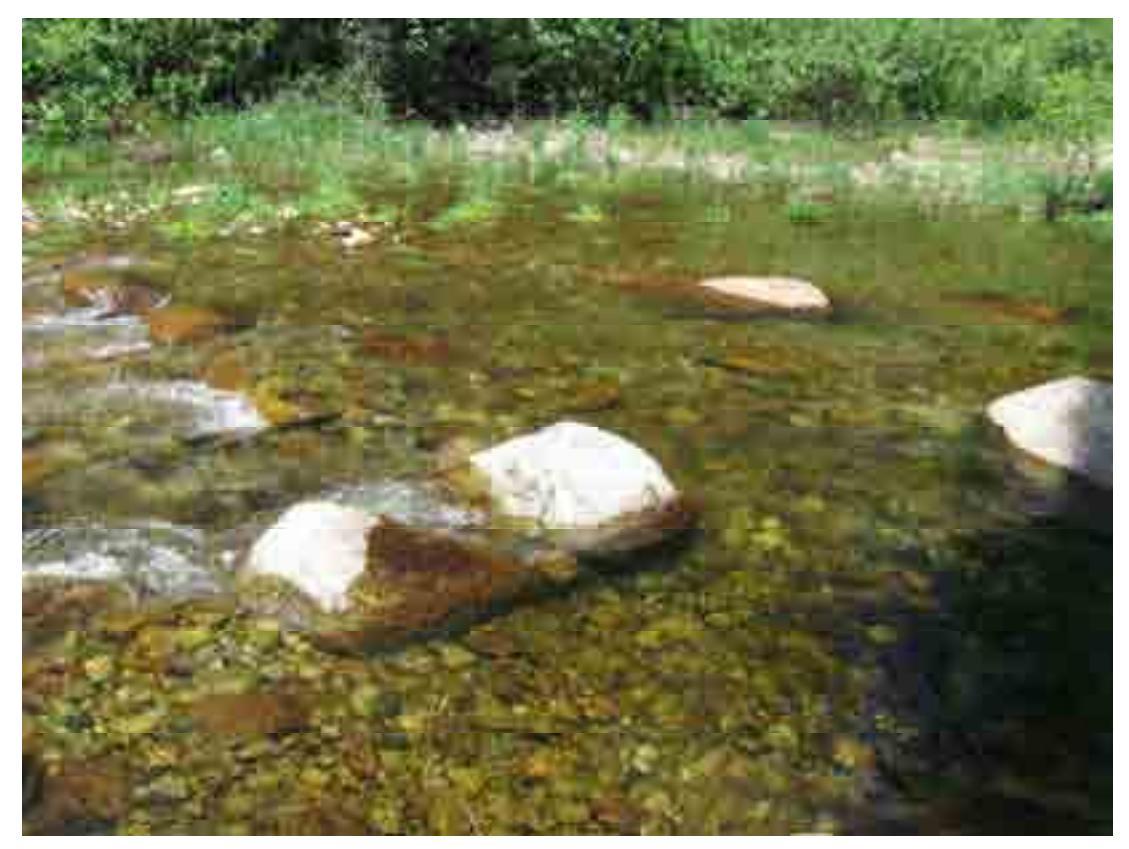
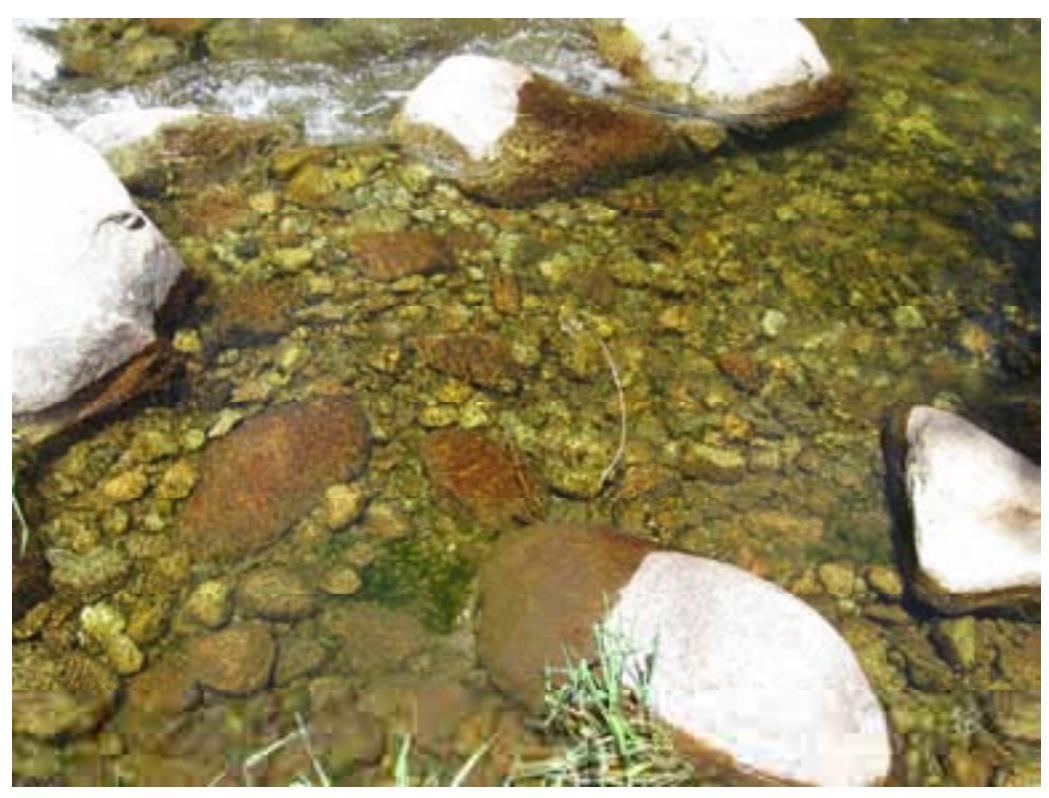
At the Plavada I-80 interchange, SYR conditions were free of films and growths (see Image 118), except for one small area of filamentous green algae shown in the foreground of Image 119.

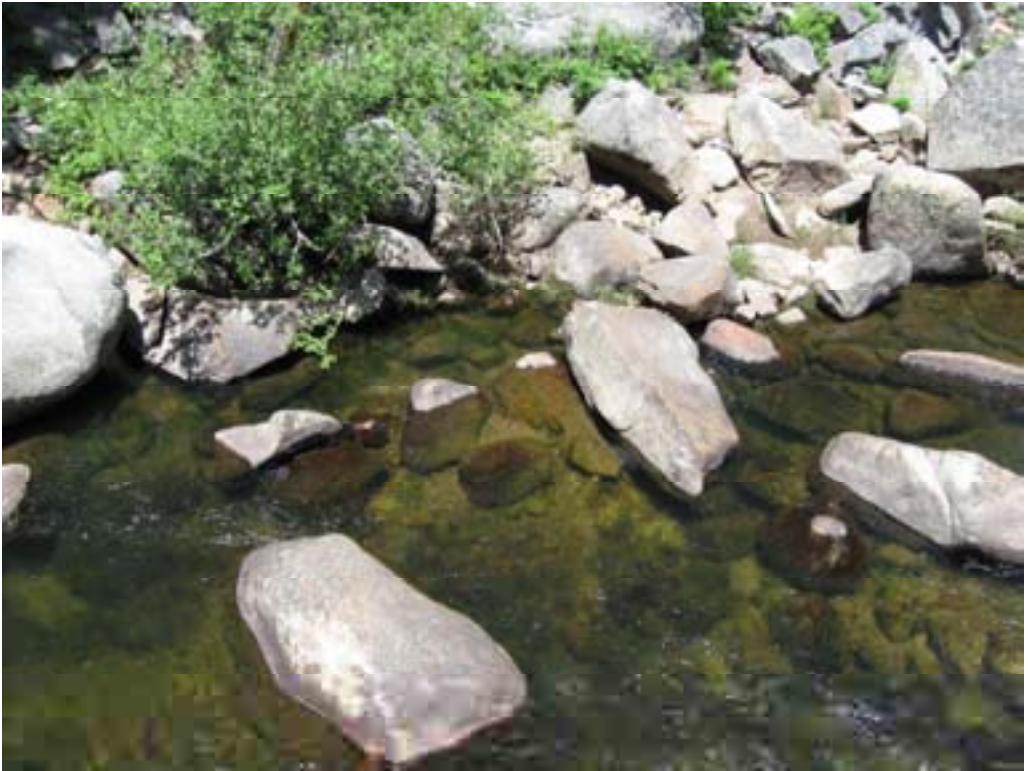
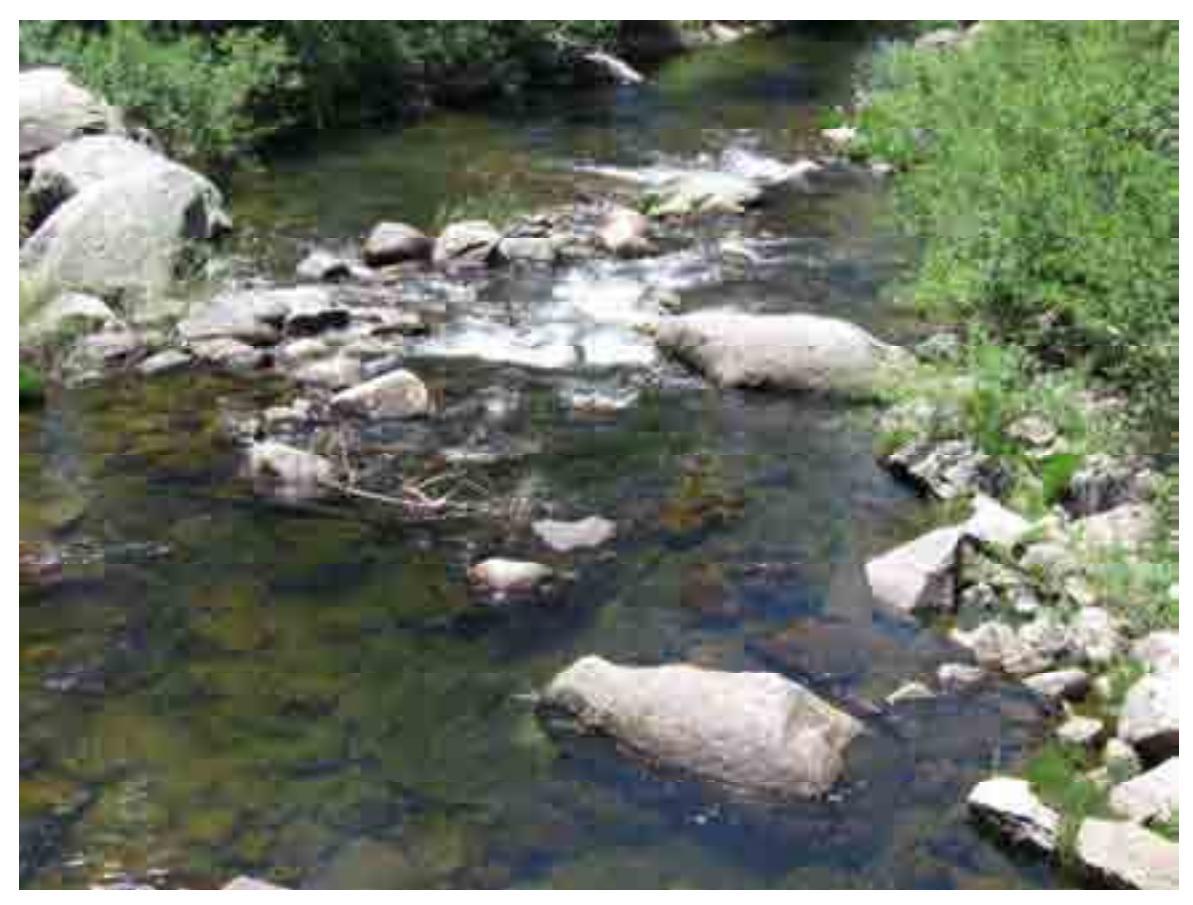
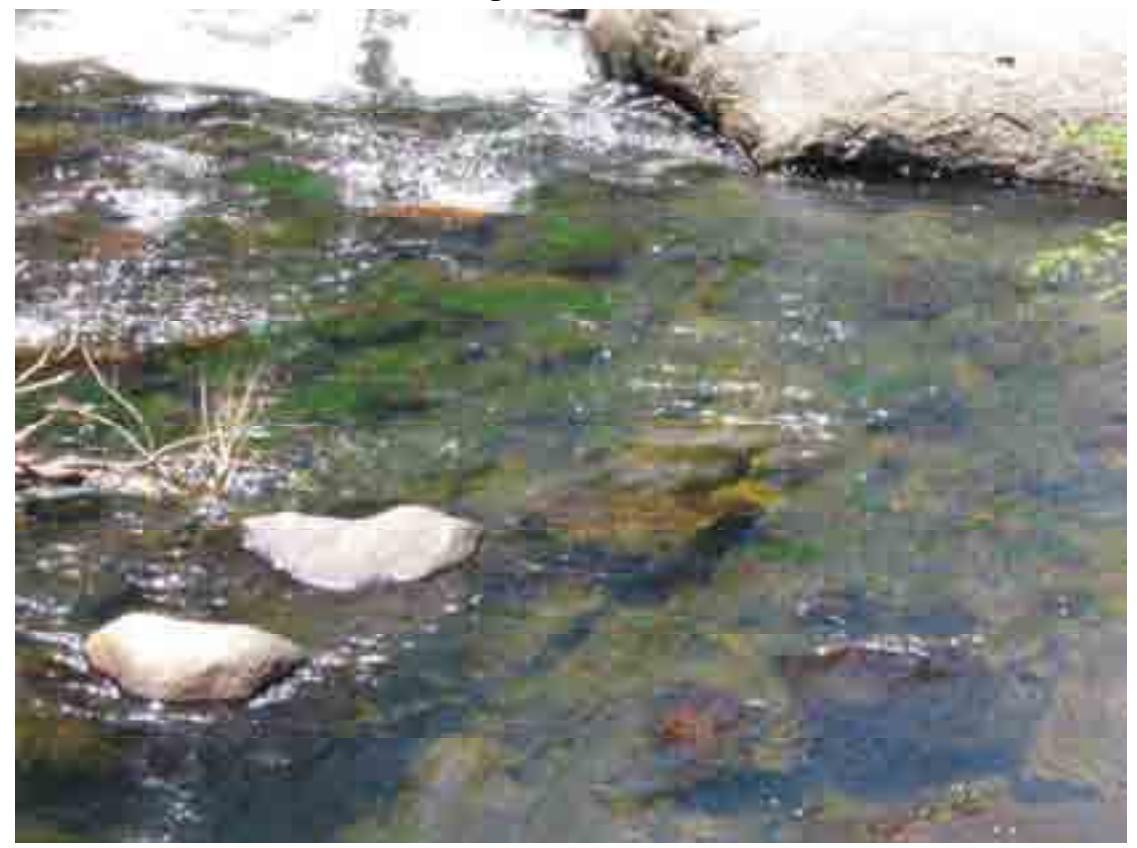
At the US 40 bridge downstream of Cold Springs Campground, the rocks were generally clear of films and filamentous growths as shown in Images 120 and 121. Small tufts of green algae could be seen on the edges of some rocks (e.g., see lower right-hand corner of Image 120). One bloom of filamentous green algae was observed (see the center of Image 121), which is shown in close-up in Image 122.

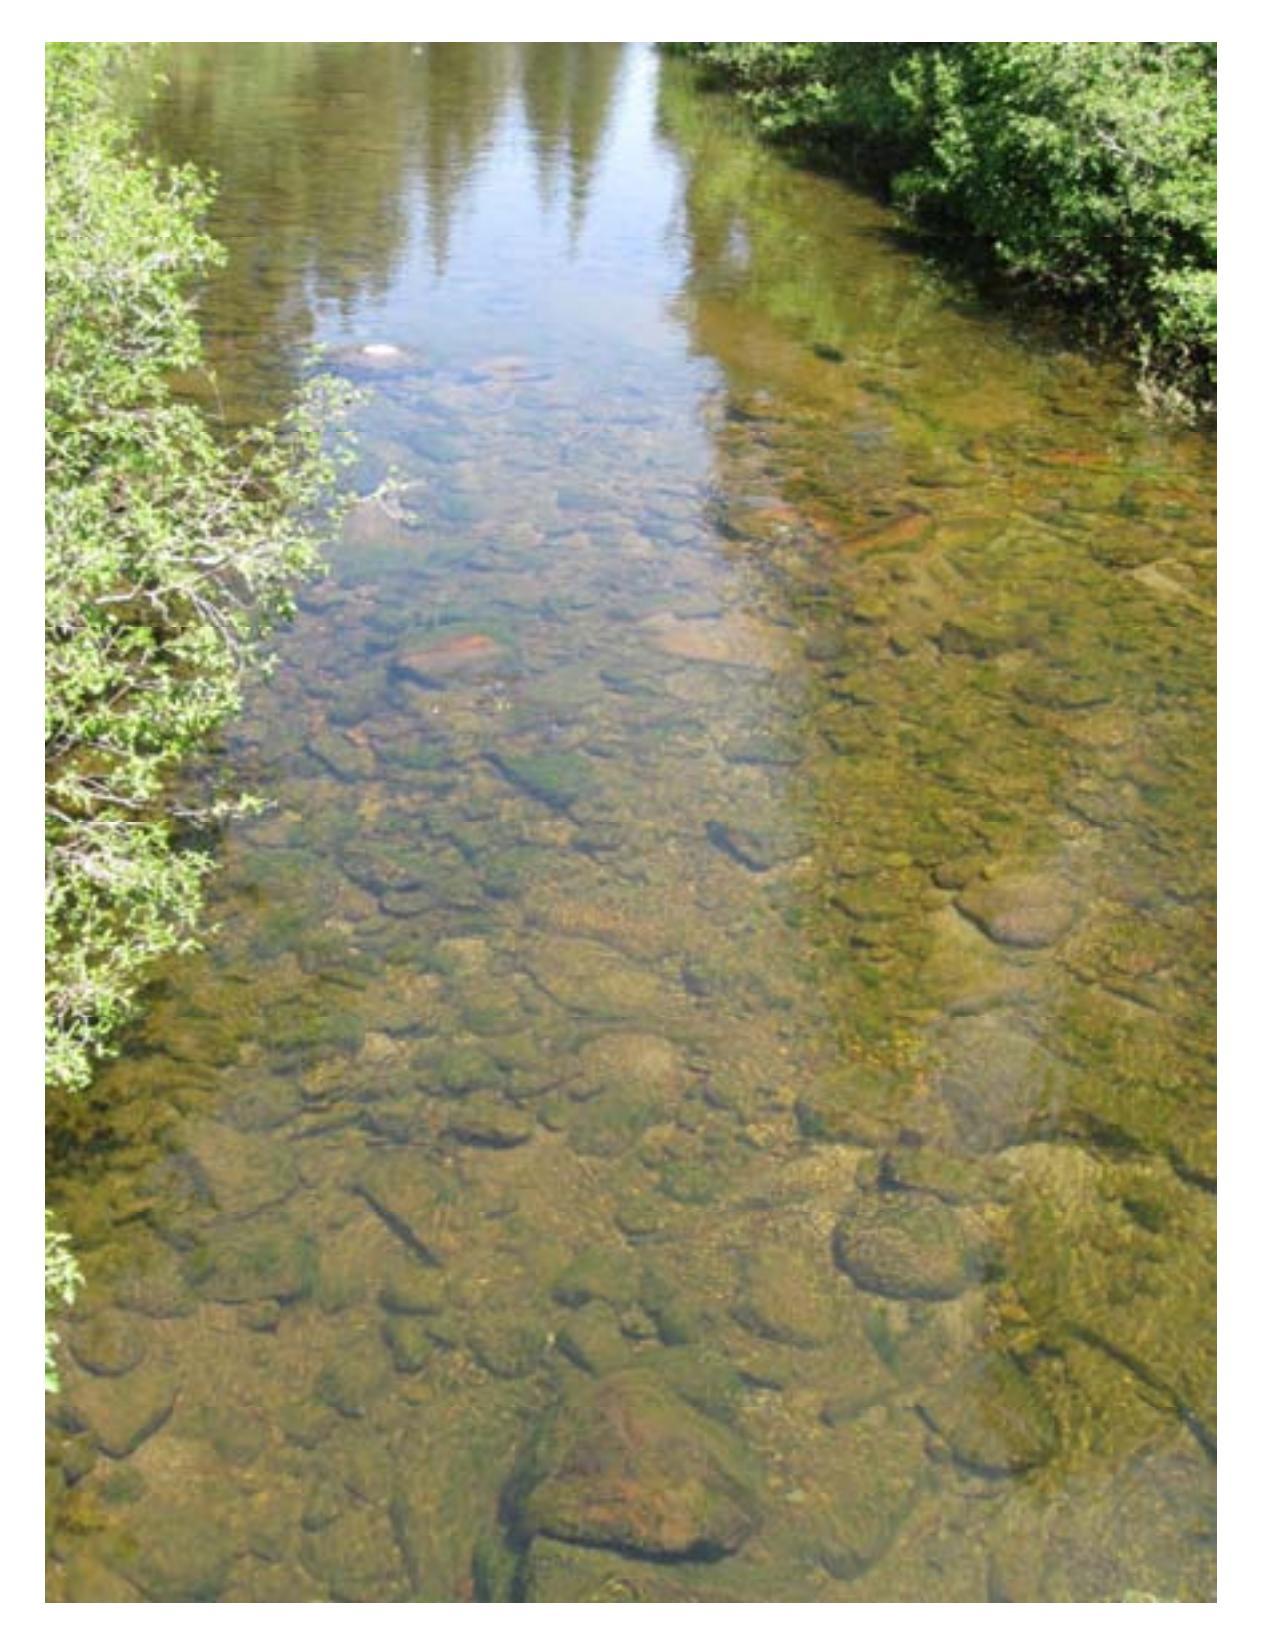
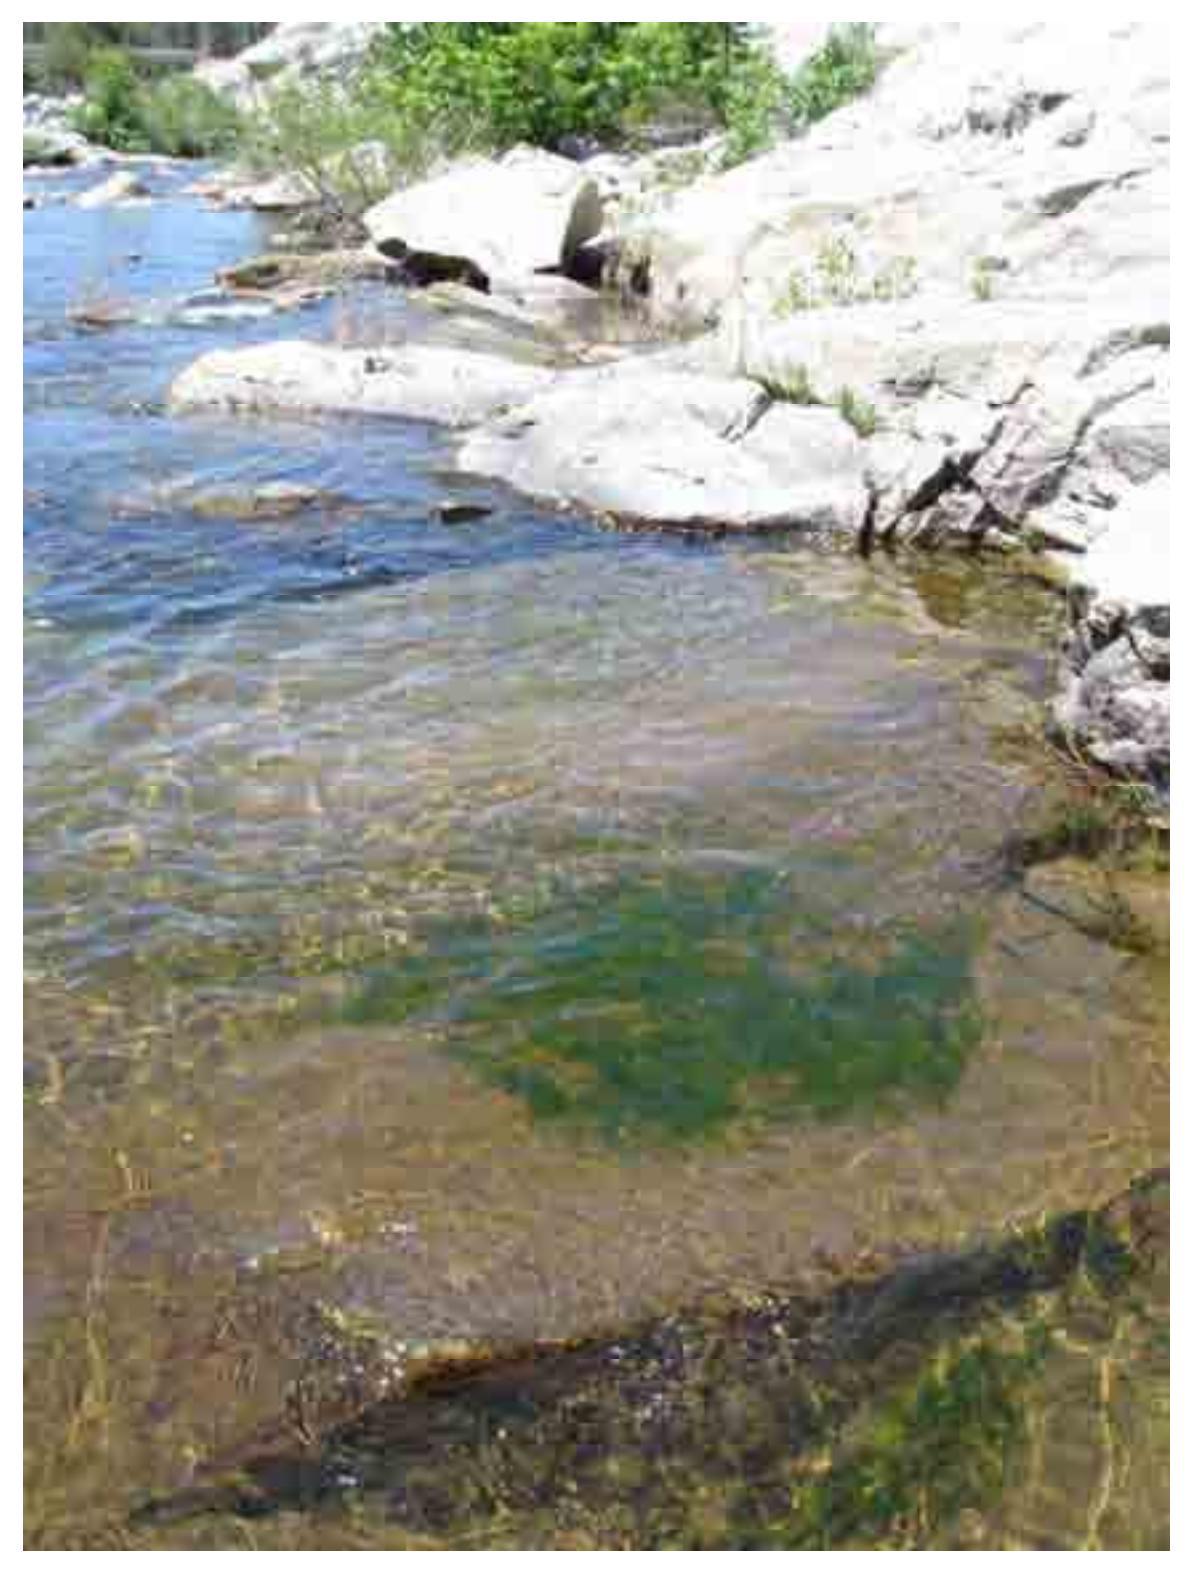
From the small private concrete bridge between US 40 and I-80, brown films and some green growths were evident in the upstream still water (see Image 123). Some more filamentous green algae were evident in the more rushing downstream waters (see Image 124).

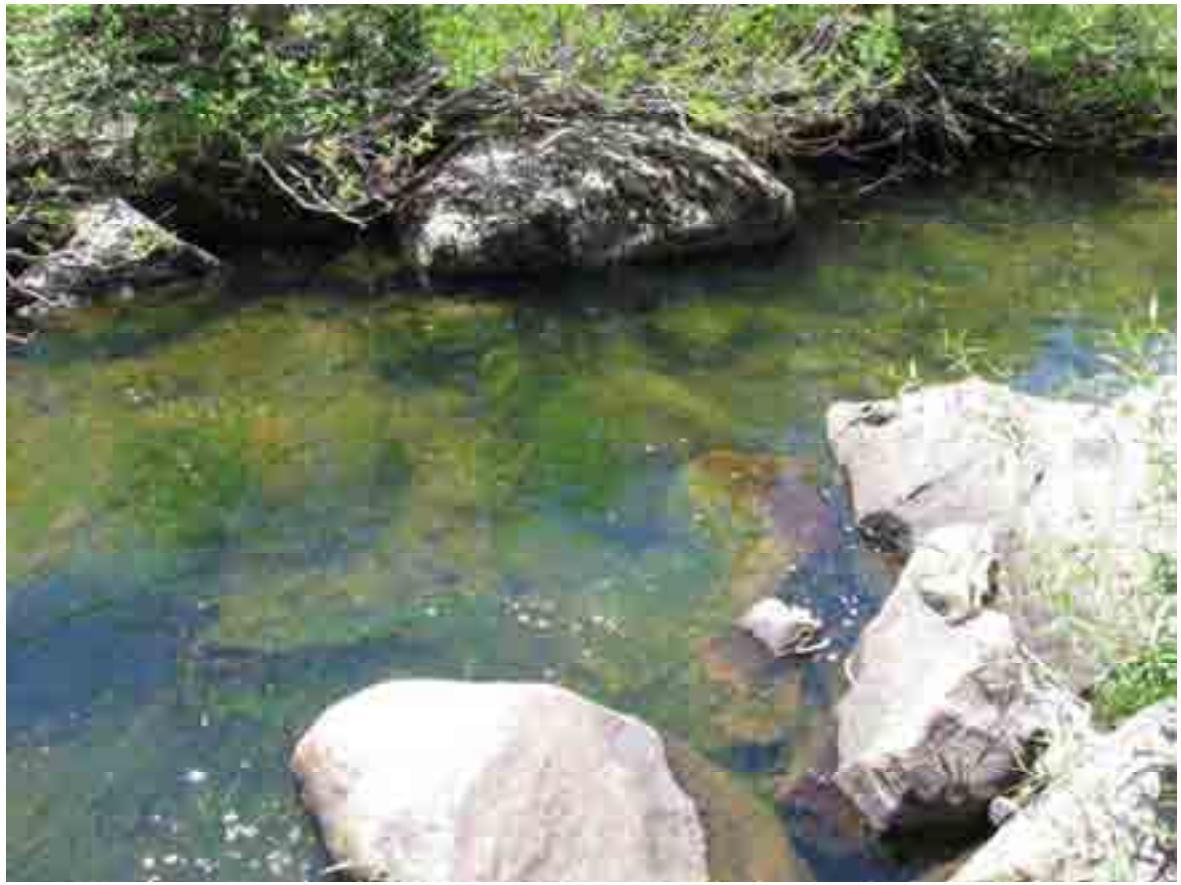
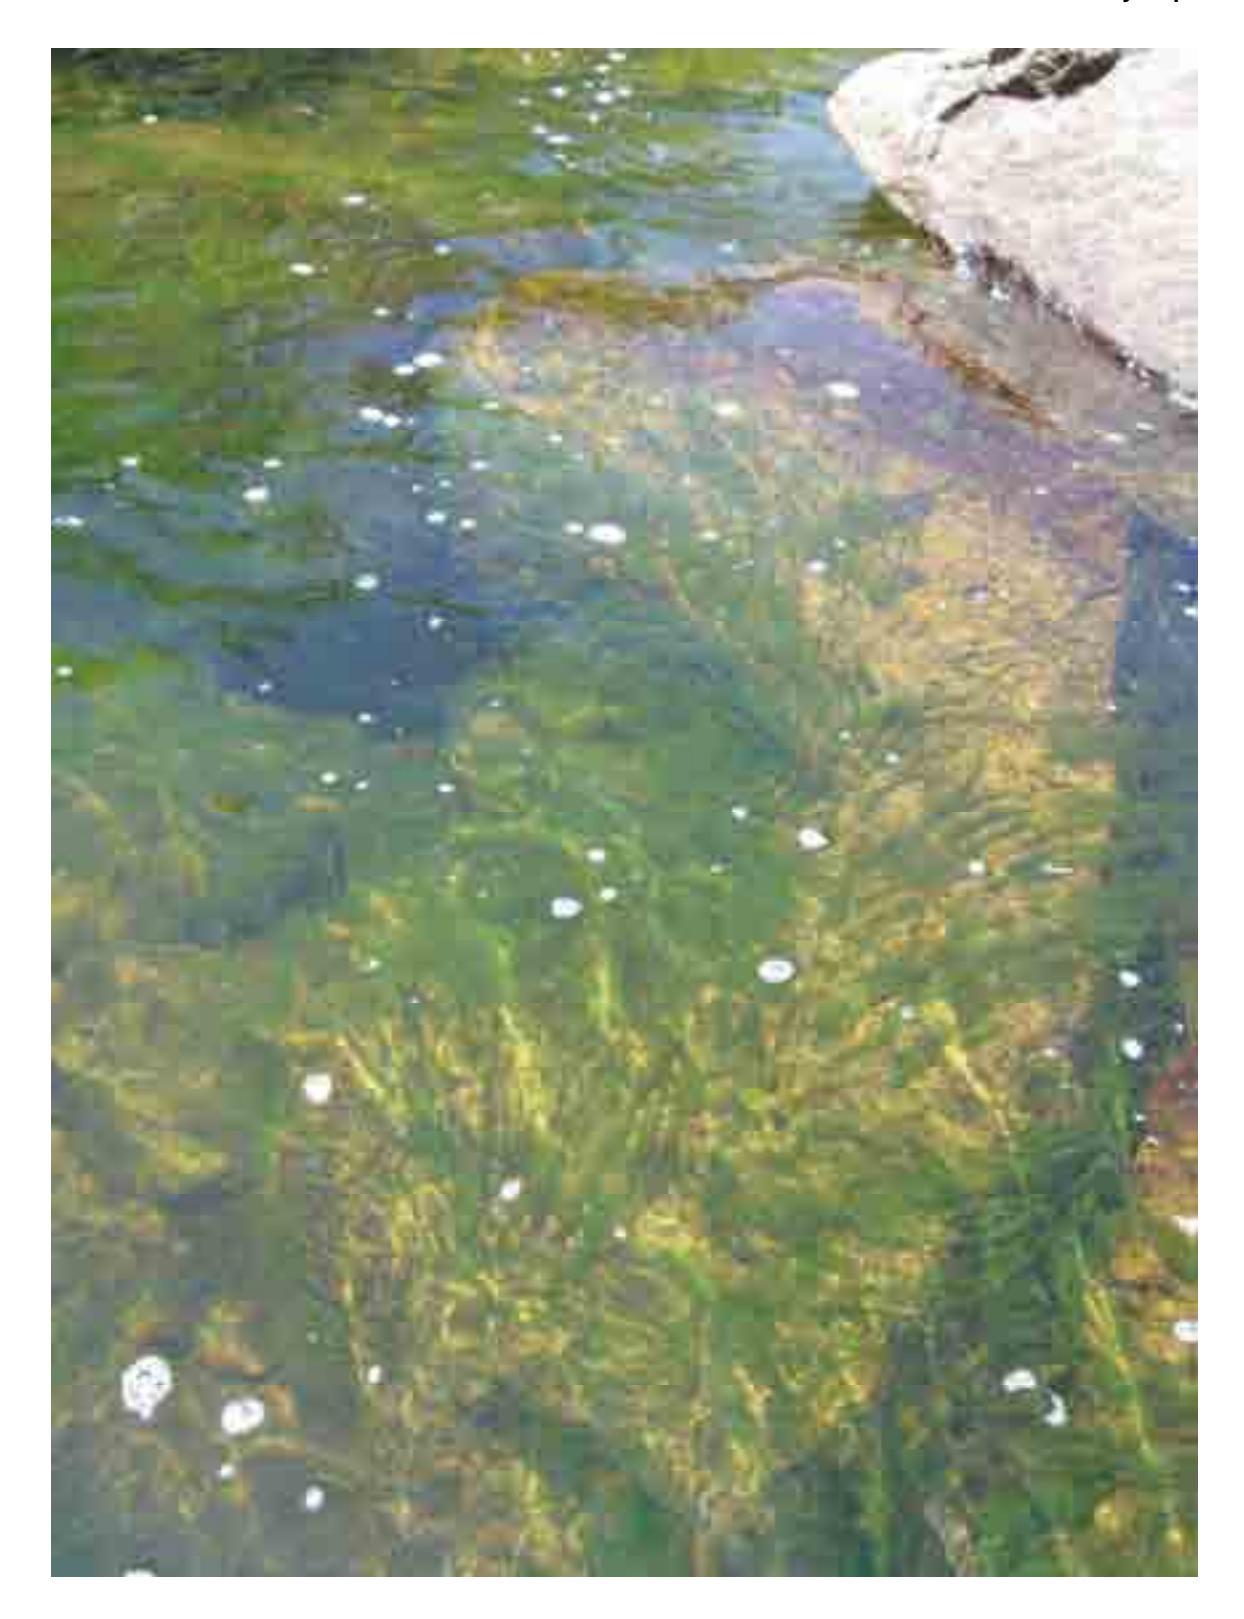
Above Hampshire Rocks Campground, long filamentous algae continued to be vital and evident as shown in Images 125, 126, and 127.
