#### **RE: Donner Summit Public Utility District Biostimulatory Substances Study**

Photo Essay Report No. 3 South Yuba River Biostimulation Photo Essay Report

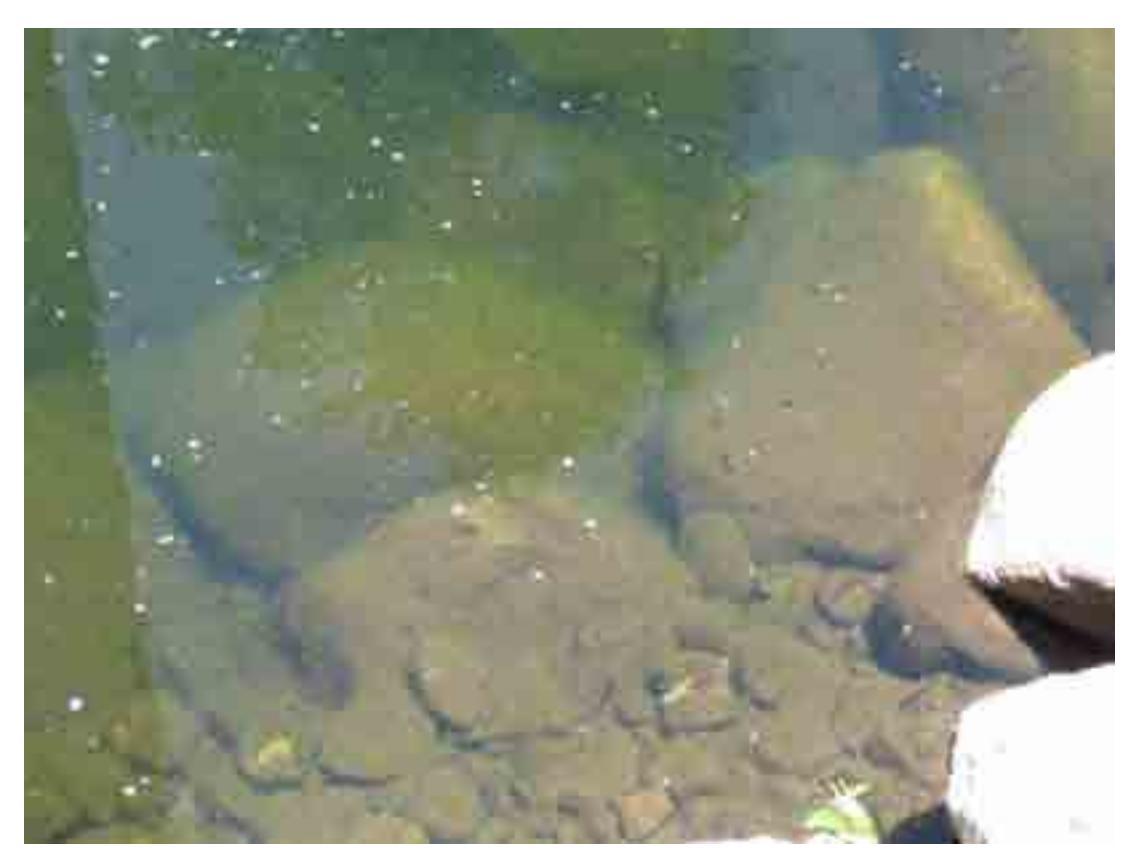
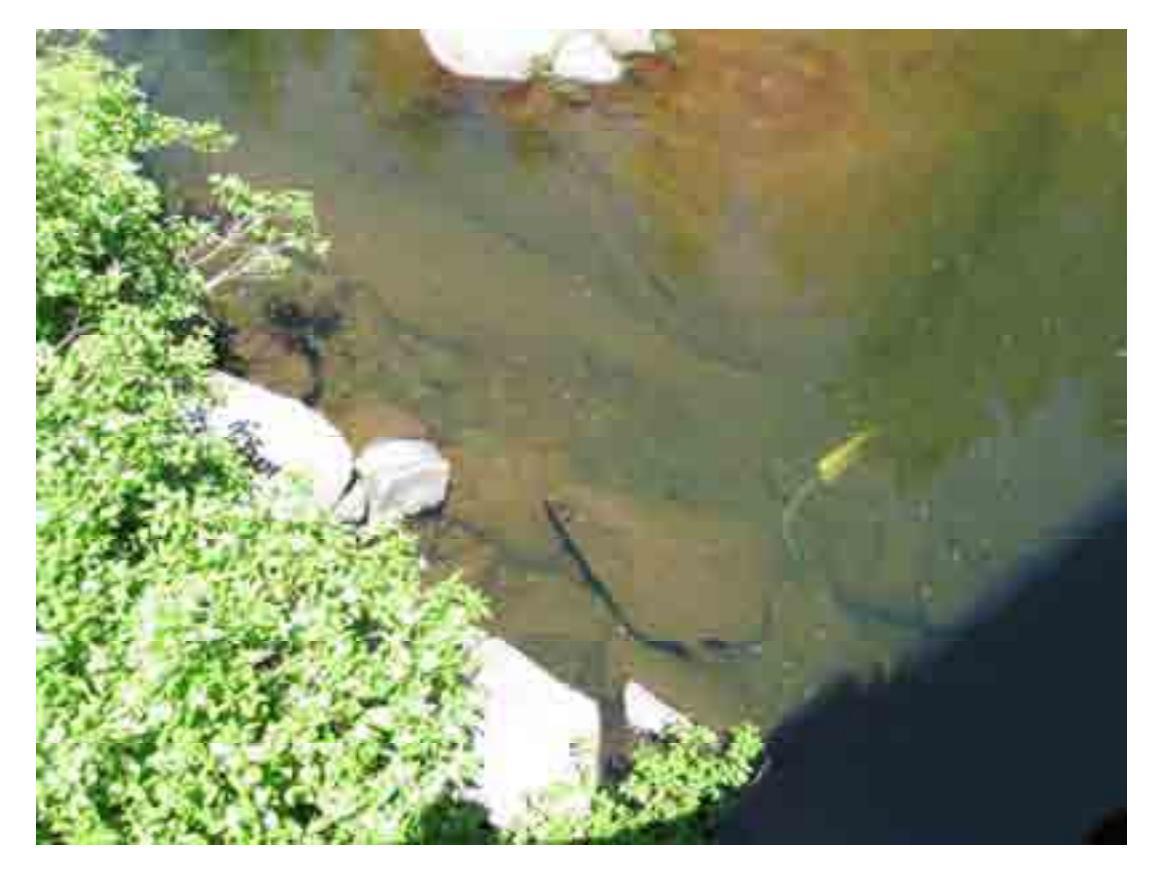
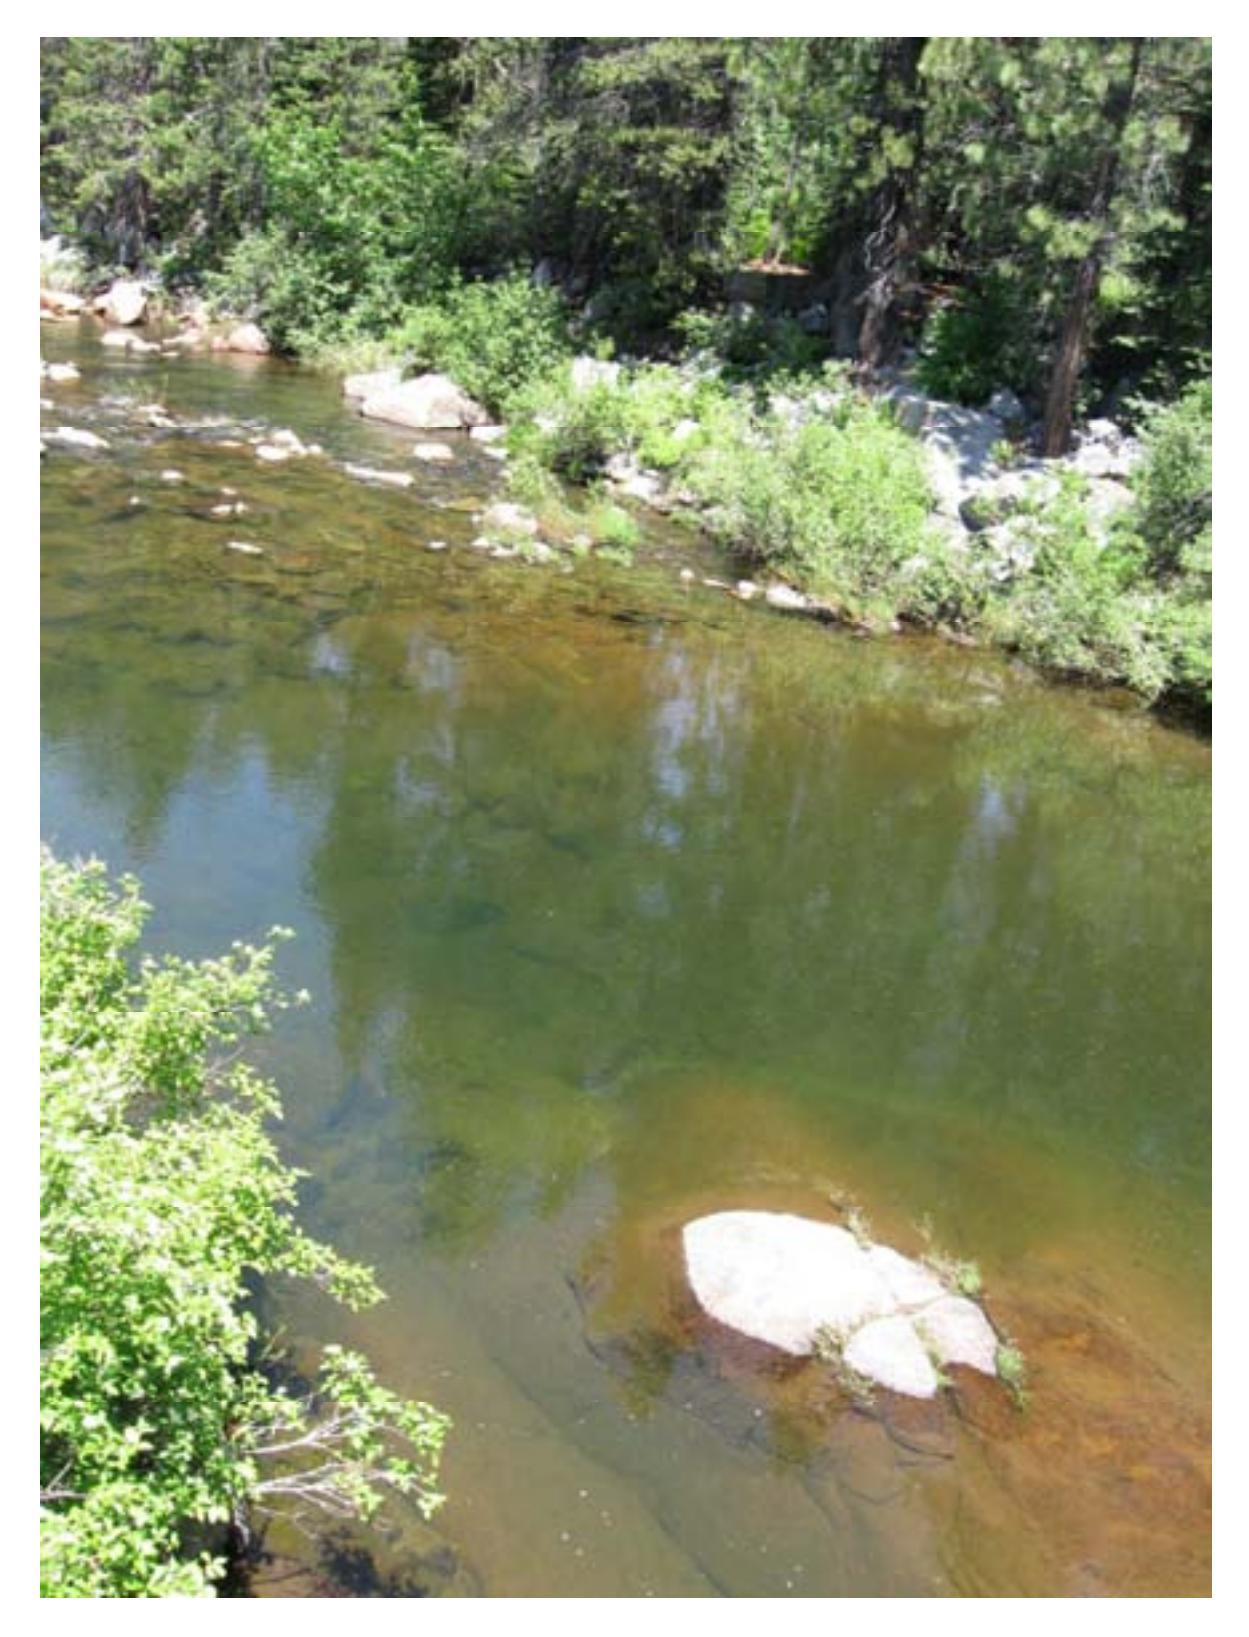
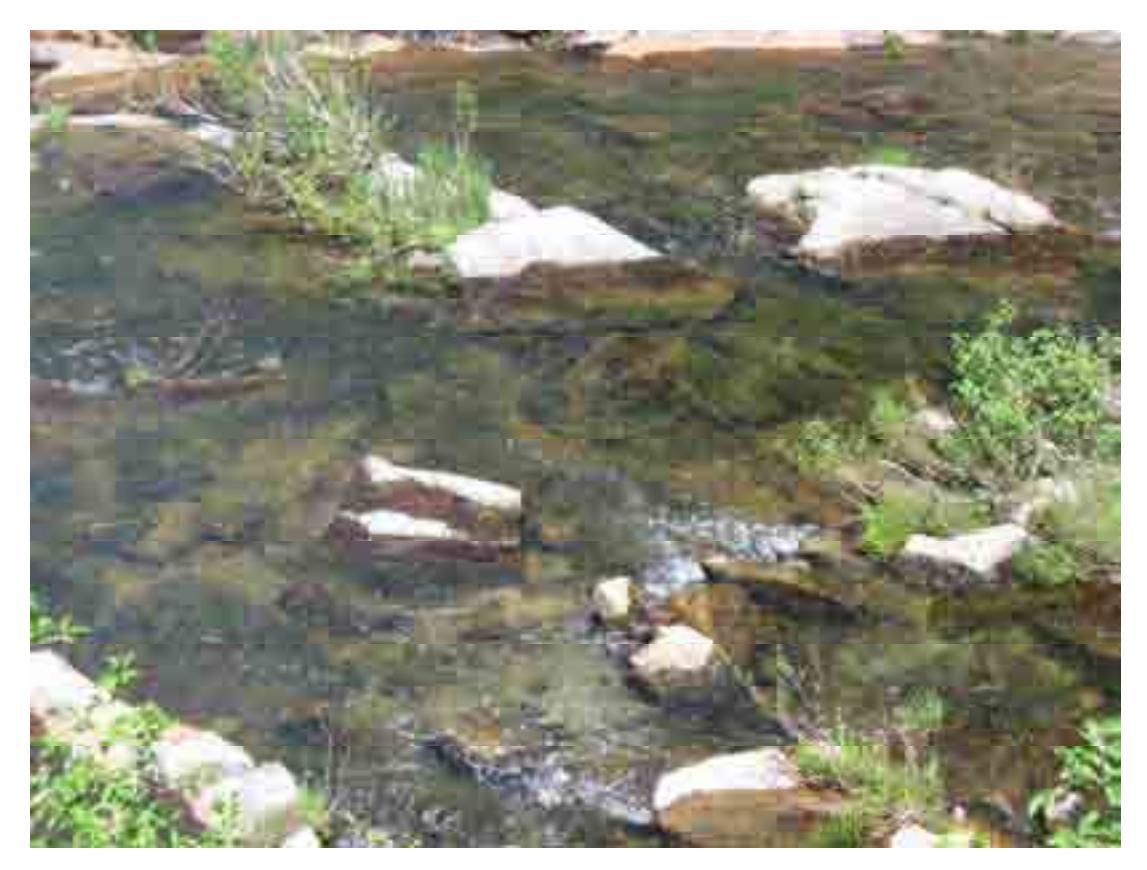
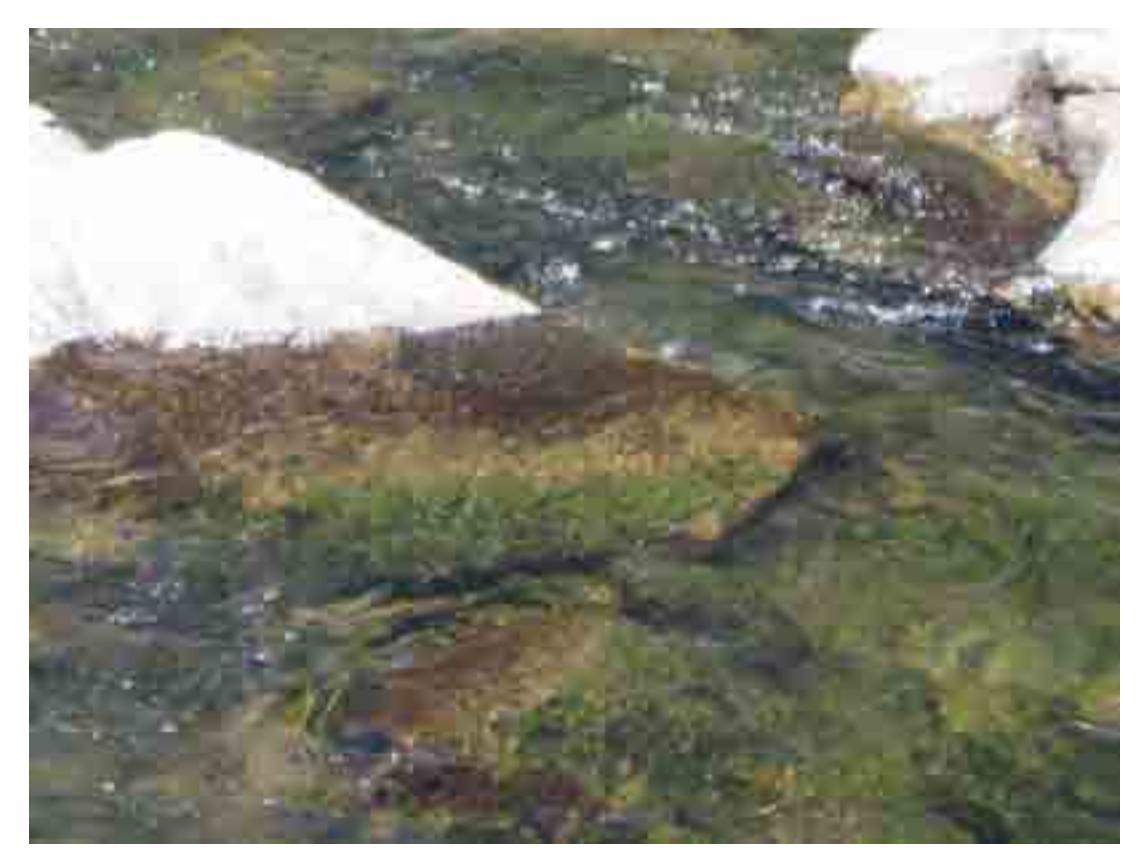
At Rainbow Lodge bridge pool, brown films and relatively sparse growths of filamentous green algae were evident as shown in Image 128. The depth of the water at this location allowed the overall greenish color of the water to be more evident as shown by Images 129 and 130. In flowing, shallower water just downstream of the Rainbow Lodge bridge pool the SYR is relatively clear and clean with green filamentous algae being present on the edges of some rocks (see the base of the large emergent rock in the upper center of Image 131, shown close-up in Image 132).

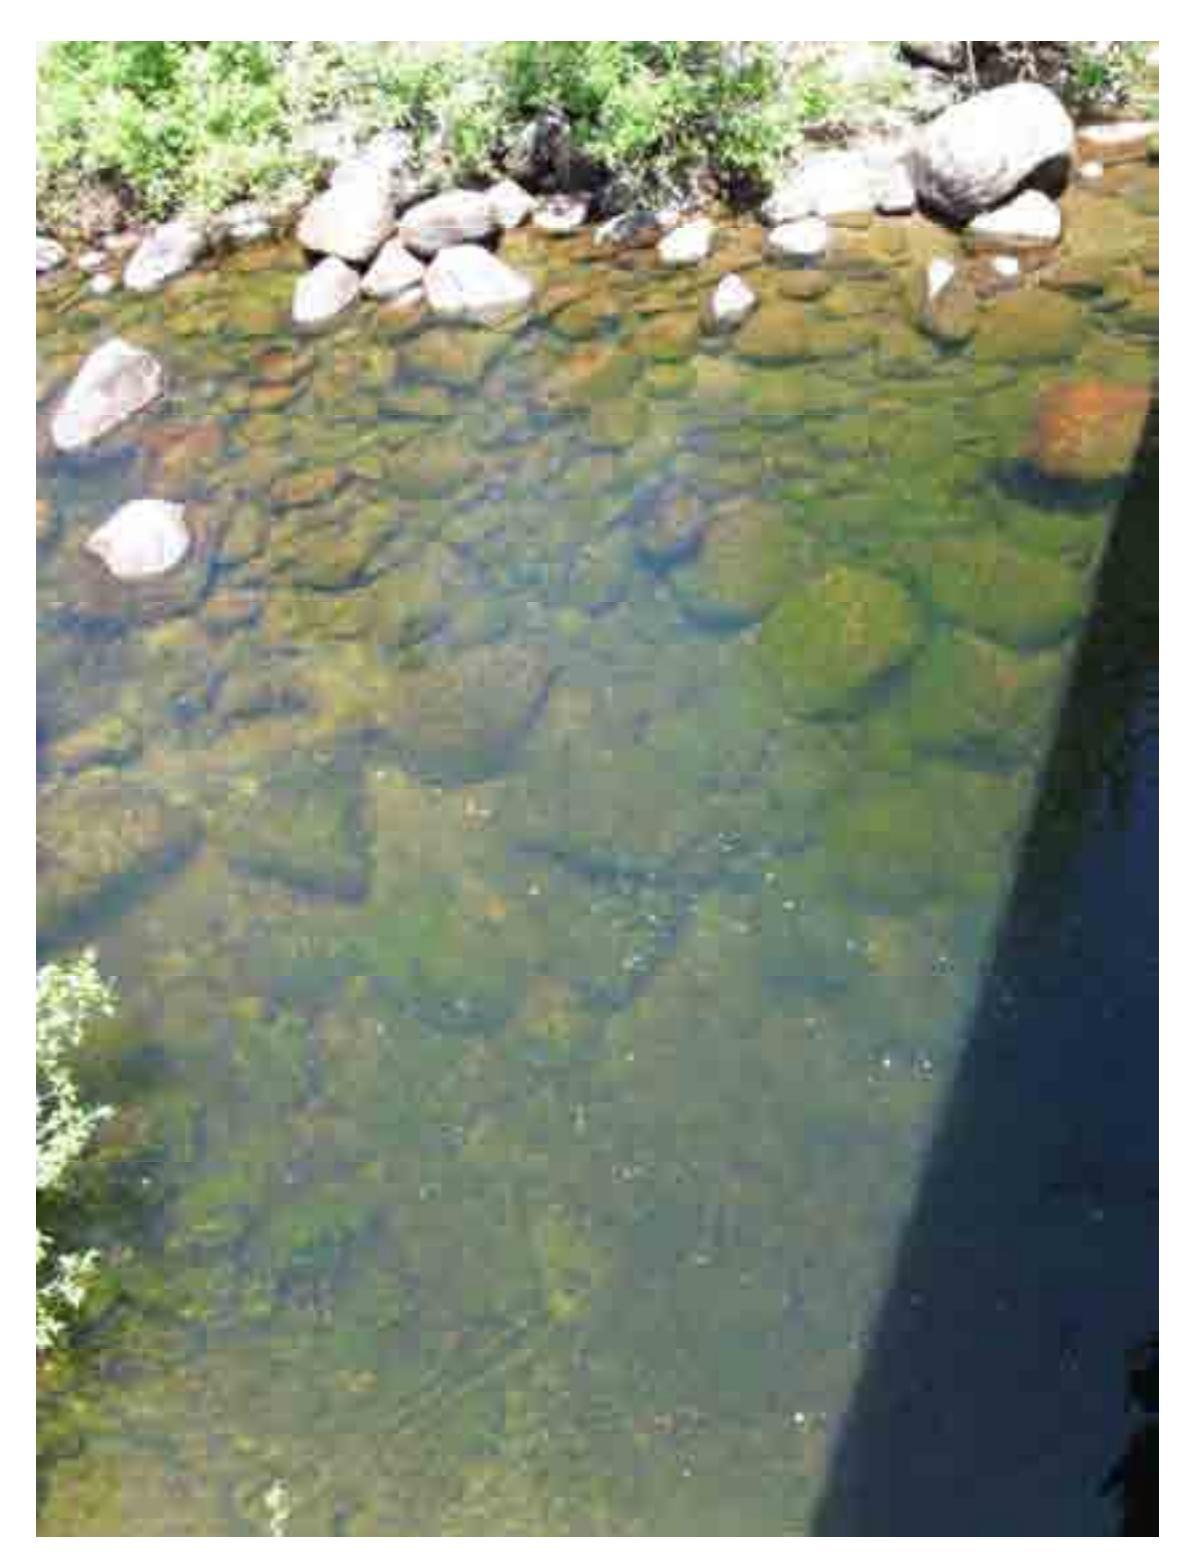
Image 133 (N)

At Big Bend bridge, general coatings of filamentous green algae were evident on many rocks as shown in Image 133.

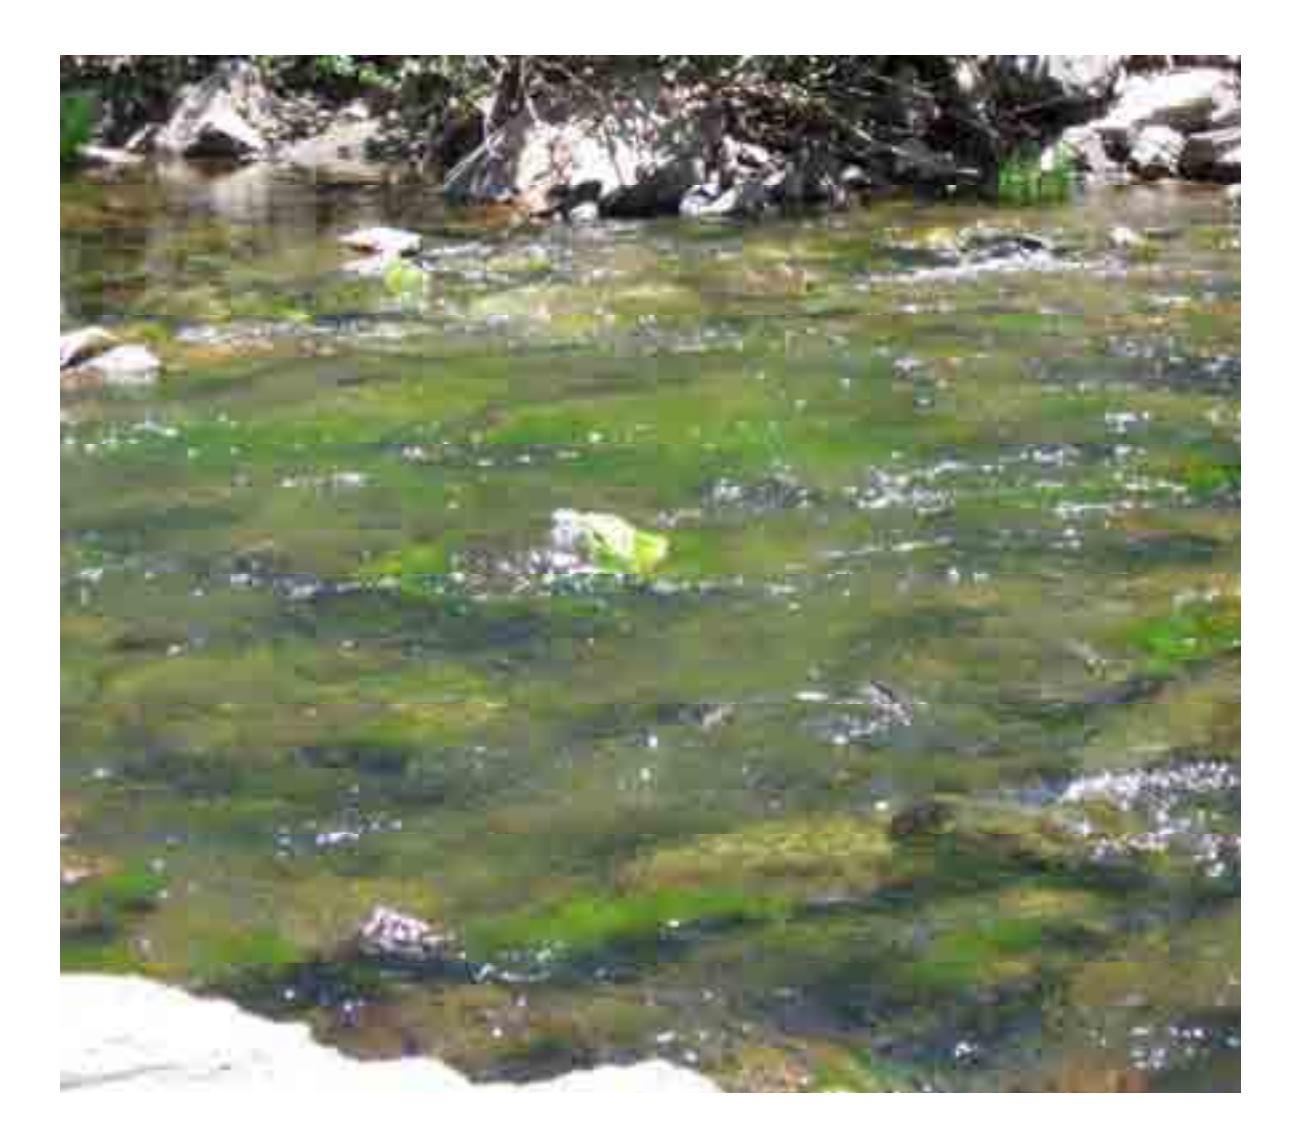
## Image 134 (O)

In the gorge between Rainbow Lodge and Cisco Grove, green filamentous algae growths continued to be vital and evident as shown in Image 134.

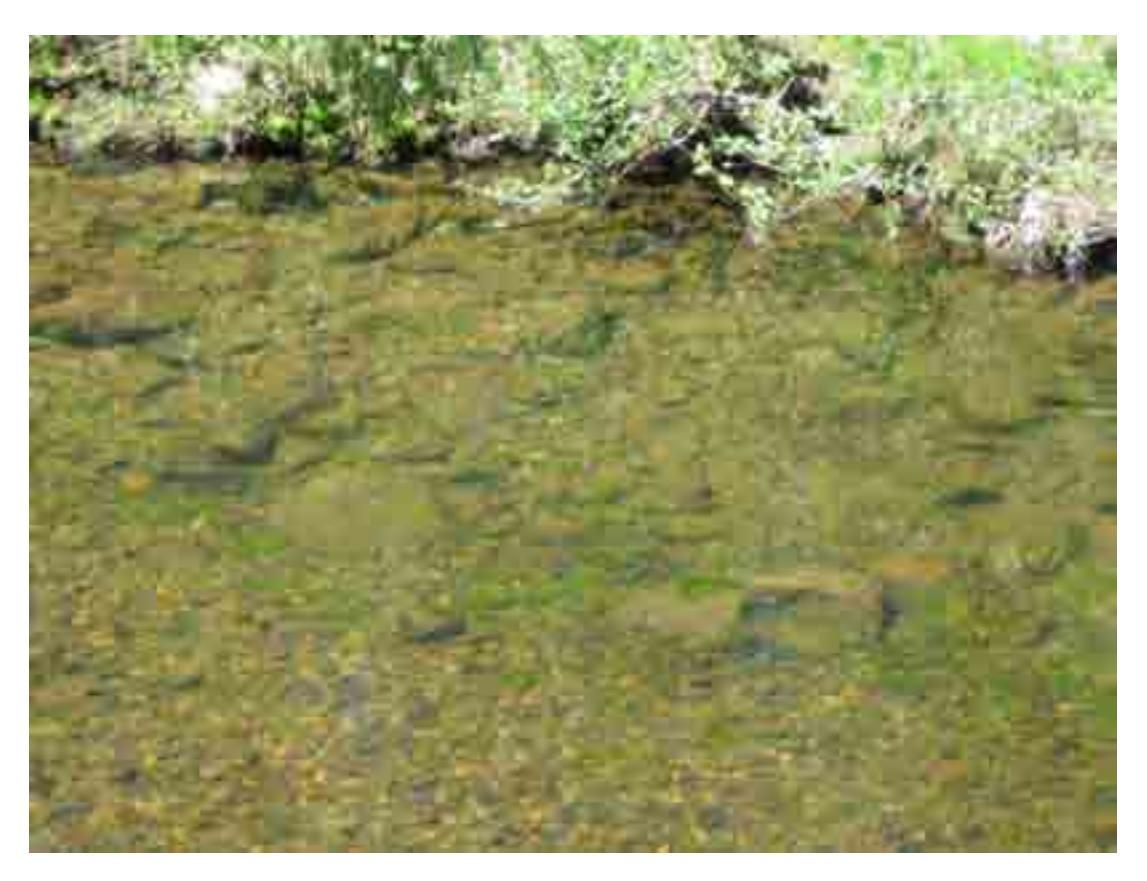
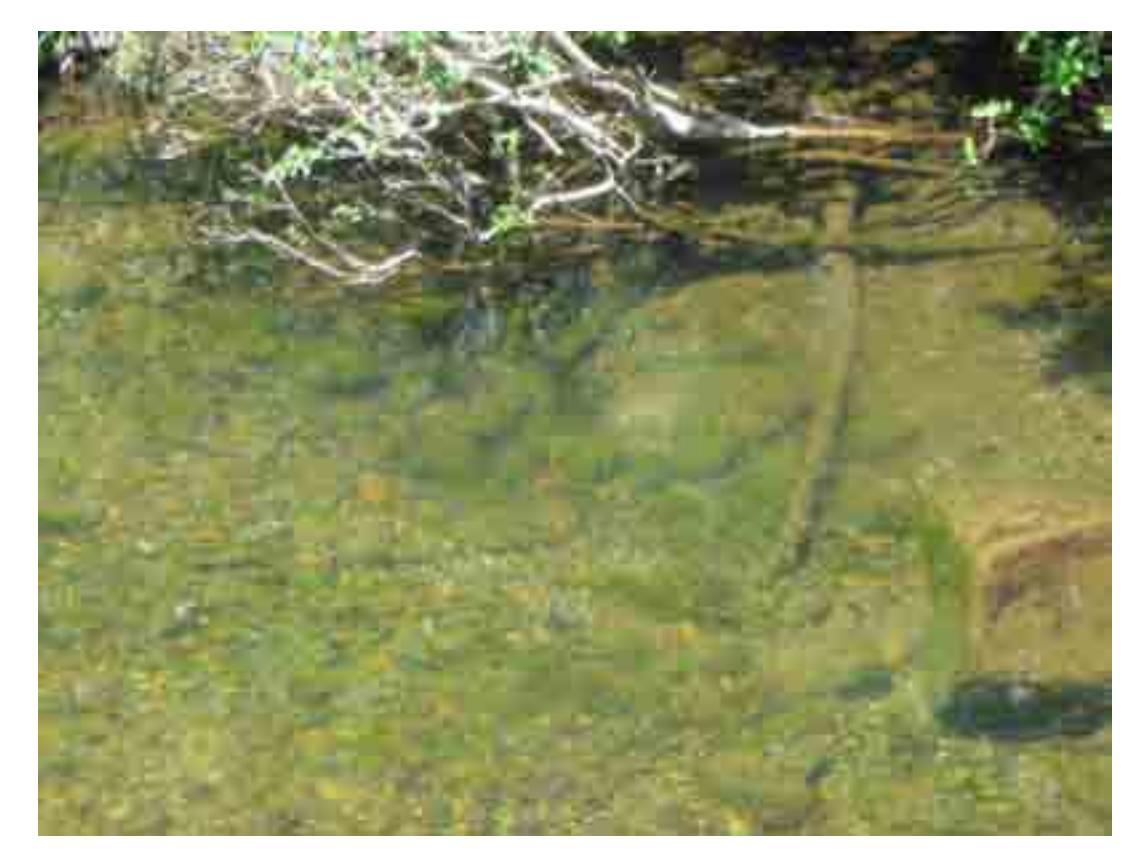
At the Cisco Grove bridge, brown films covered many of the rocks, and tufts of filamentous algae were present as shown in Images 135 and 136. these tufts tended to be in areas of deeper flowing water, and on the edges of rocks, possibly suggesting a sensitivity of over exposure to sunlight.
